## **Appendix B**

### **Beach Profile Plots**

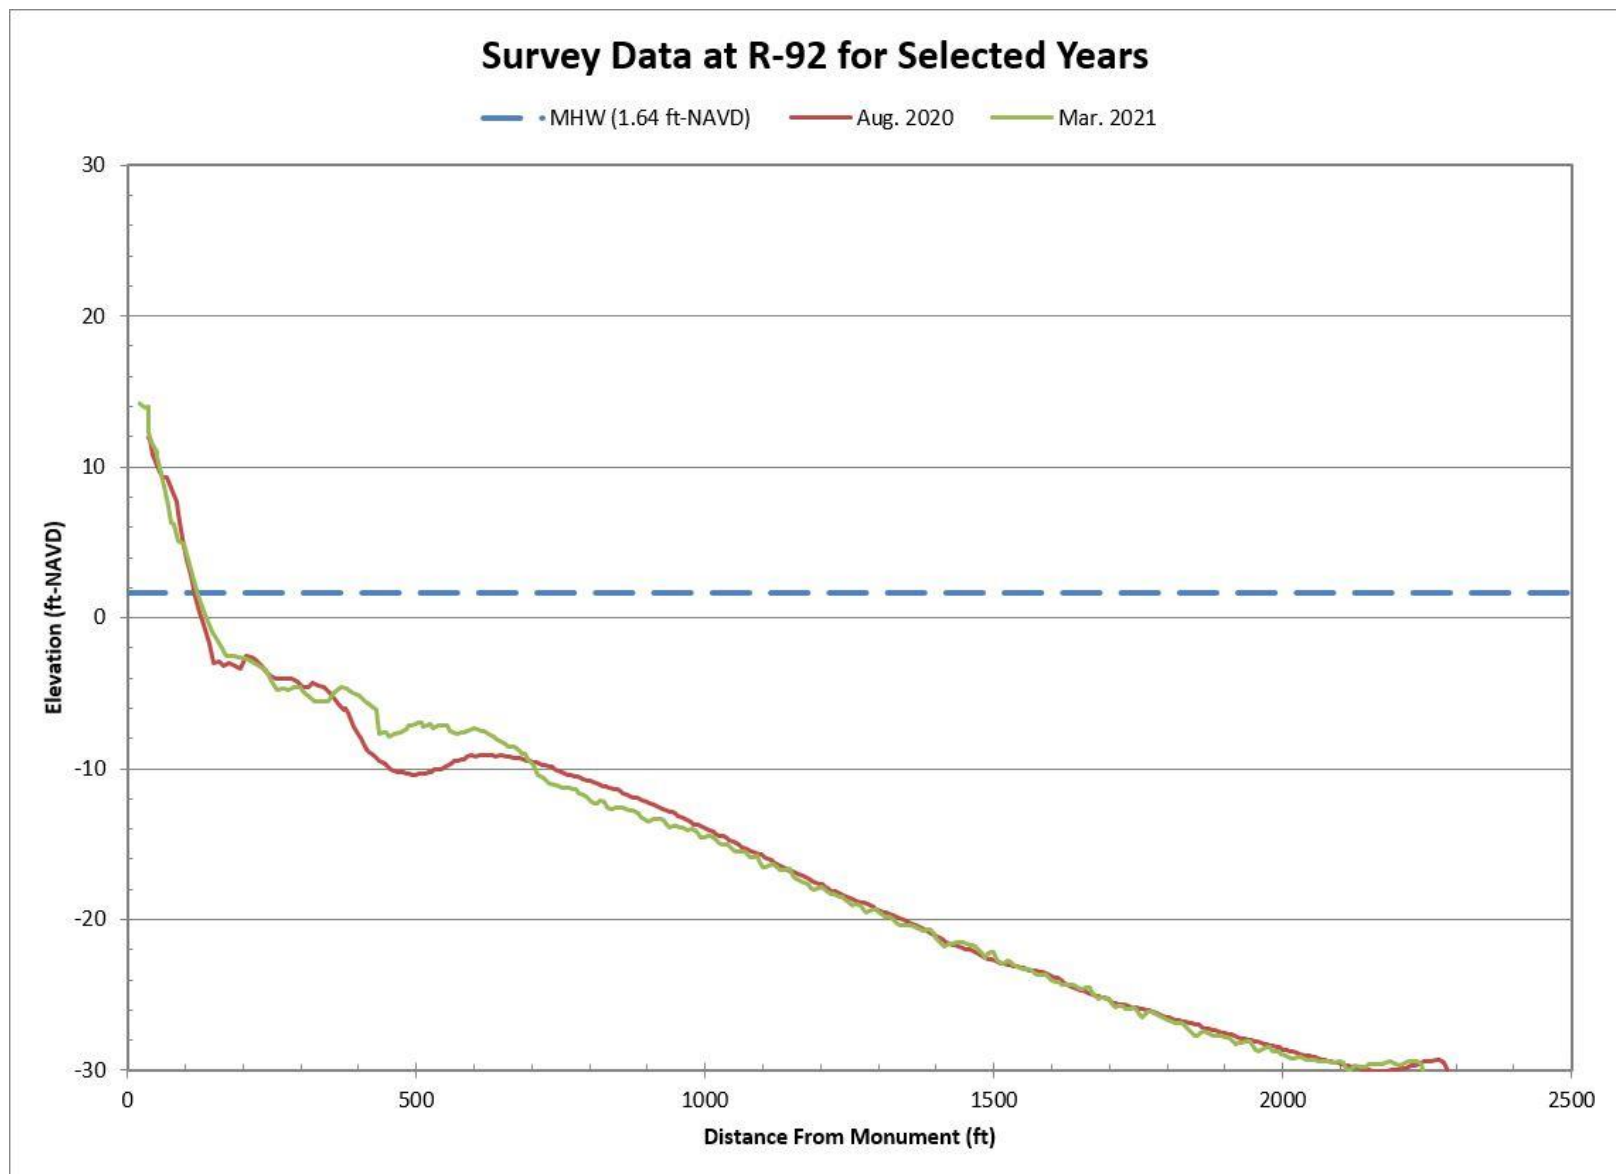
**Figure B-13. Aug. 2020 Pre-Construction vs. Mar. 2021 Post-Construction Beach Profiles Along R-92**

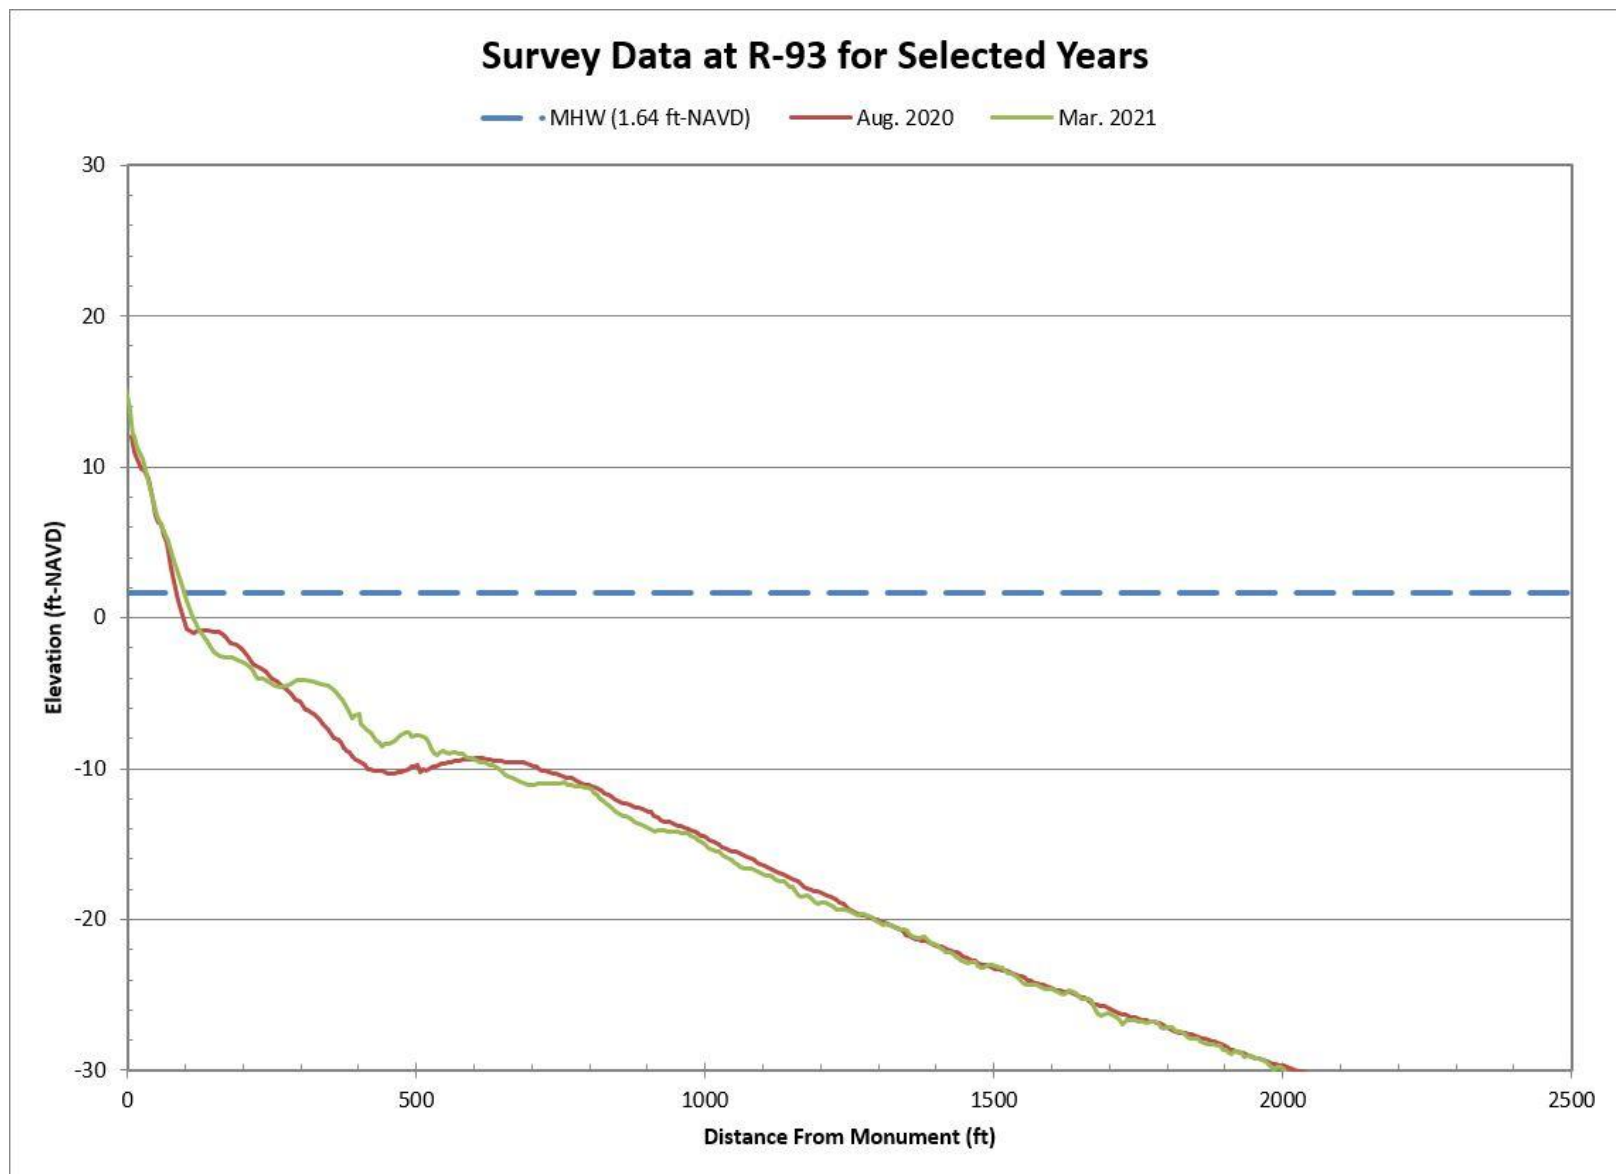
**Figure B-14. Aug. 2020 Pre-Construction vs. Mar. 2021 Post-Construction Beach Profiles Along R-93**

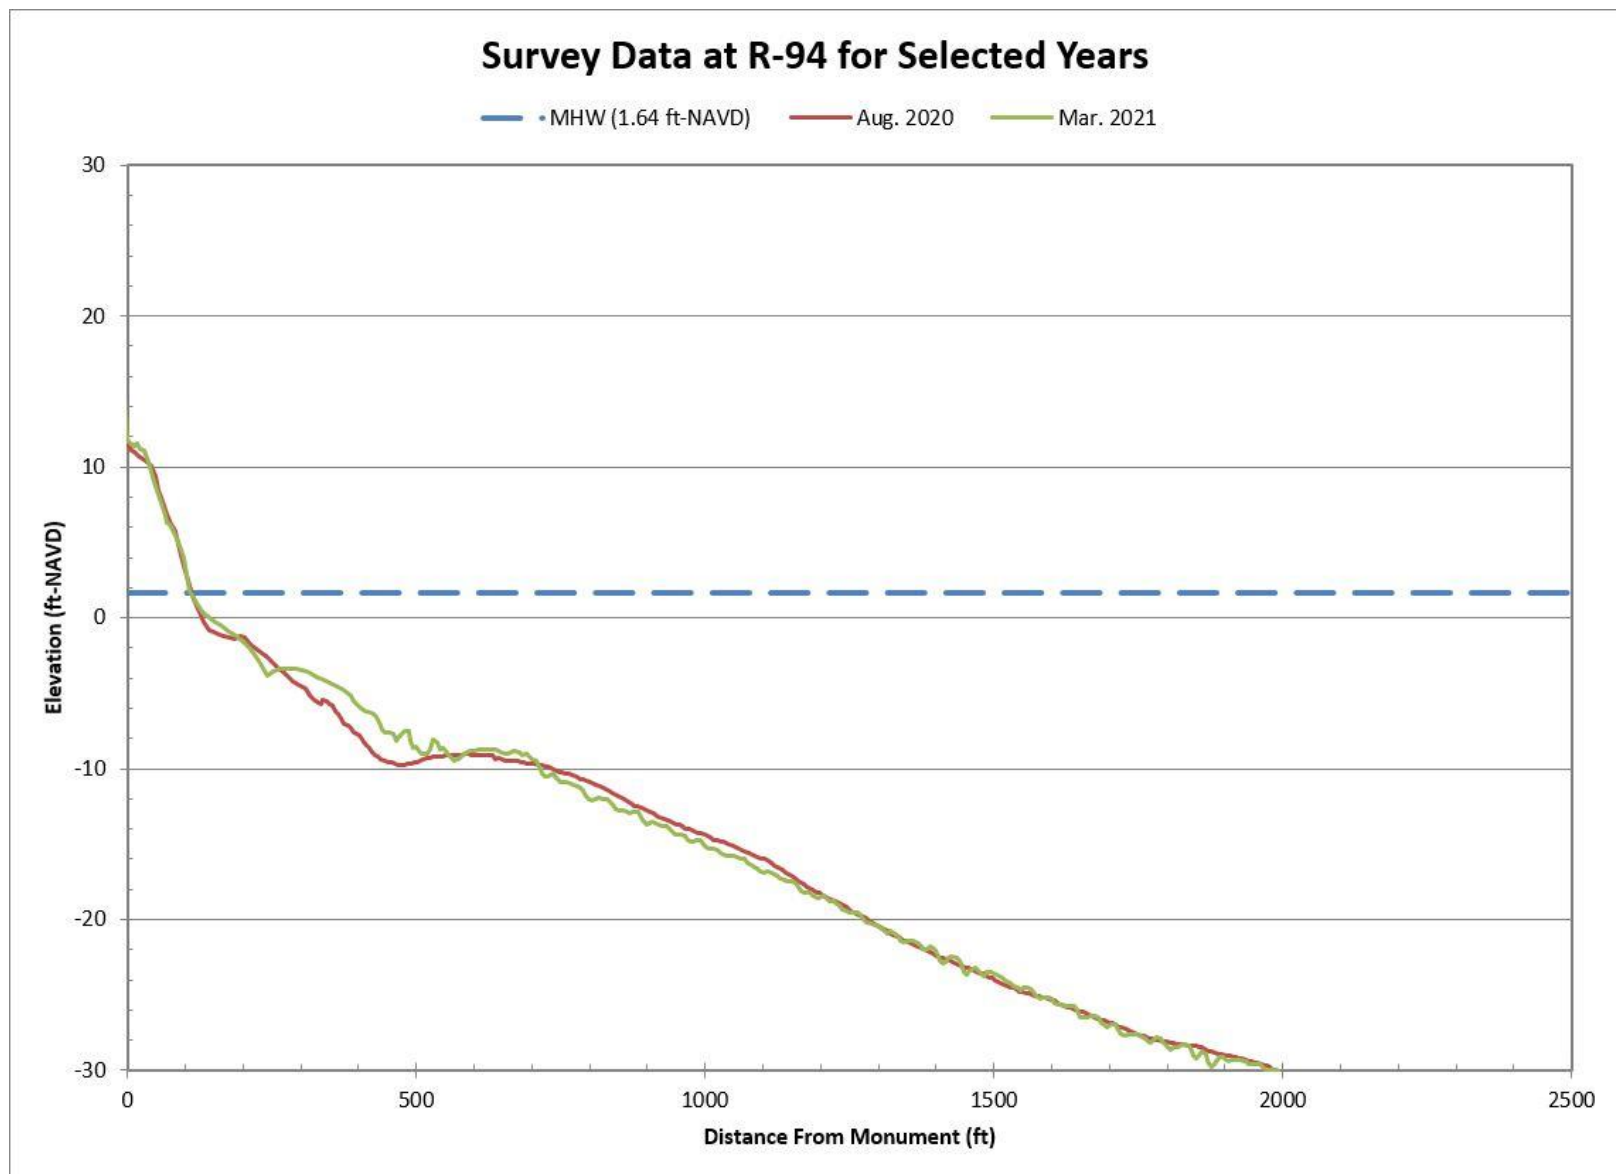
**Figure B-15. Aug. 2020 Pre-Construction vs. Mar. 2021 Post-Construction Beach Profiles Along R-94**

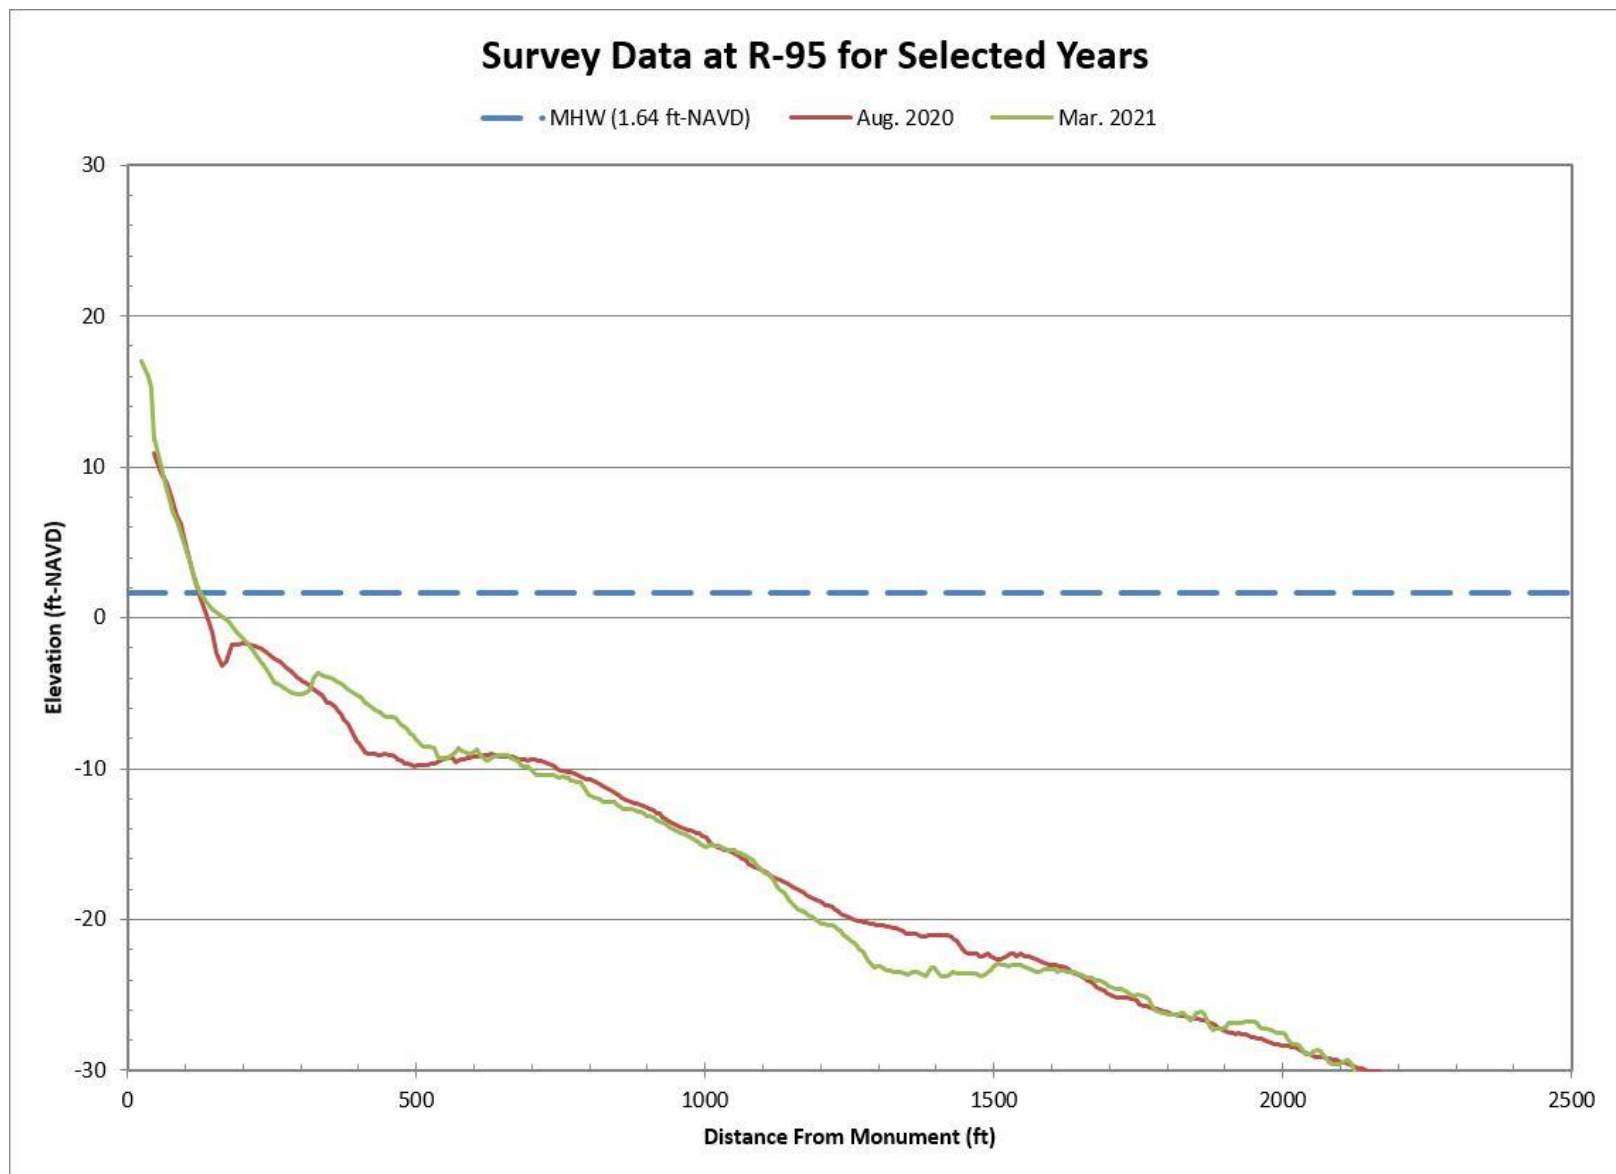
**Figure B-16. Aug. 2020 Pre-Construction vs. Mar. 2021 Post-Construction Beach Profiles Along R-95**

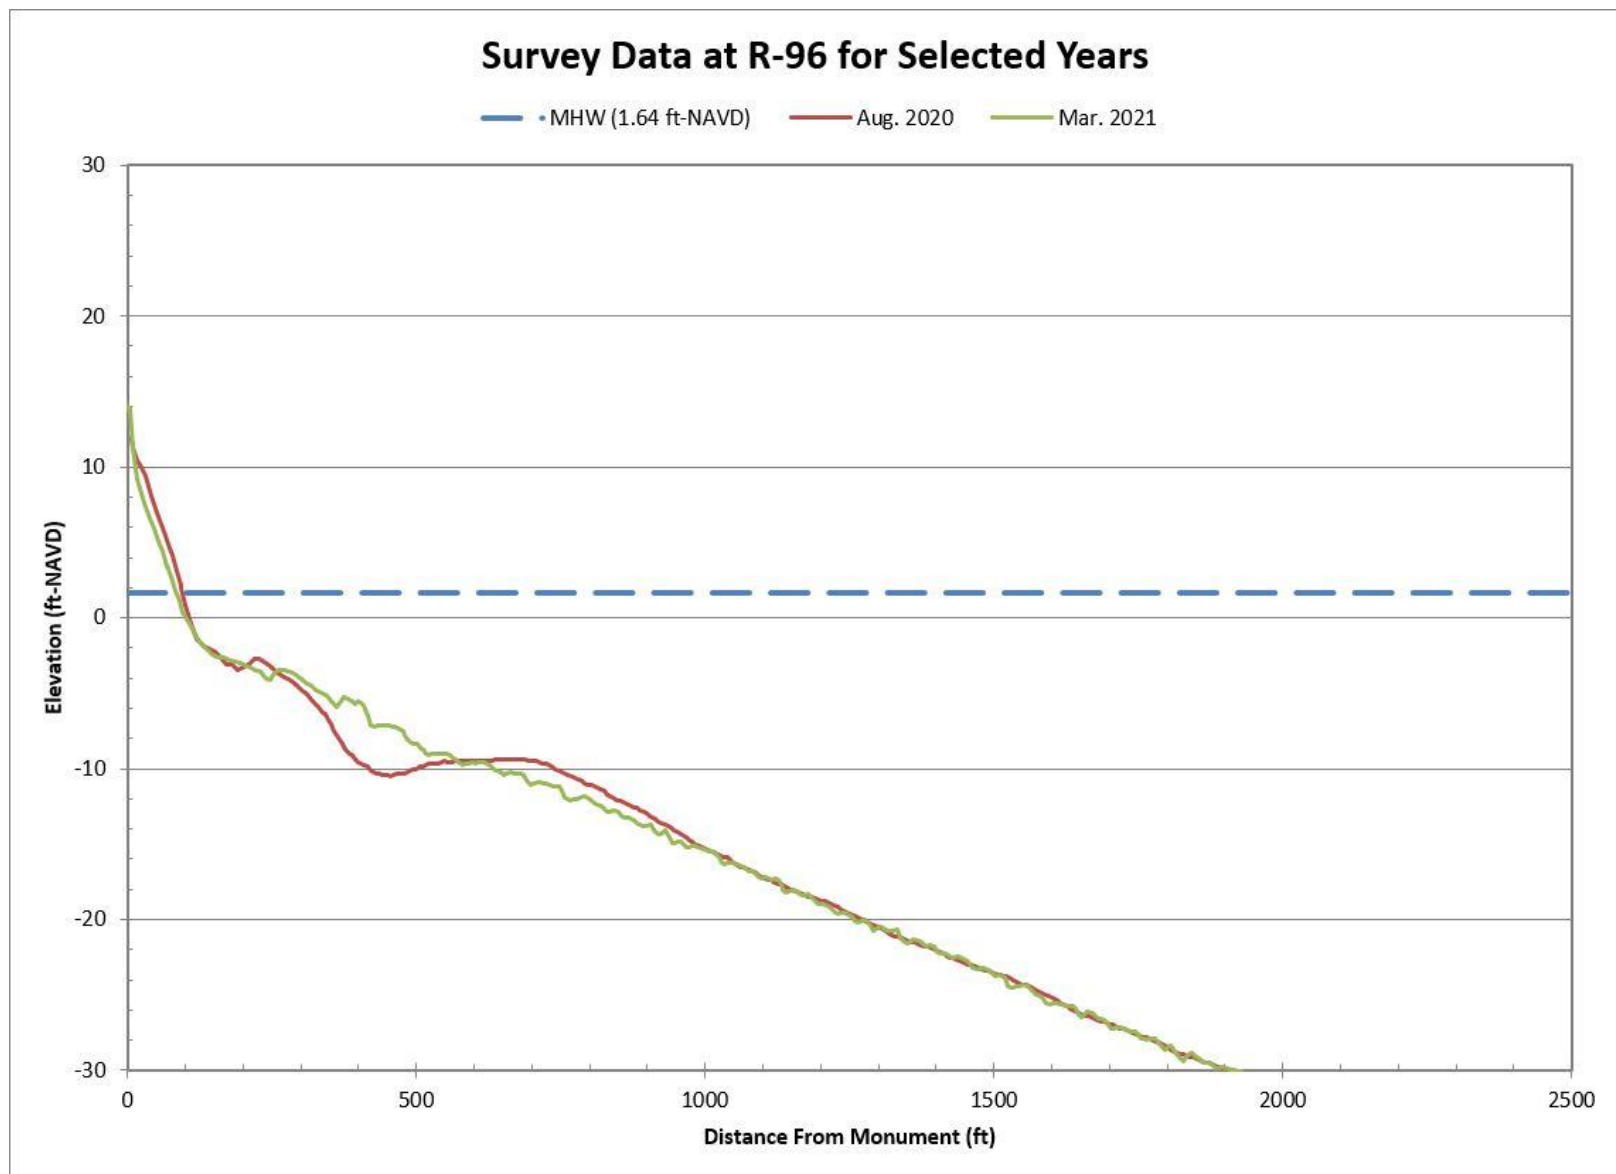
**Figure B-17. Aug. 2020 Pre-Construction vs. Mar. 2021 Post-Construction Beach Profiles Along R-96**

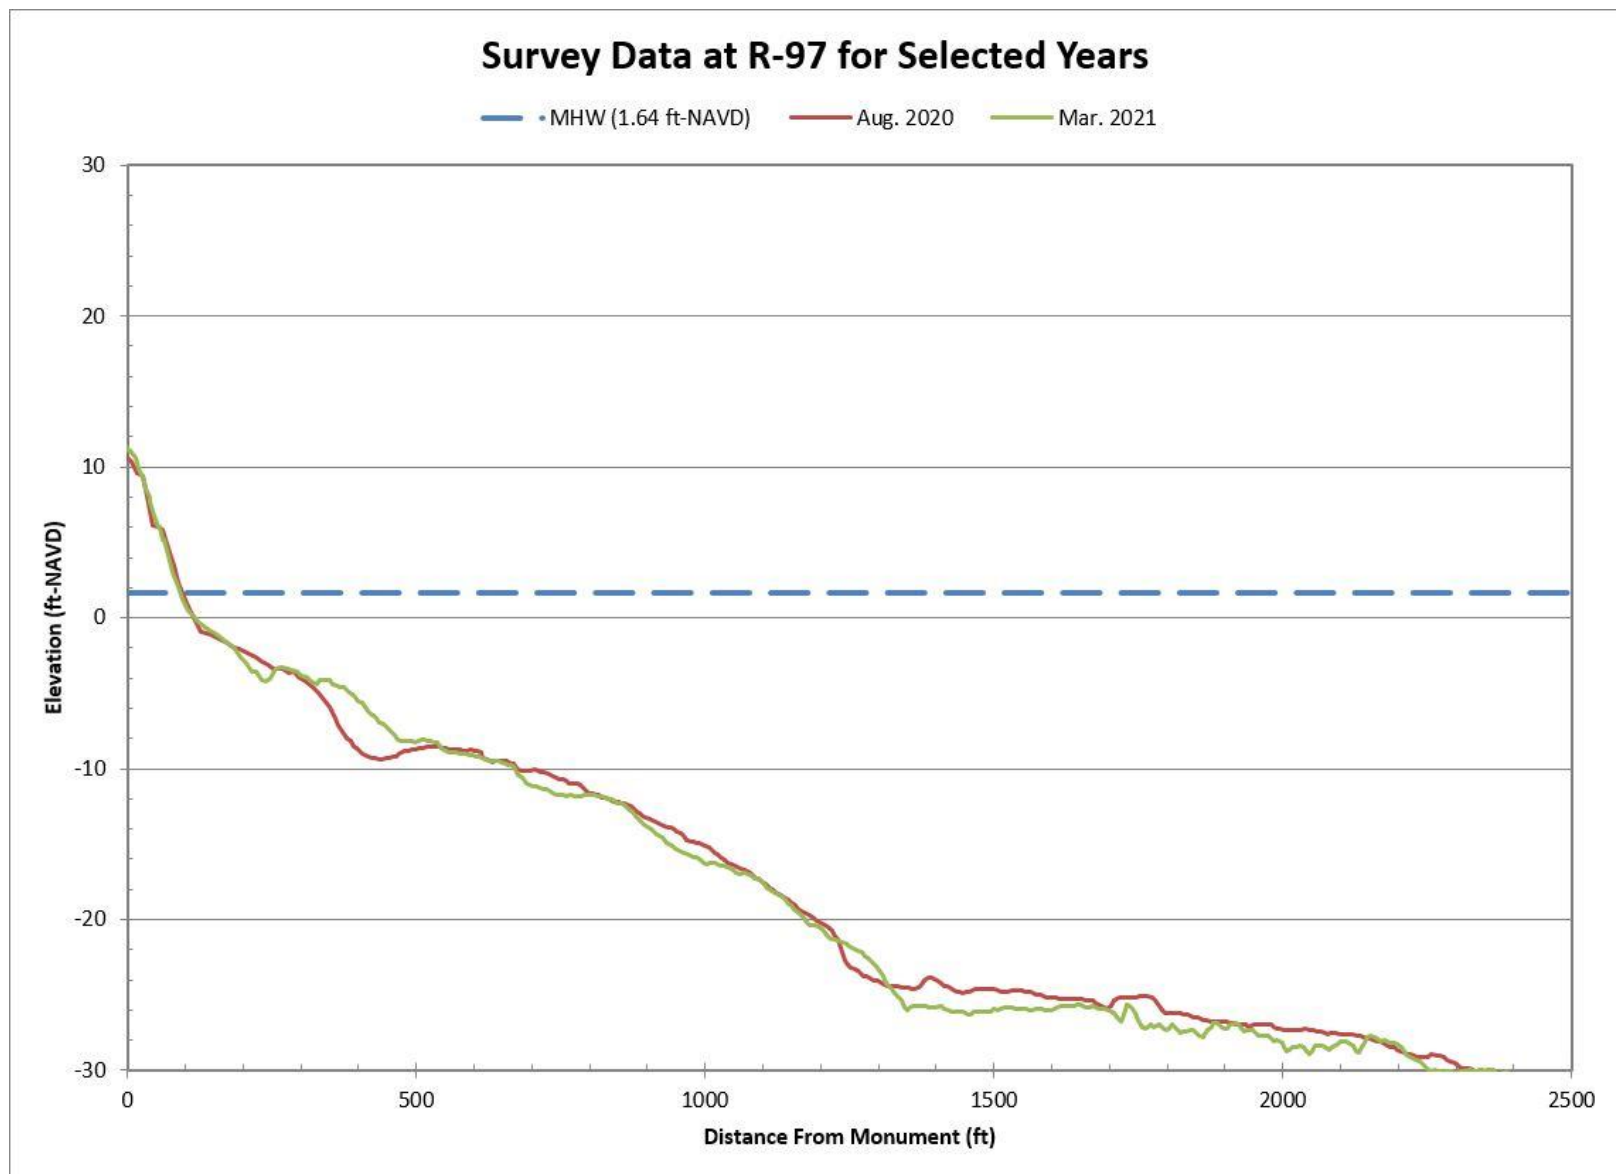
**Figure B-18. Aug. 2020 Pre-Construction vs. Mar. 2021 Post-Construction Beach Profiles Along R-97**

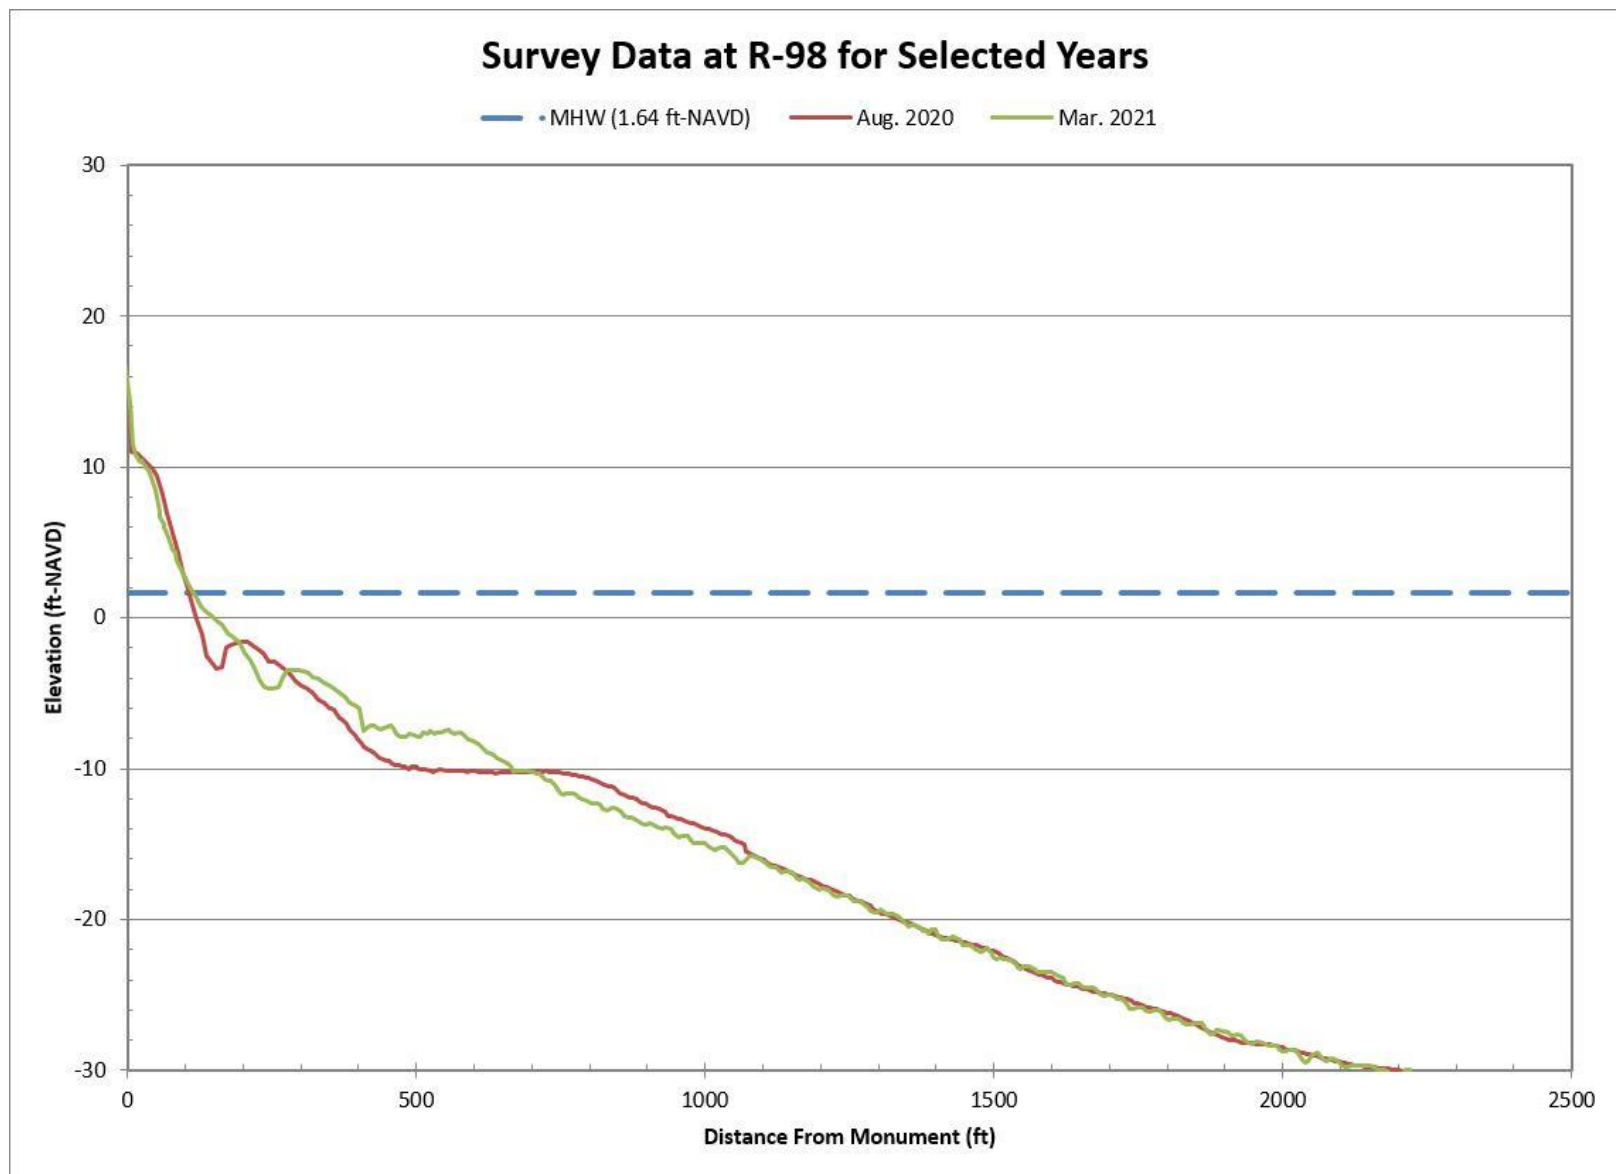
**Figure B-19. Aug. 2020 Pre-Construction vs. Mar. 2021 Post-Construction Beach Profiles Along R-98**

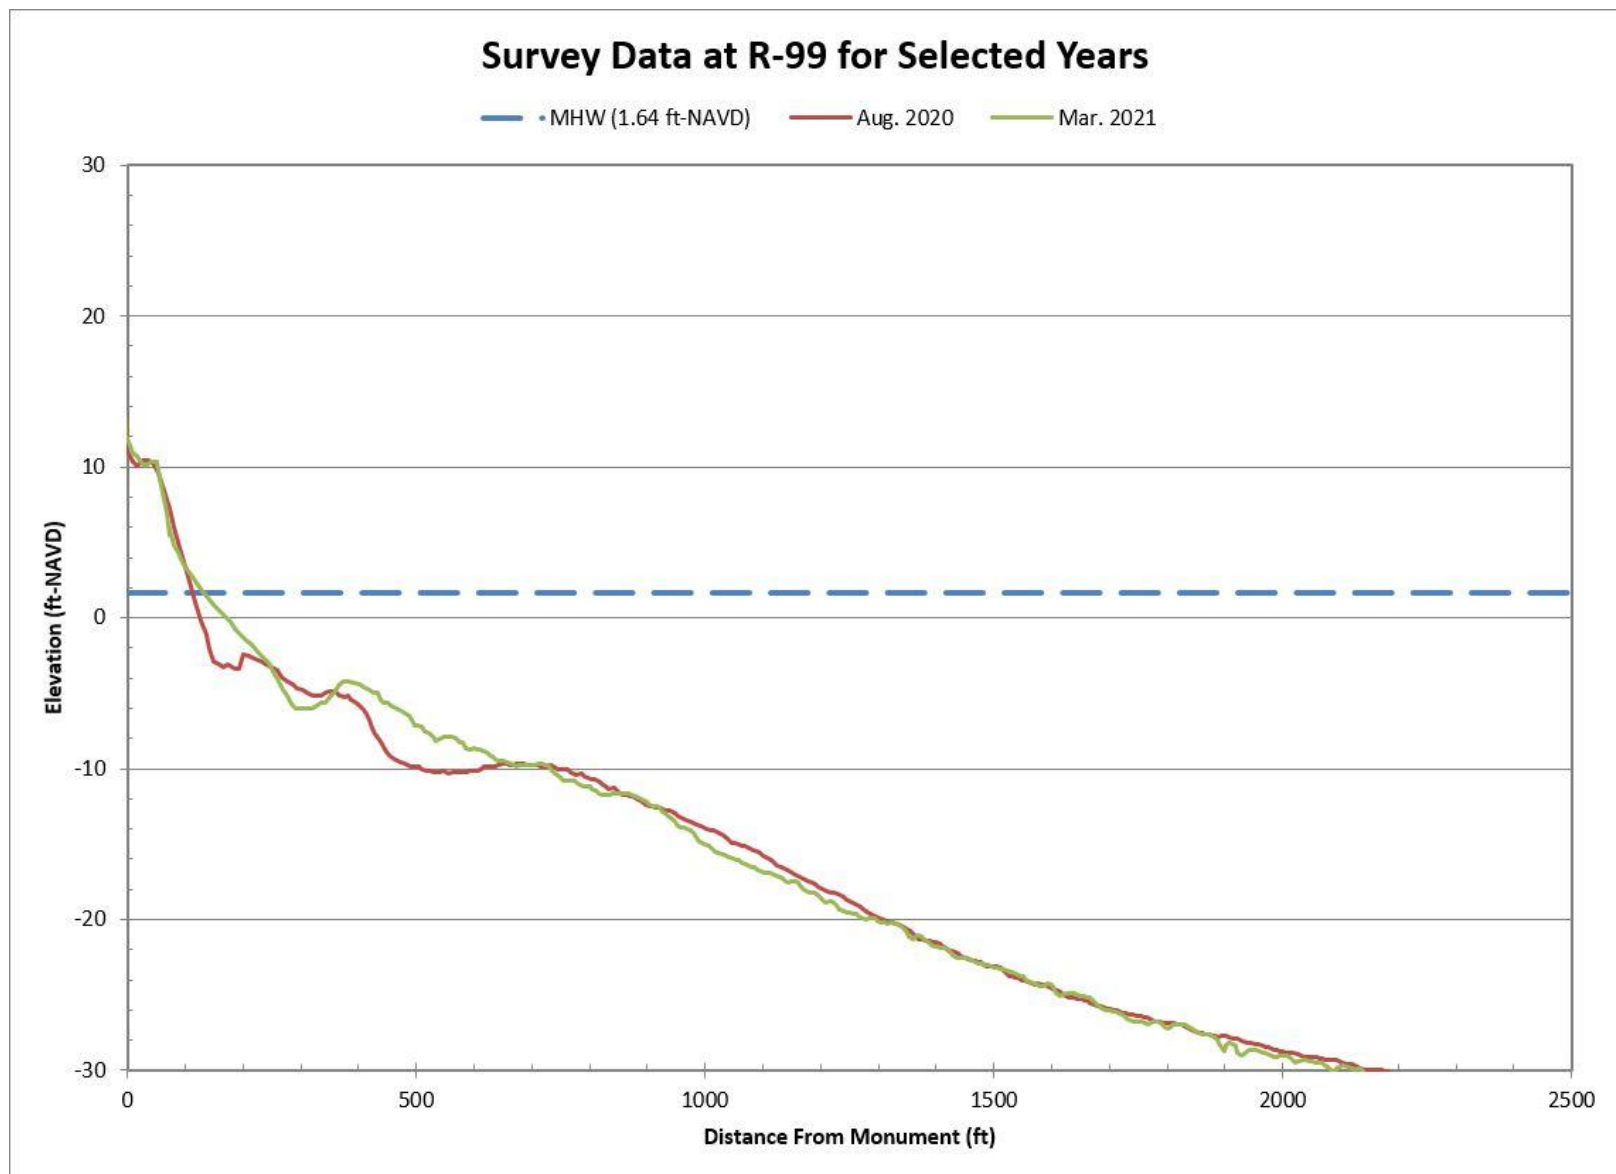
Figure B-20. Aug. 2020 Pre-Construction vs. Mar. 2021 Post-Construction Beach Profiles Along R-99

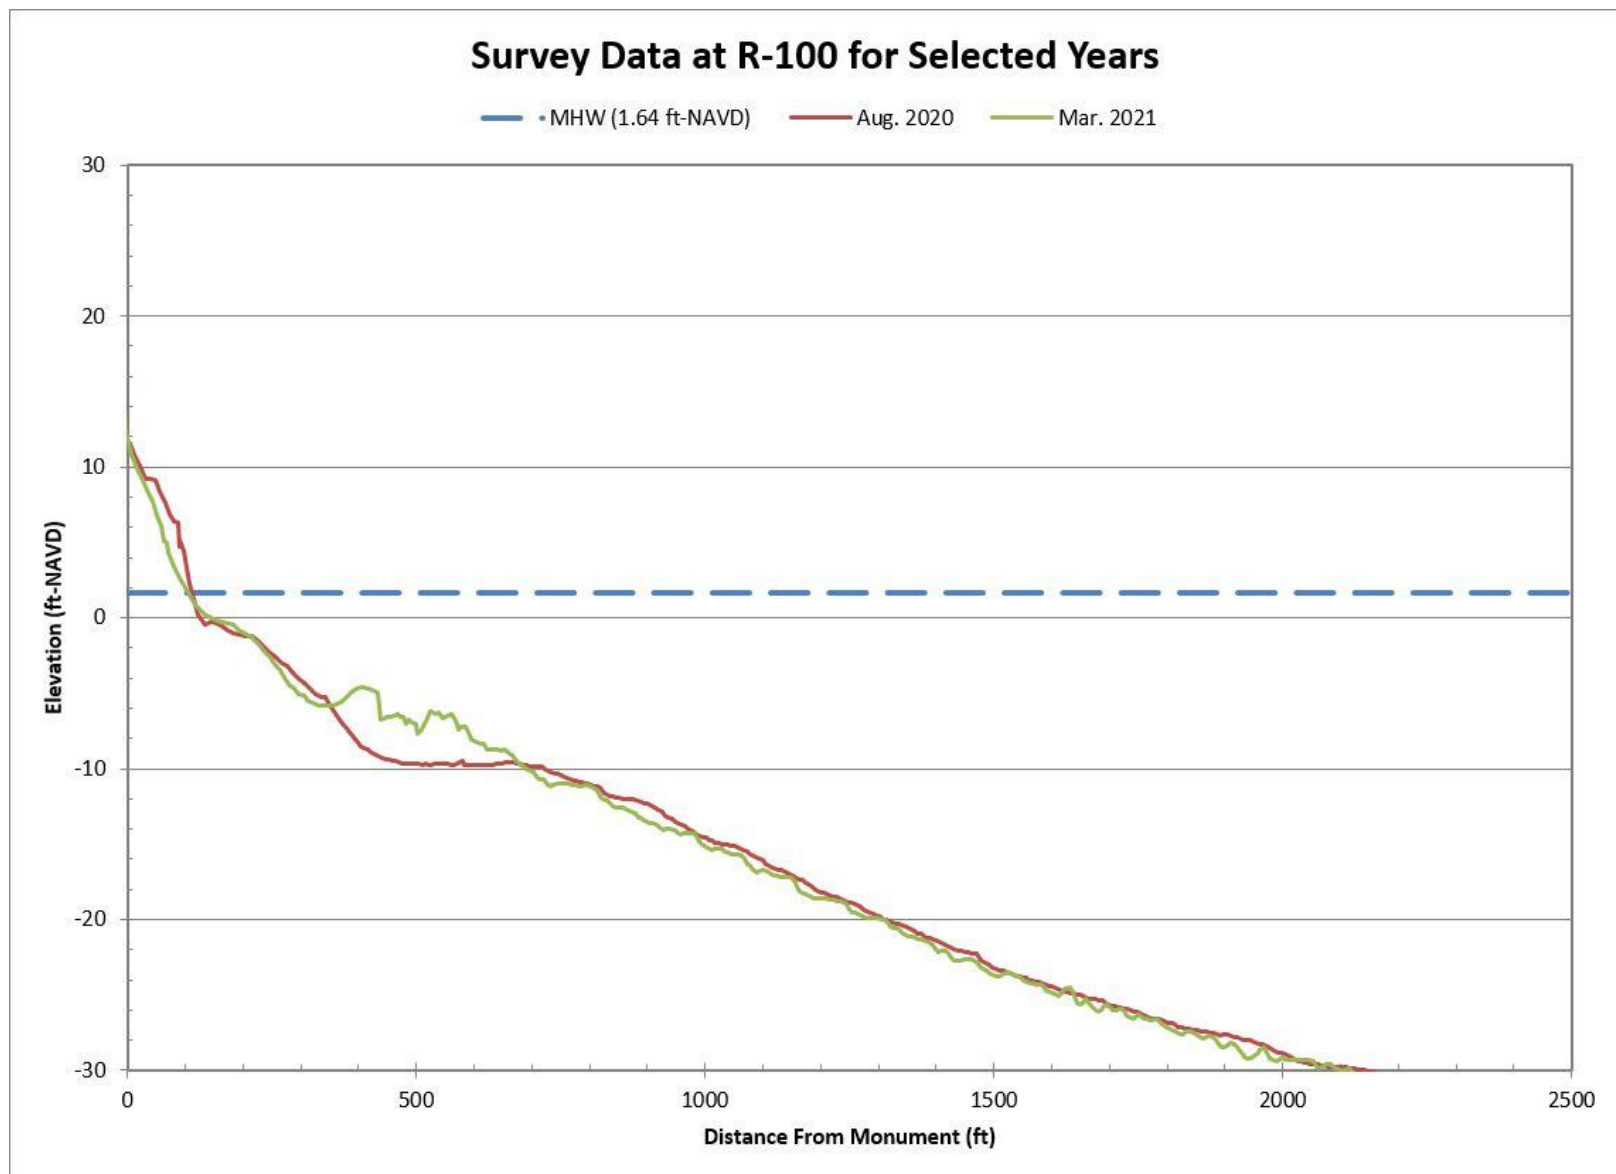
Figure B-21. Aug. 2020 Pre-Construction vs. Mar. 2021 Post-Construction Beach Profiles Along R-100

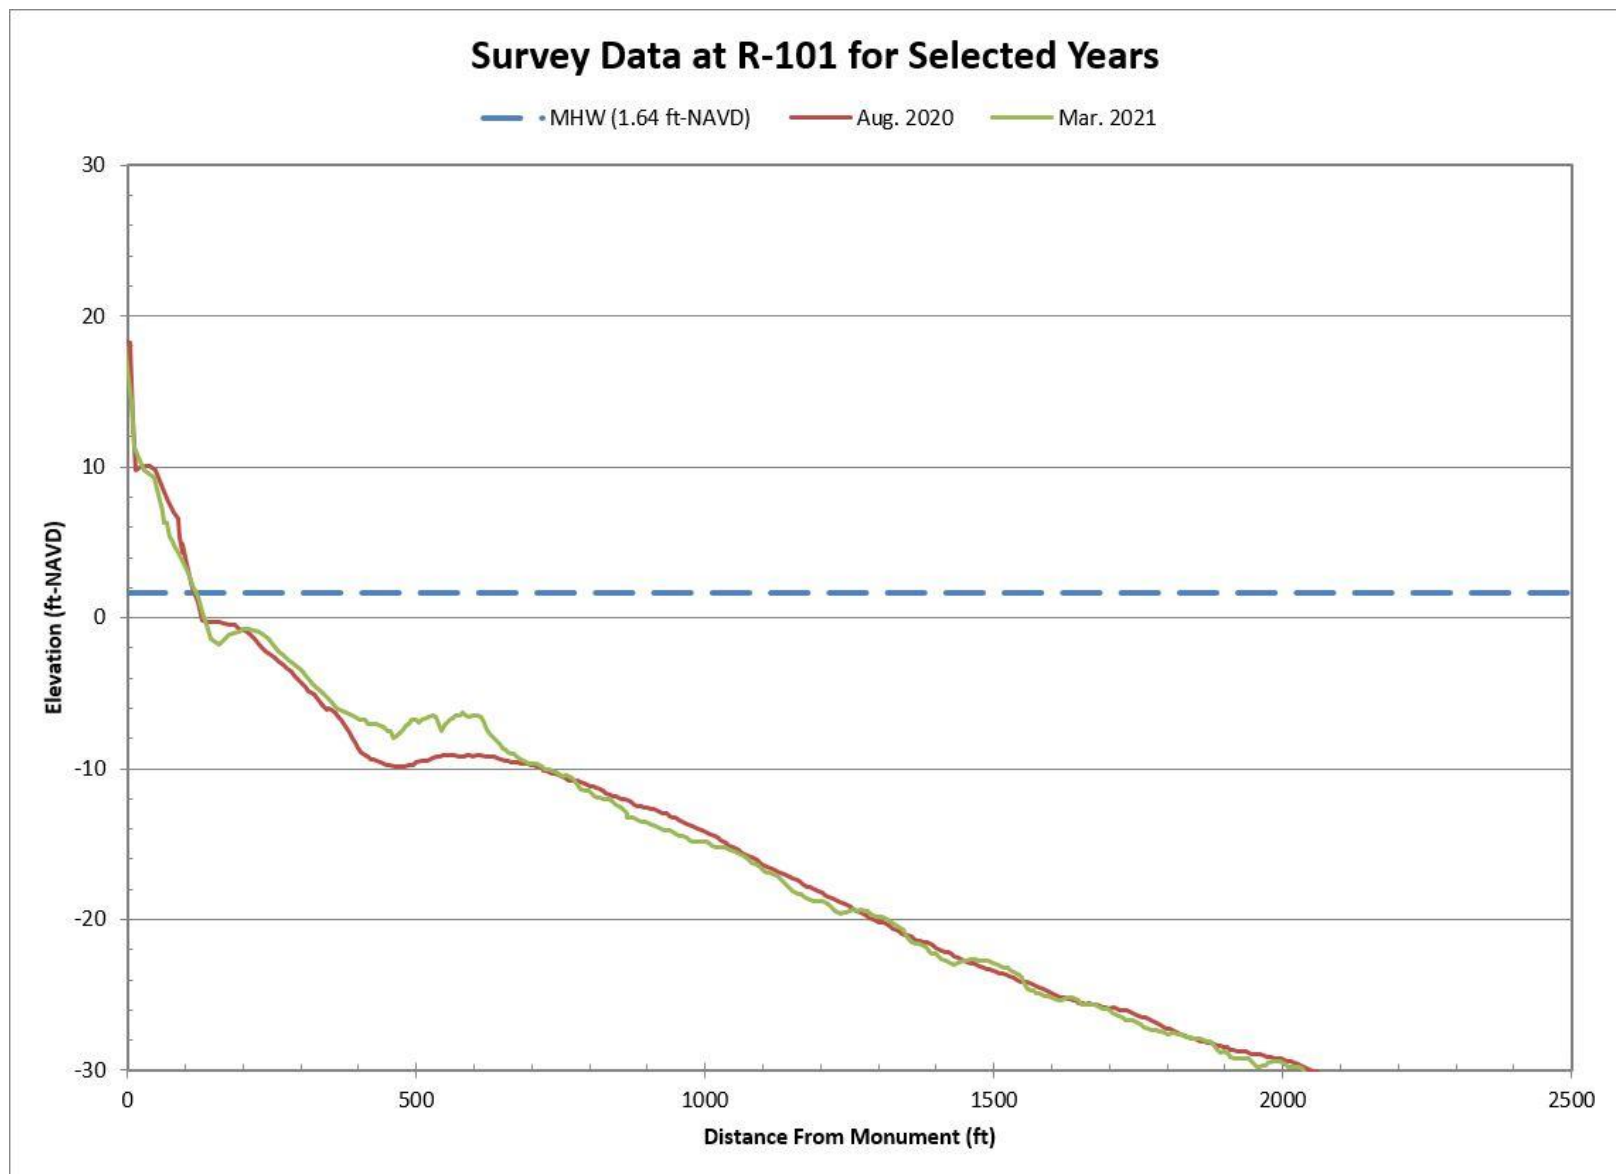
Figure B-22. Aug. 2020 Pre-Construction vs. Mar. 2021 Post-Construction Beach Profiles Along R-101

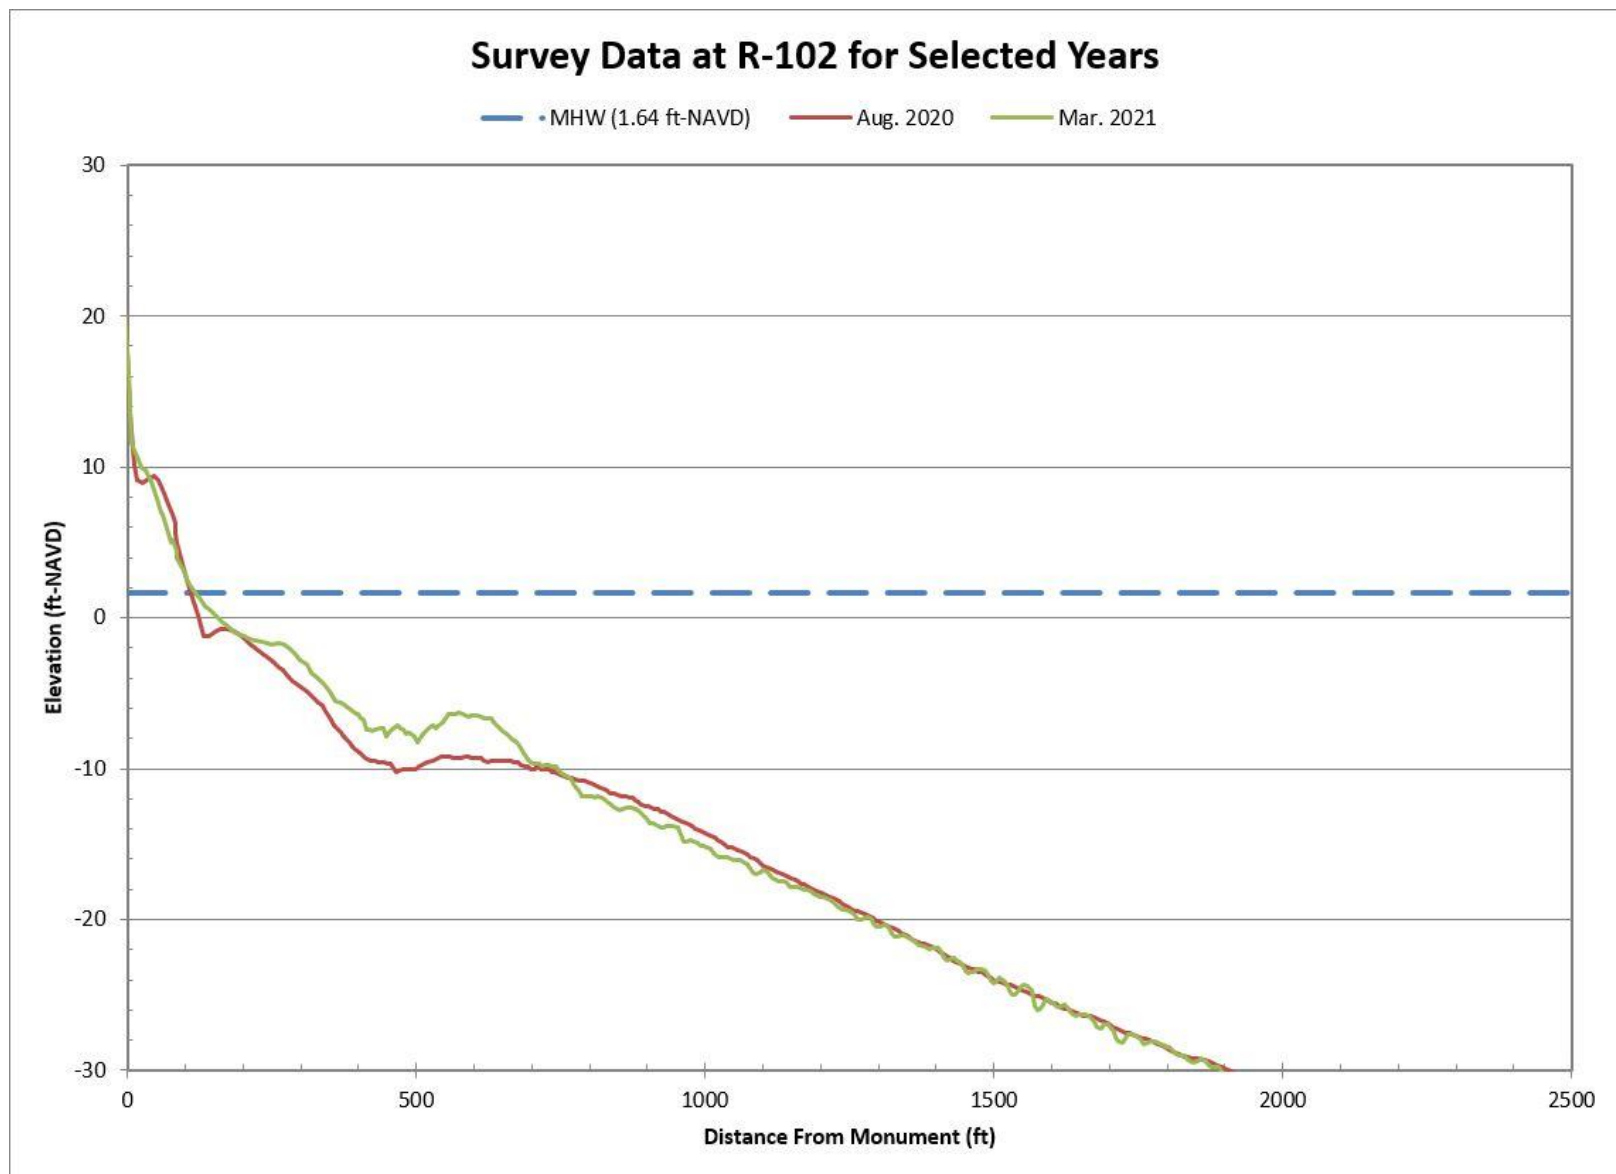
**Figure B-23. Aug. 2020 Pre-Construction vs. Mar. 2021 Post-Construction Beach Profiles Along R-102**

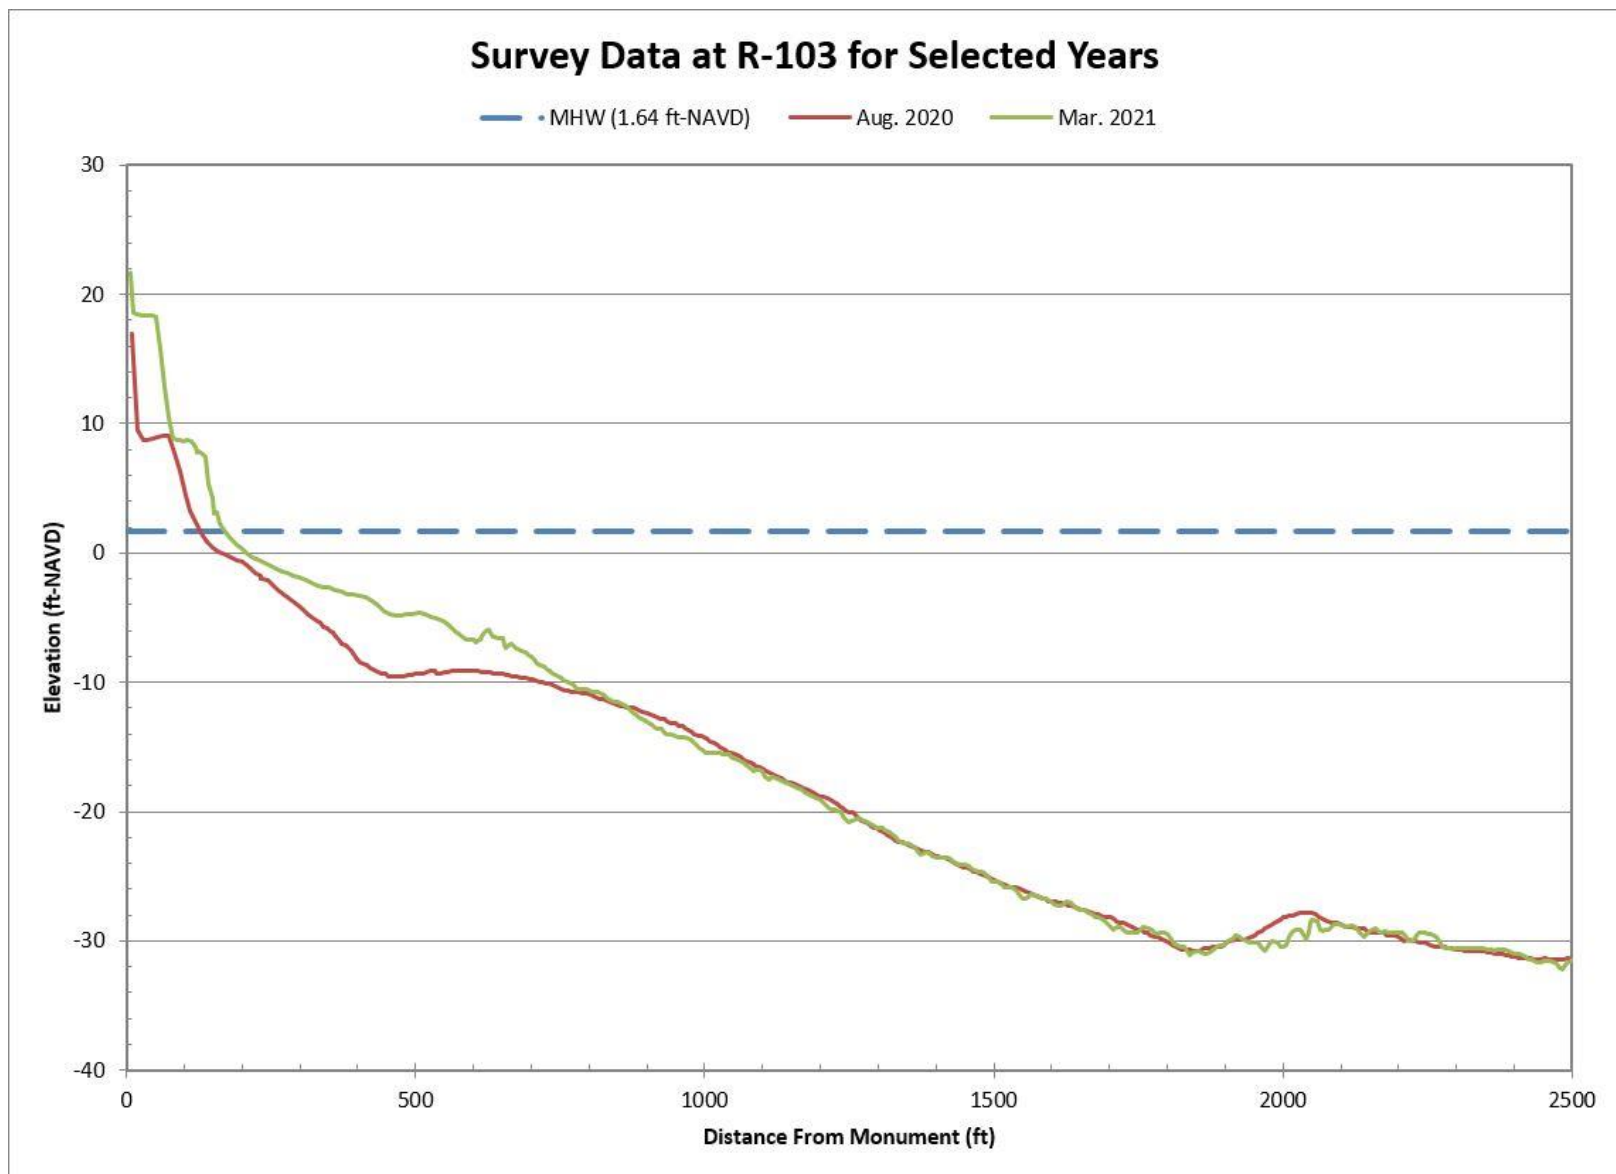
**Figure B-24. Aug. 2020 Pre-Construction vs. Mar. 2021 Post-Construction Beach Profiles Along R-103**
