## **Appendix B**

### **Beach Profile Plots**

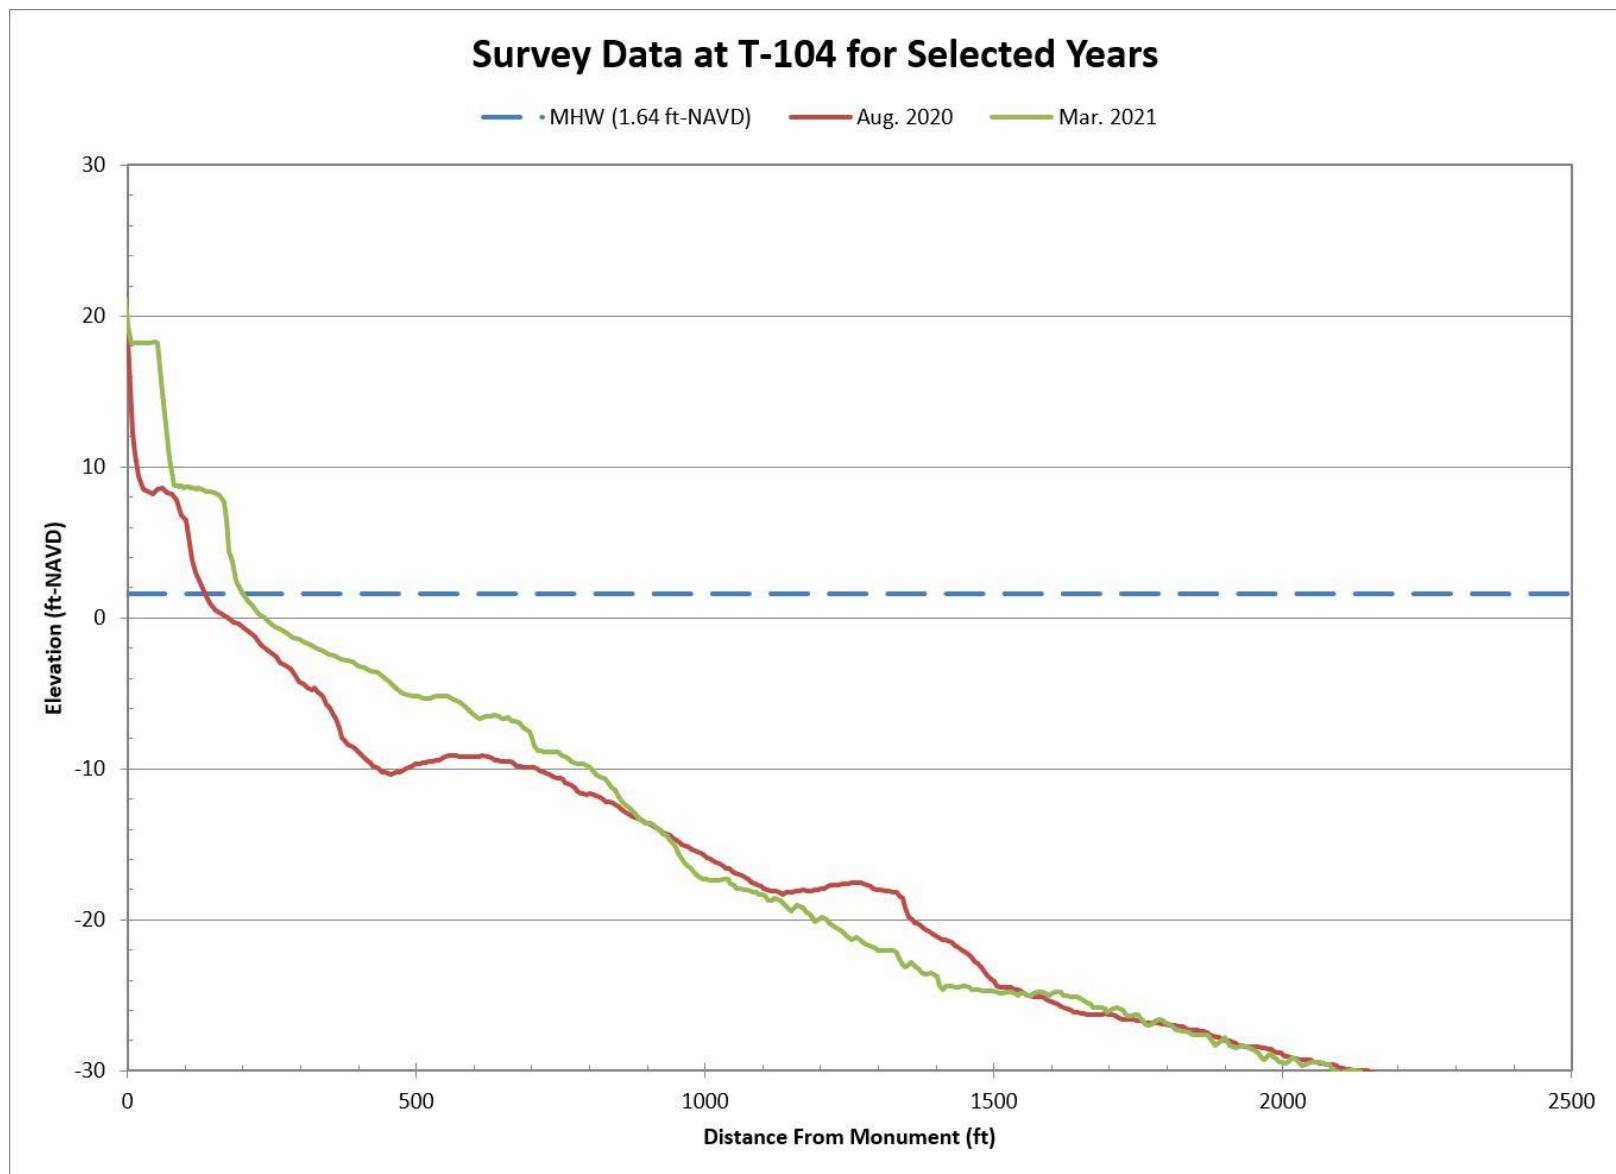
**Figure B-25. Aug. 2020 Pre-Construction vs. Mar. 2021 Post-Construction Beach Profiles Along T-104**

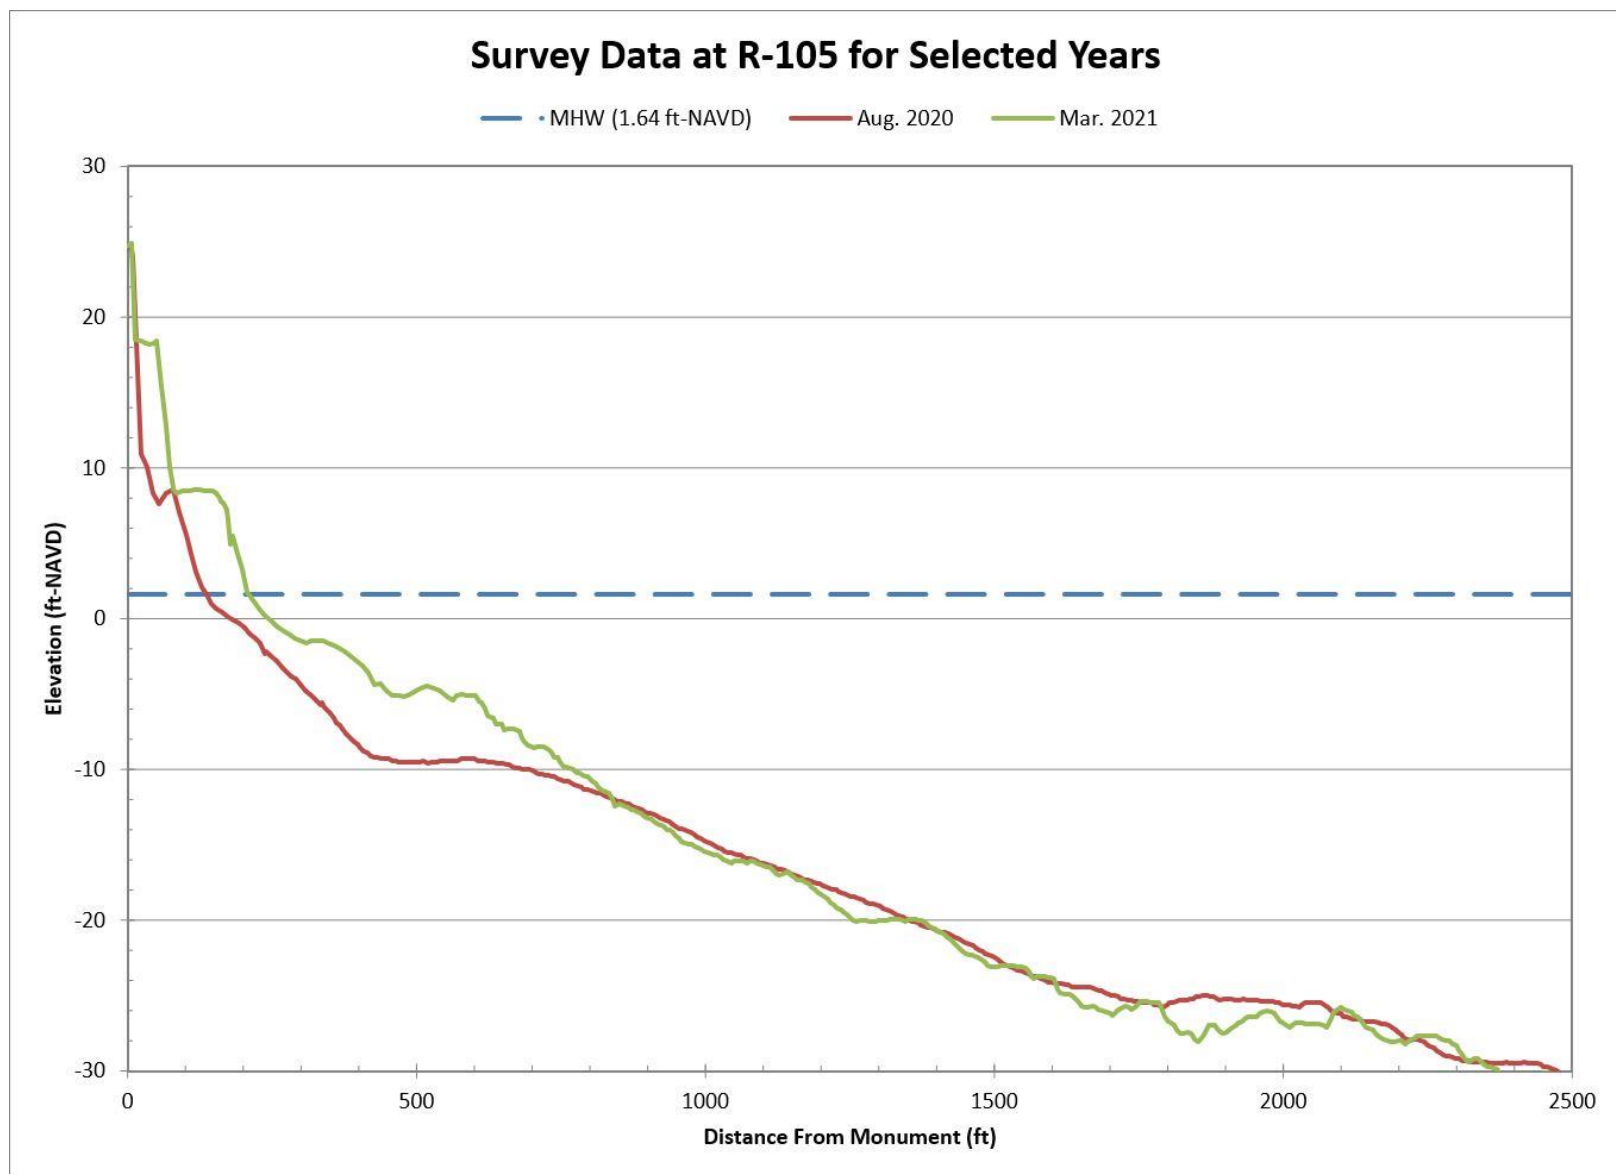
Figure B-26. Aug. 2020 Pre-Construction vs. Mar. 2021 Post-Construction Beach Profiles Along R-105

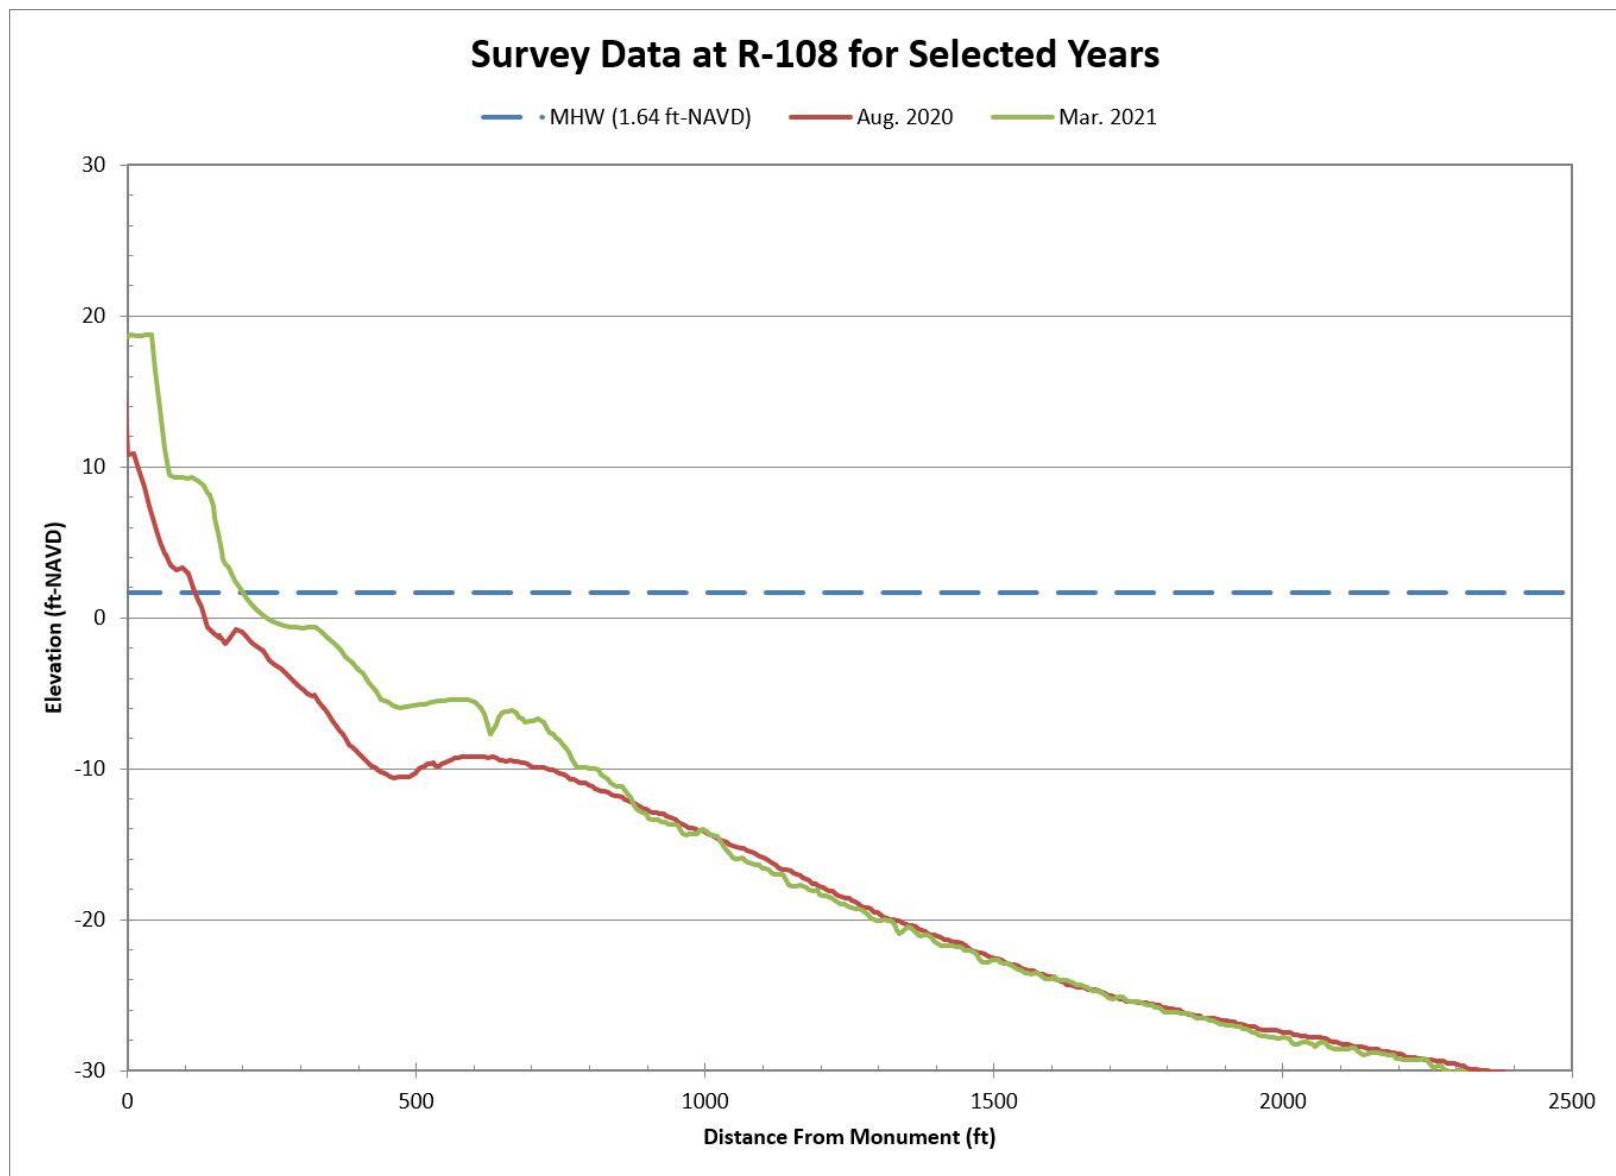
**Figure B-29. Aug. 2020 Pre-Construction vs. Mar. 2021 Post-Construction Beach Profiles Along R-108**

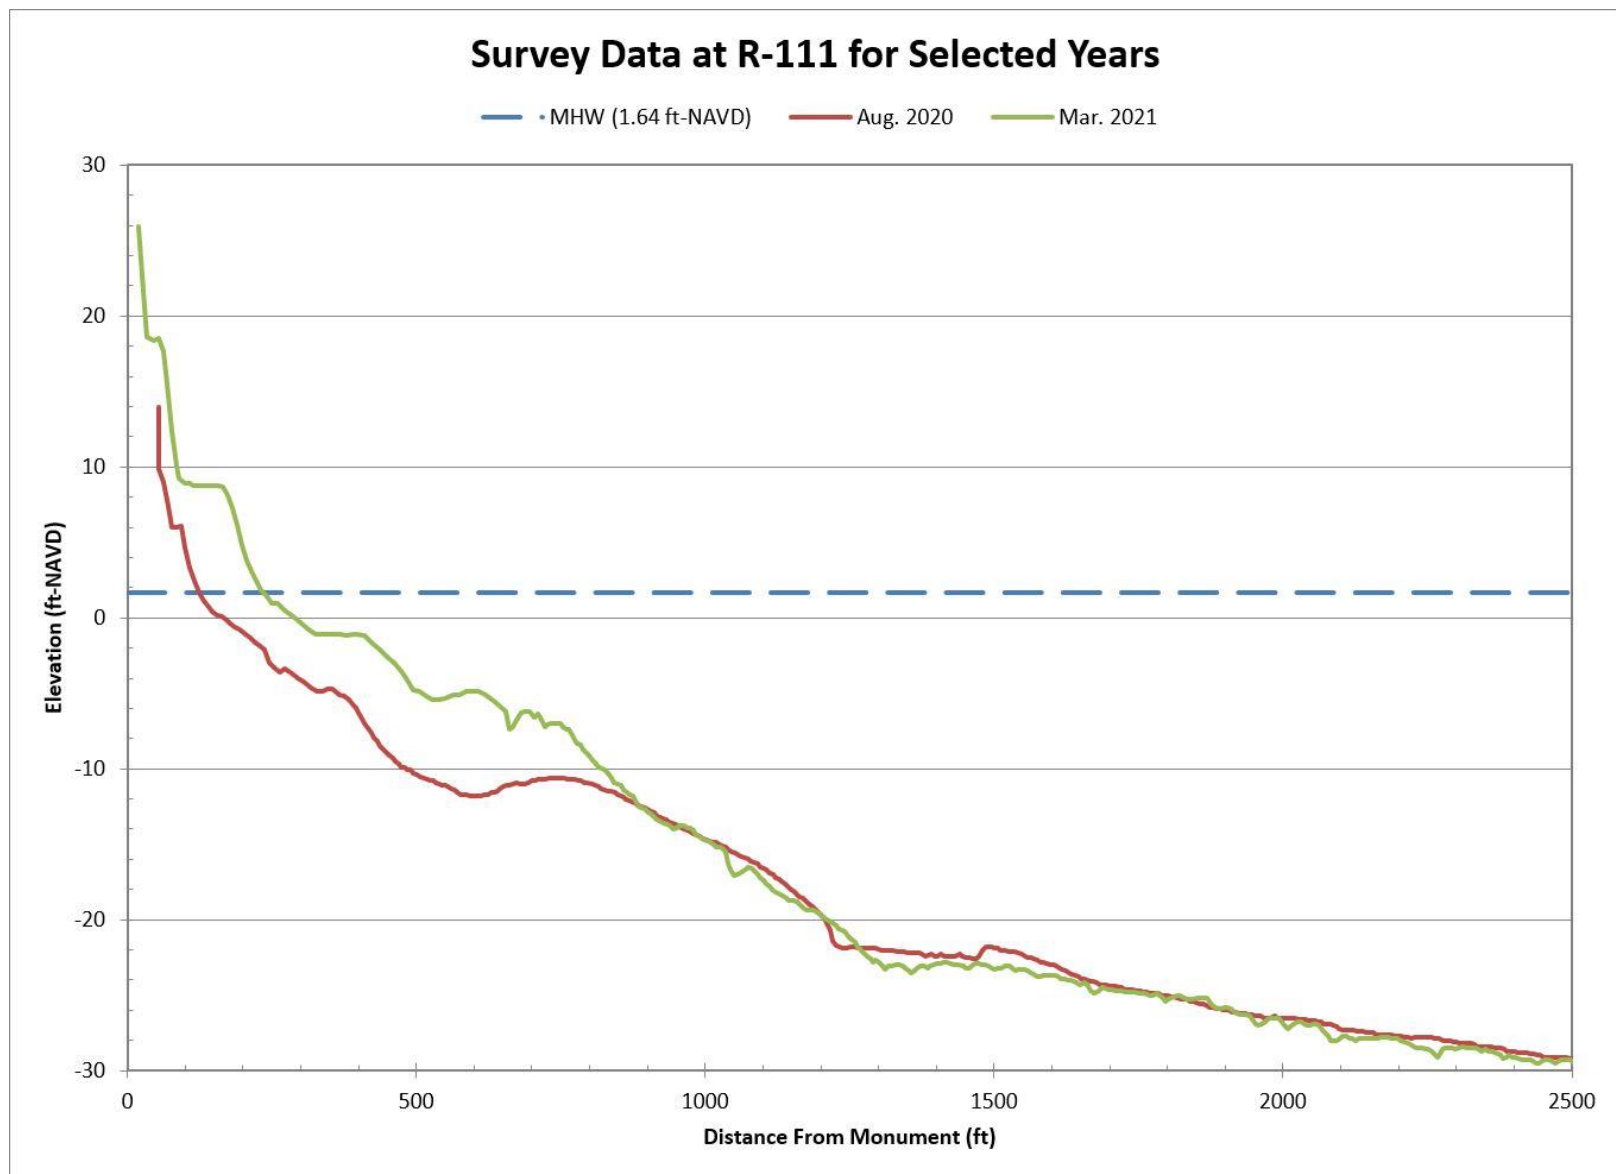
**Figure B-32. Aug. 2020 Pre-Construction vs. Mar. 2021 Post-Construction Beach Profiles Along R-111**

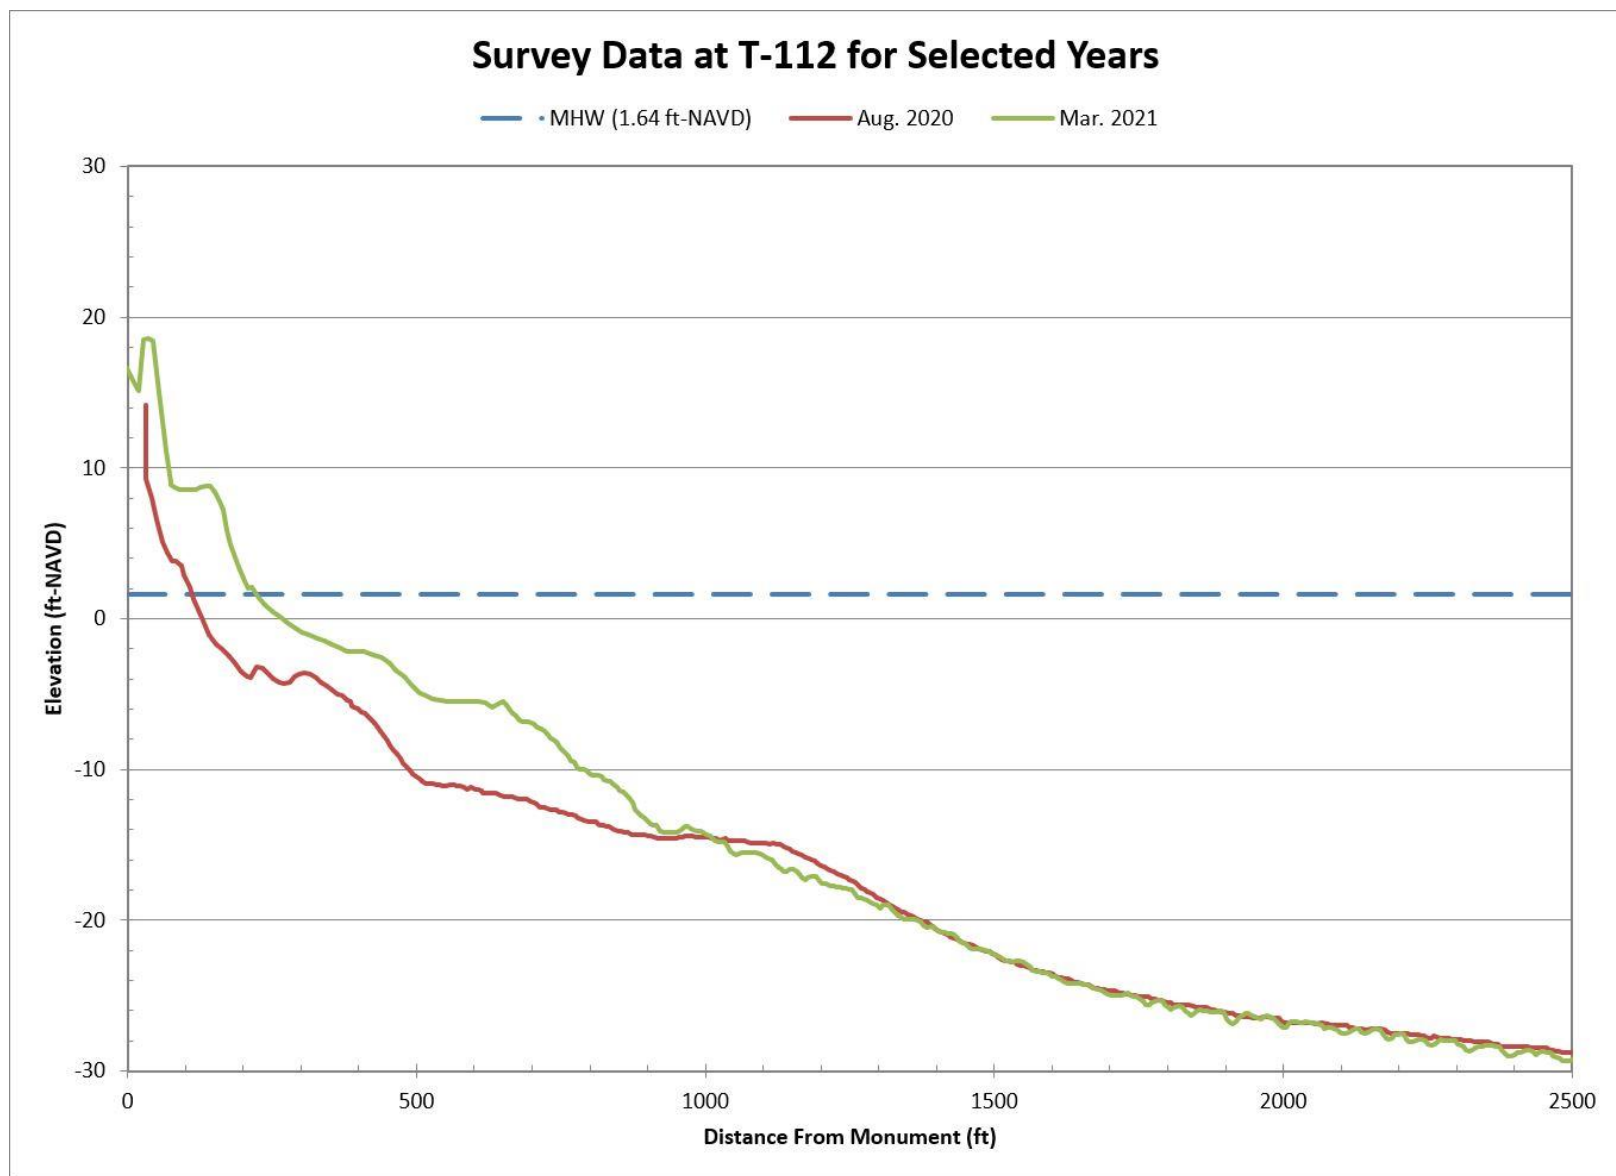
Figure B-33. Aug. 2020 Pre-Construction vs. Mar. 2021 Post-Construction Beach Profiles Along T-112

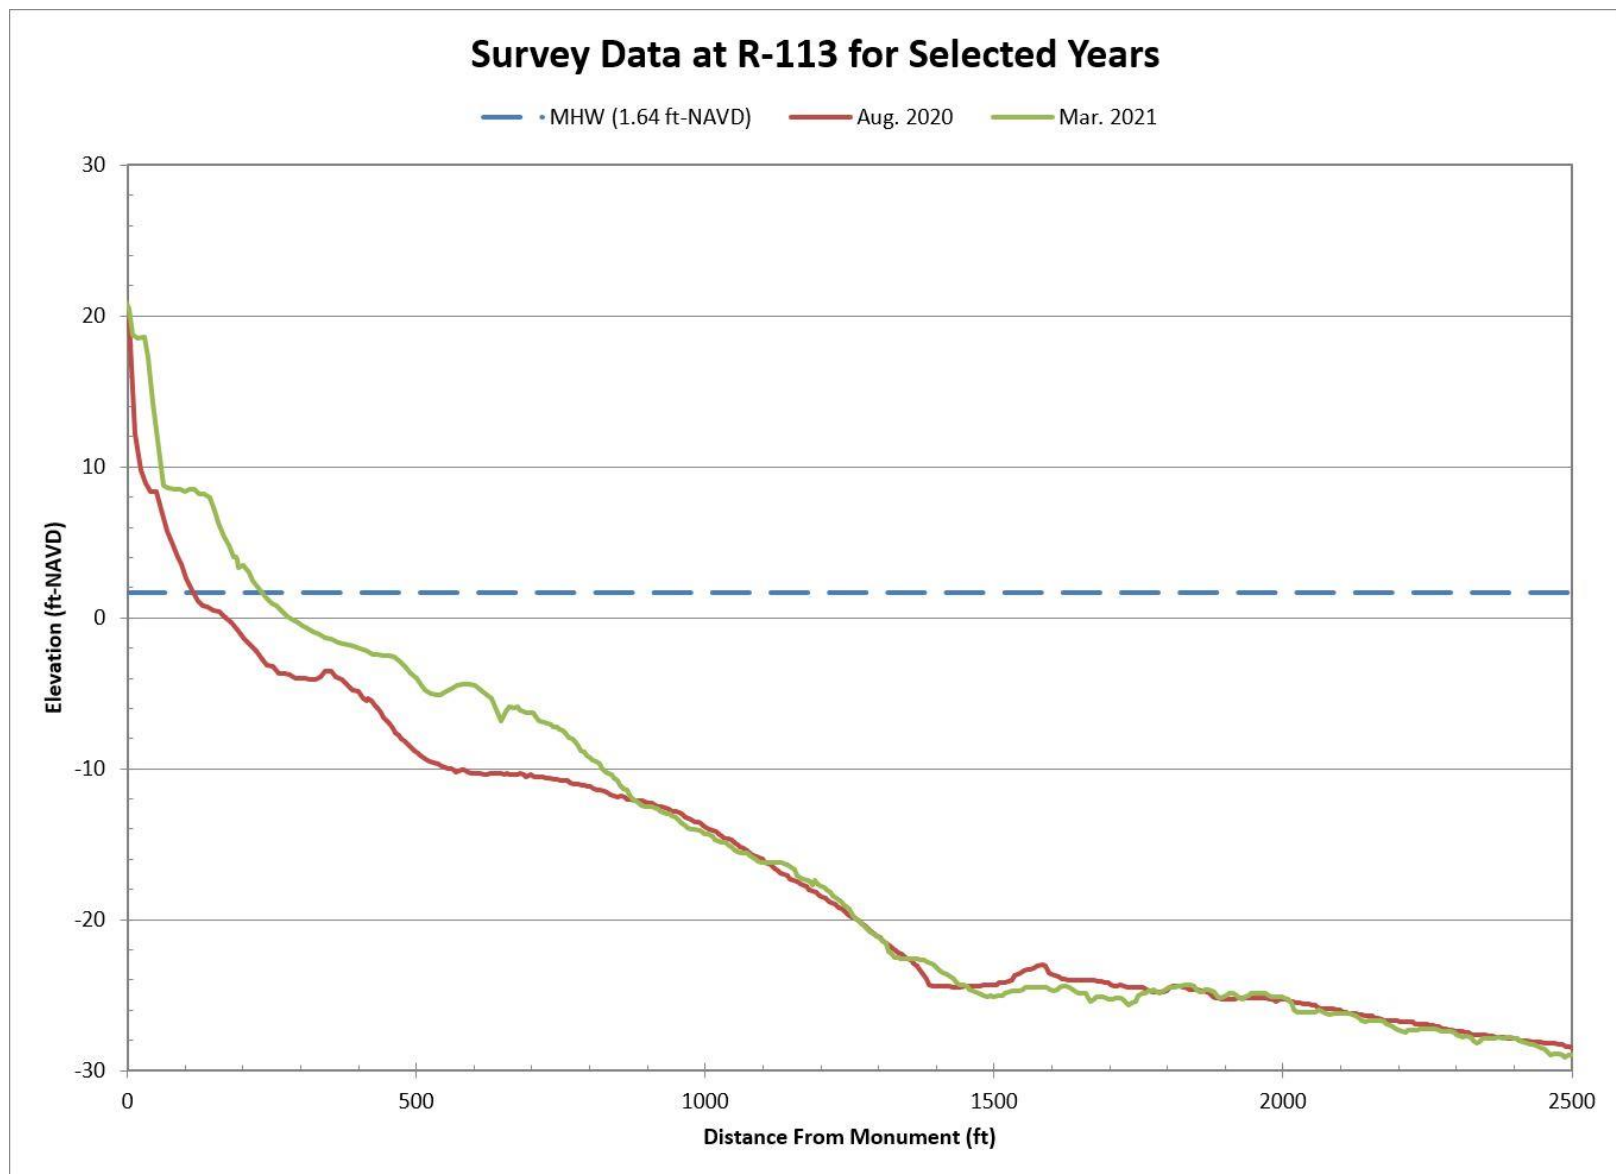
**Figure B-34. Aug. 2020 Pre-Construction vs. Mar. 2021 Post-Construction Beach Profiles Along R-113**

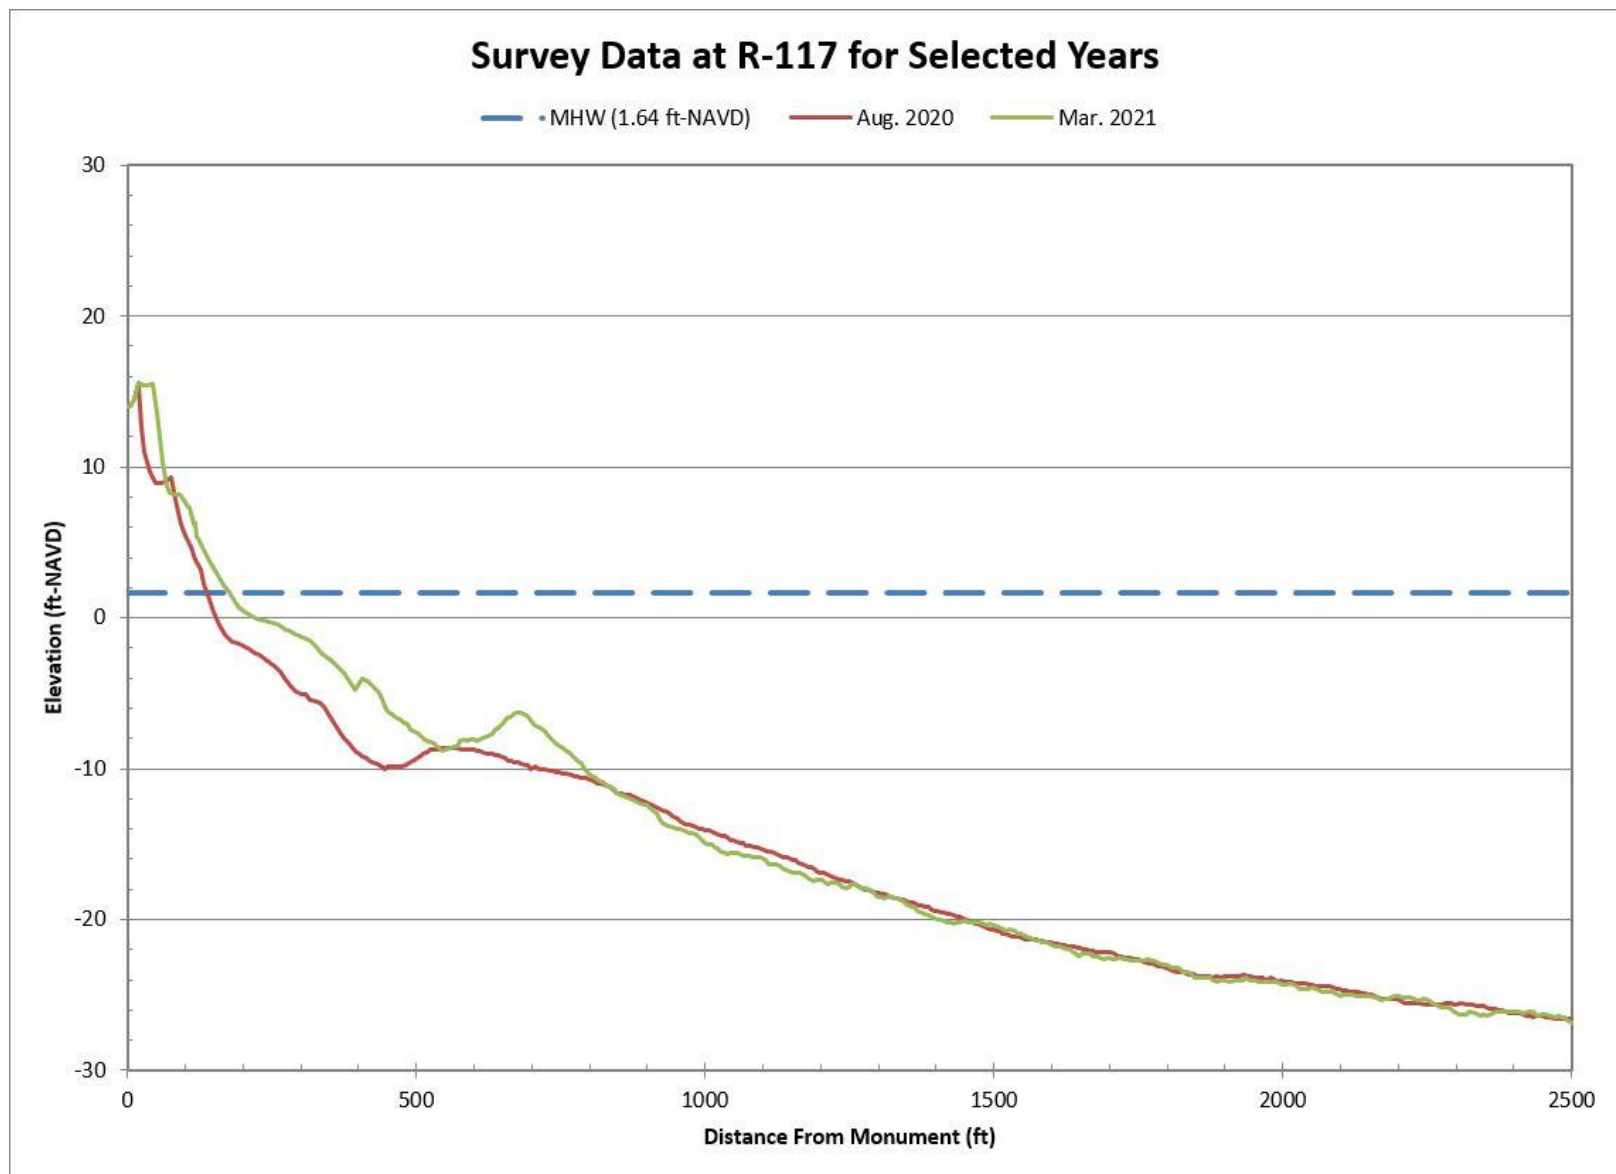
Figure B-38. Aug. 2020 Pre-Construction vs. Mar. 2021 Post-Construction Beach Profiles Along R-117

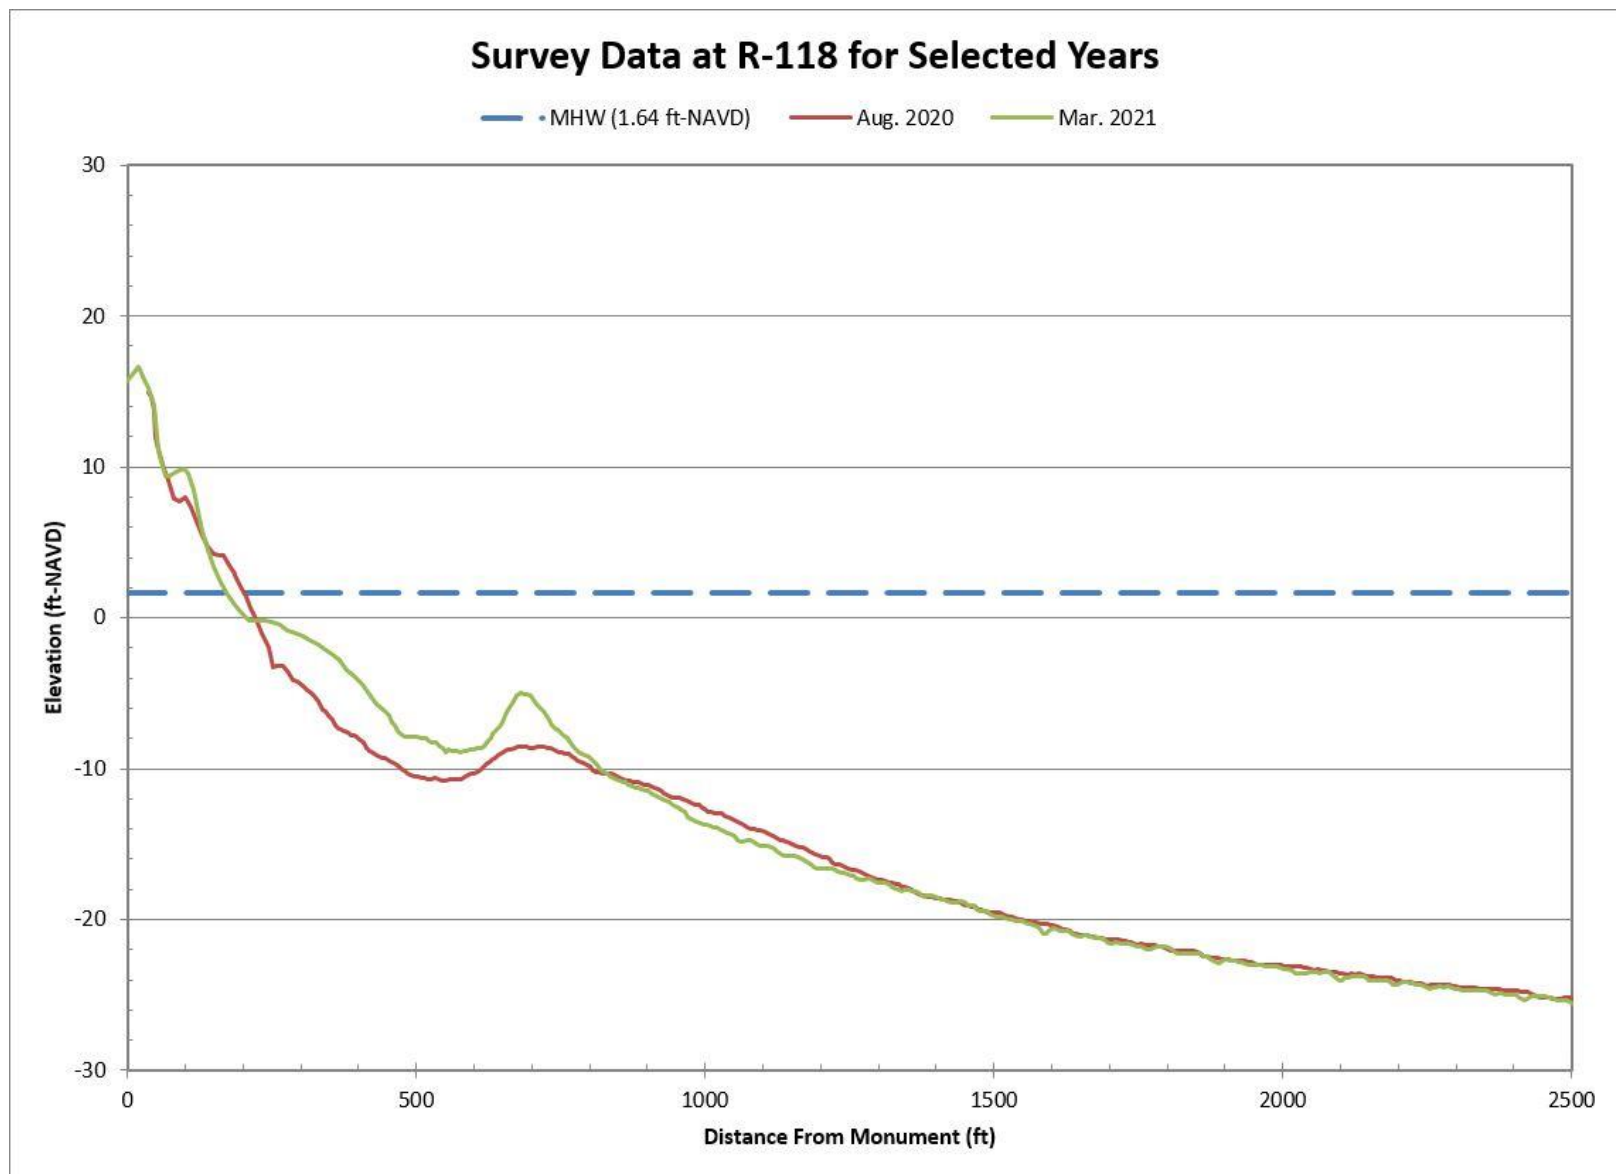
**Figure B-39. Aug. 2020 Pre-Construction vs. Mar. 2021 Post-Construction Beach Profiles Along R-118**

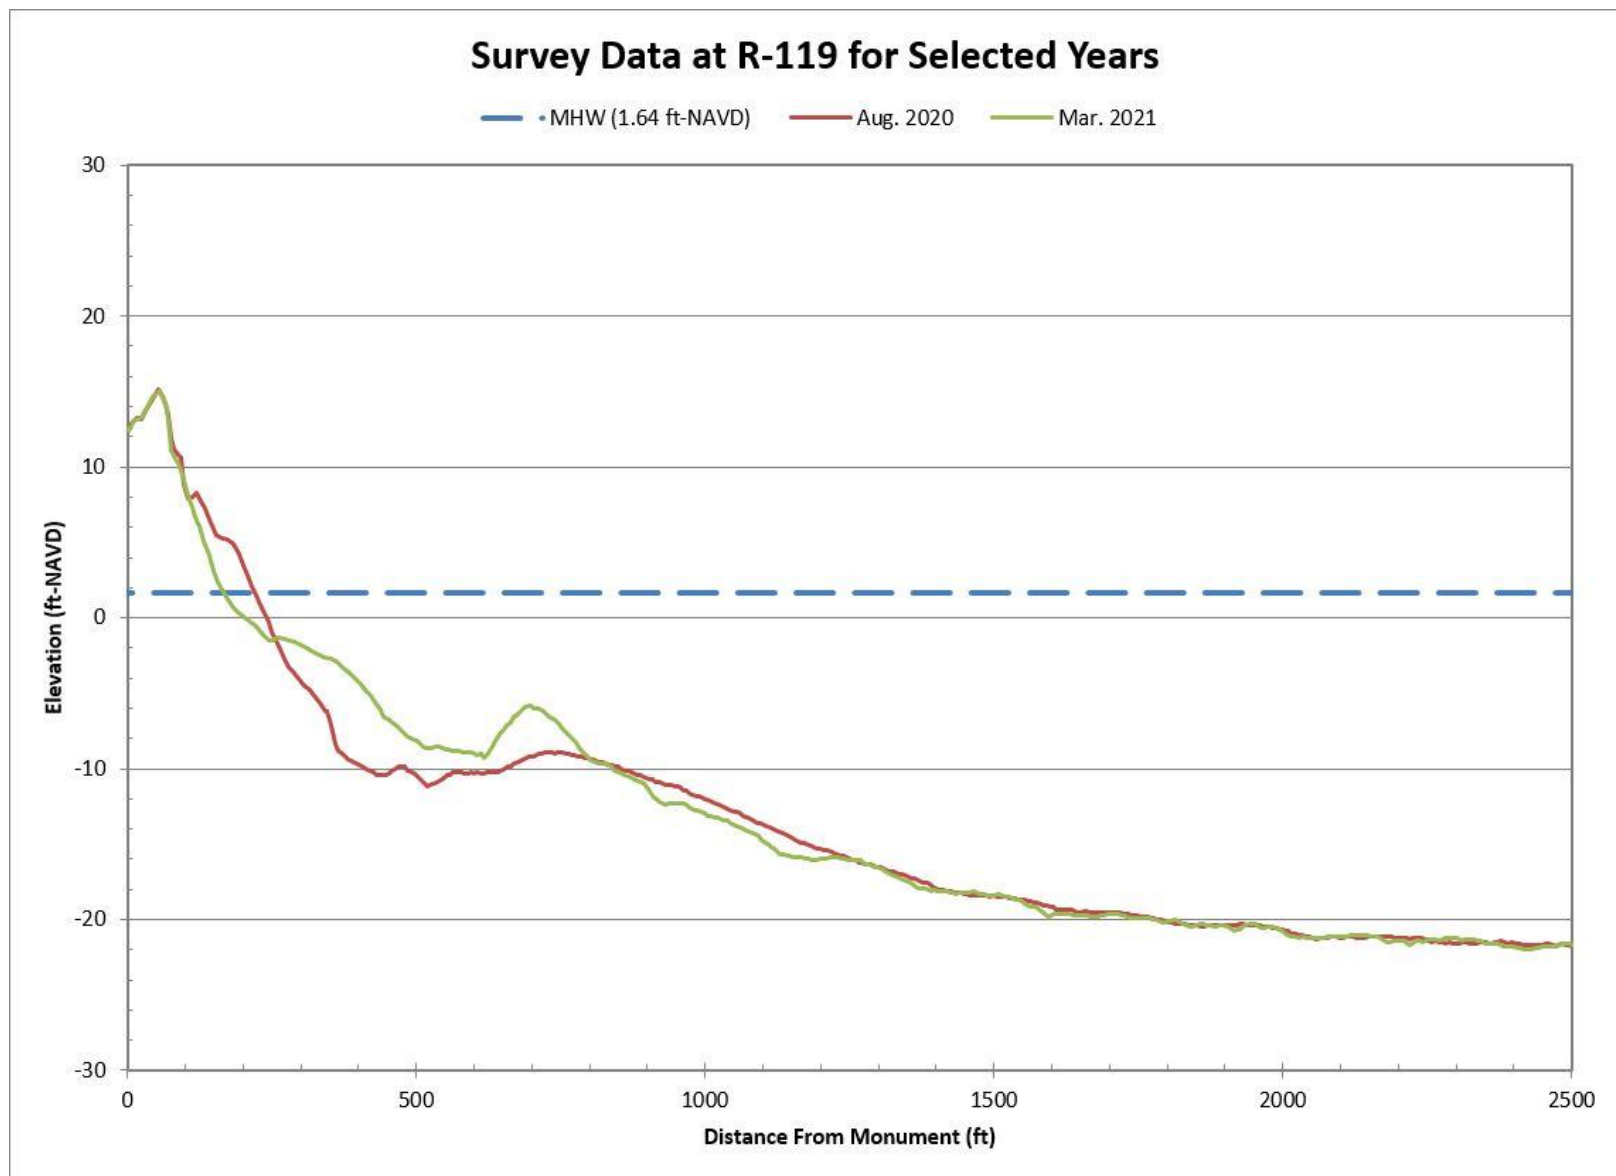
**Figure B-40. Aug. 2020 Pre-Construction vs. Mar. 2021 Post-Construction Beach Profiles Along R-119**

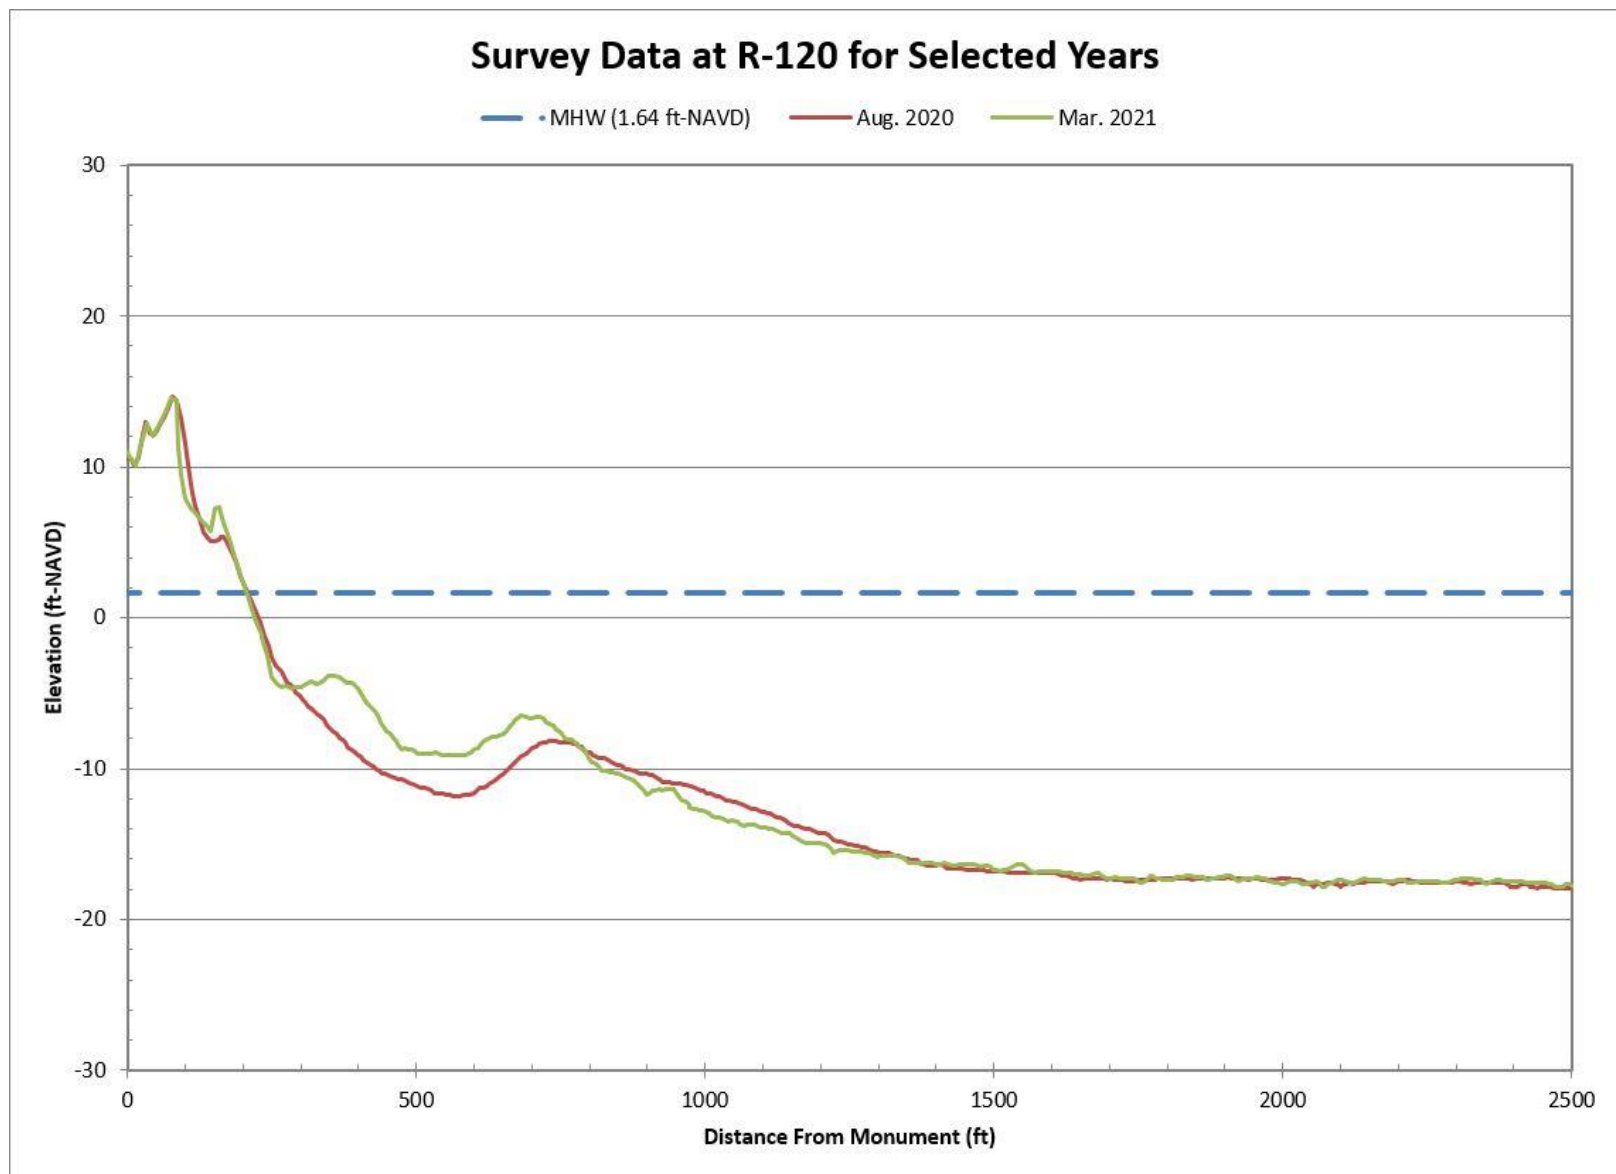
Figure B-41. Aug. 2020 Pre-Construction vs. Mar. 2021 Post-Construction Beach Profiles Along R-120

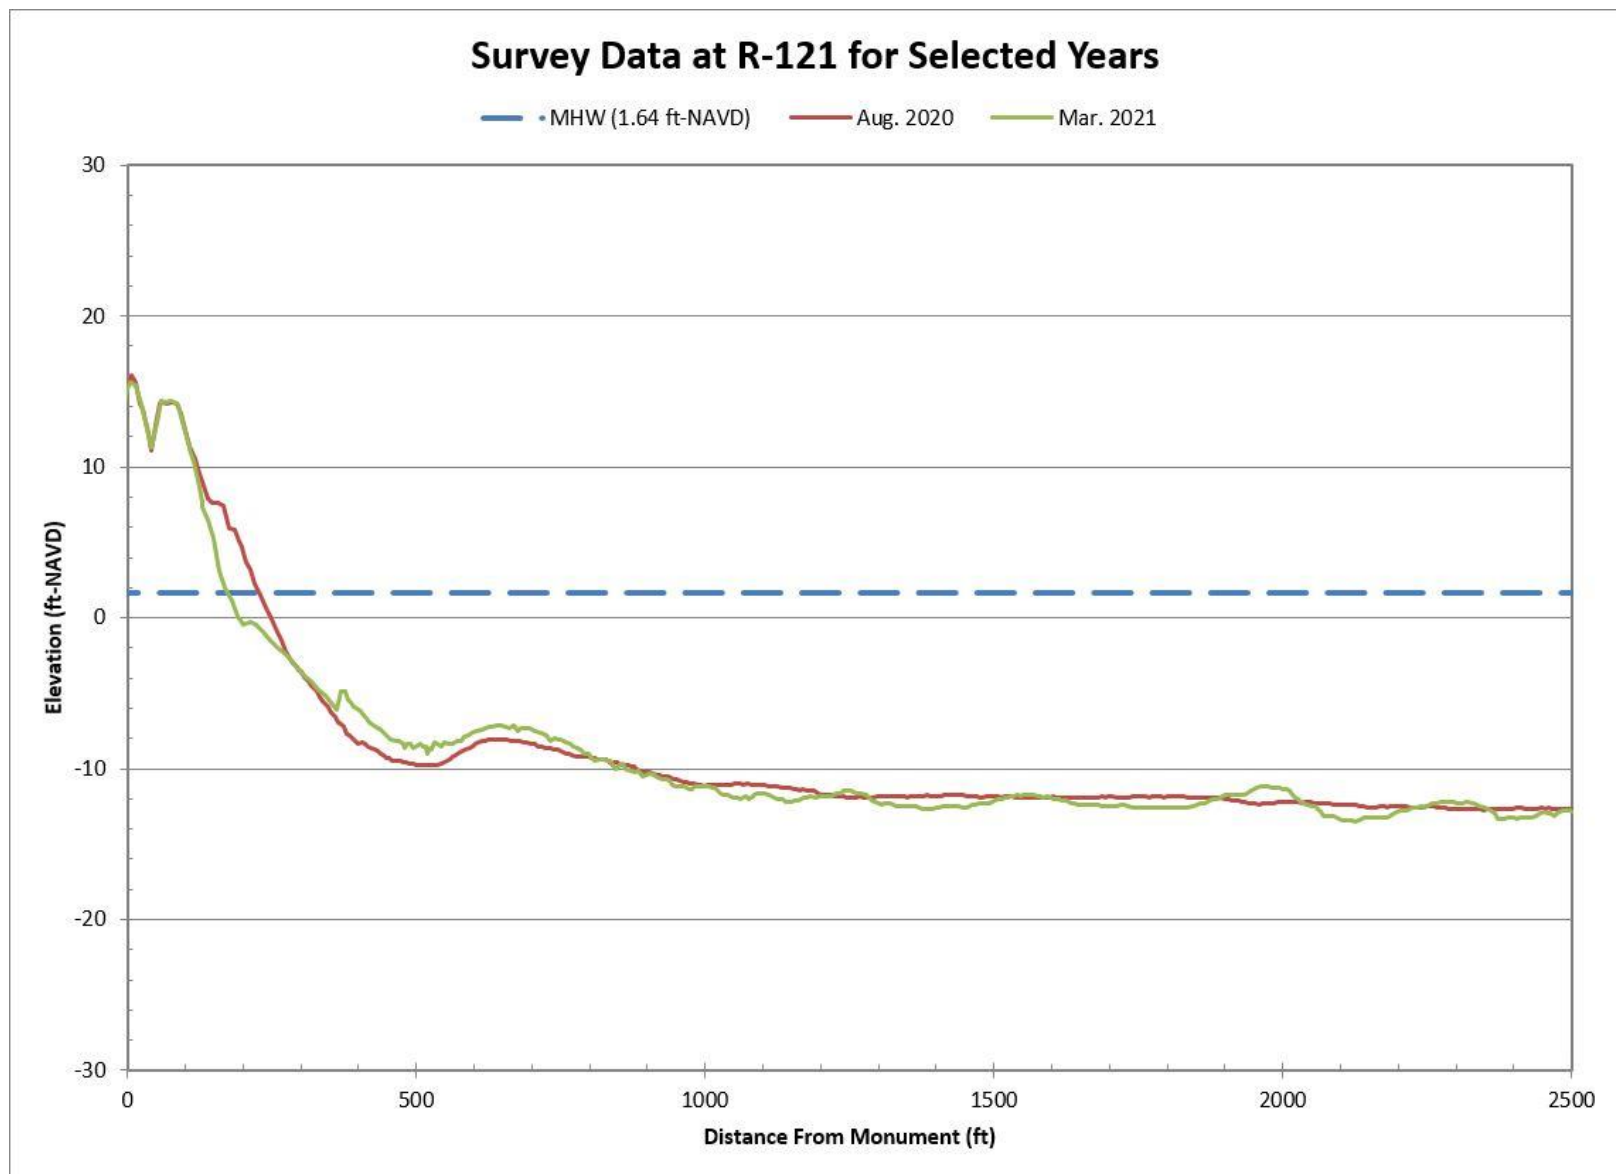
Figure B-42. Aug. 2020 Pre-Construction vs. Mar. 2021 Post-Construction Beach Profiles Along R-121

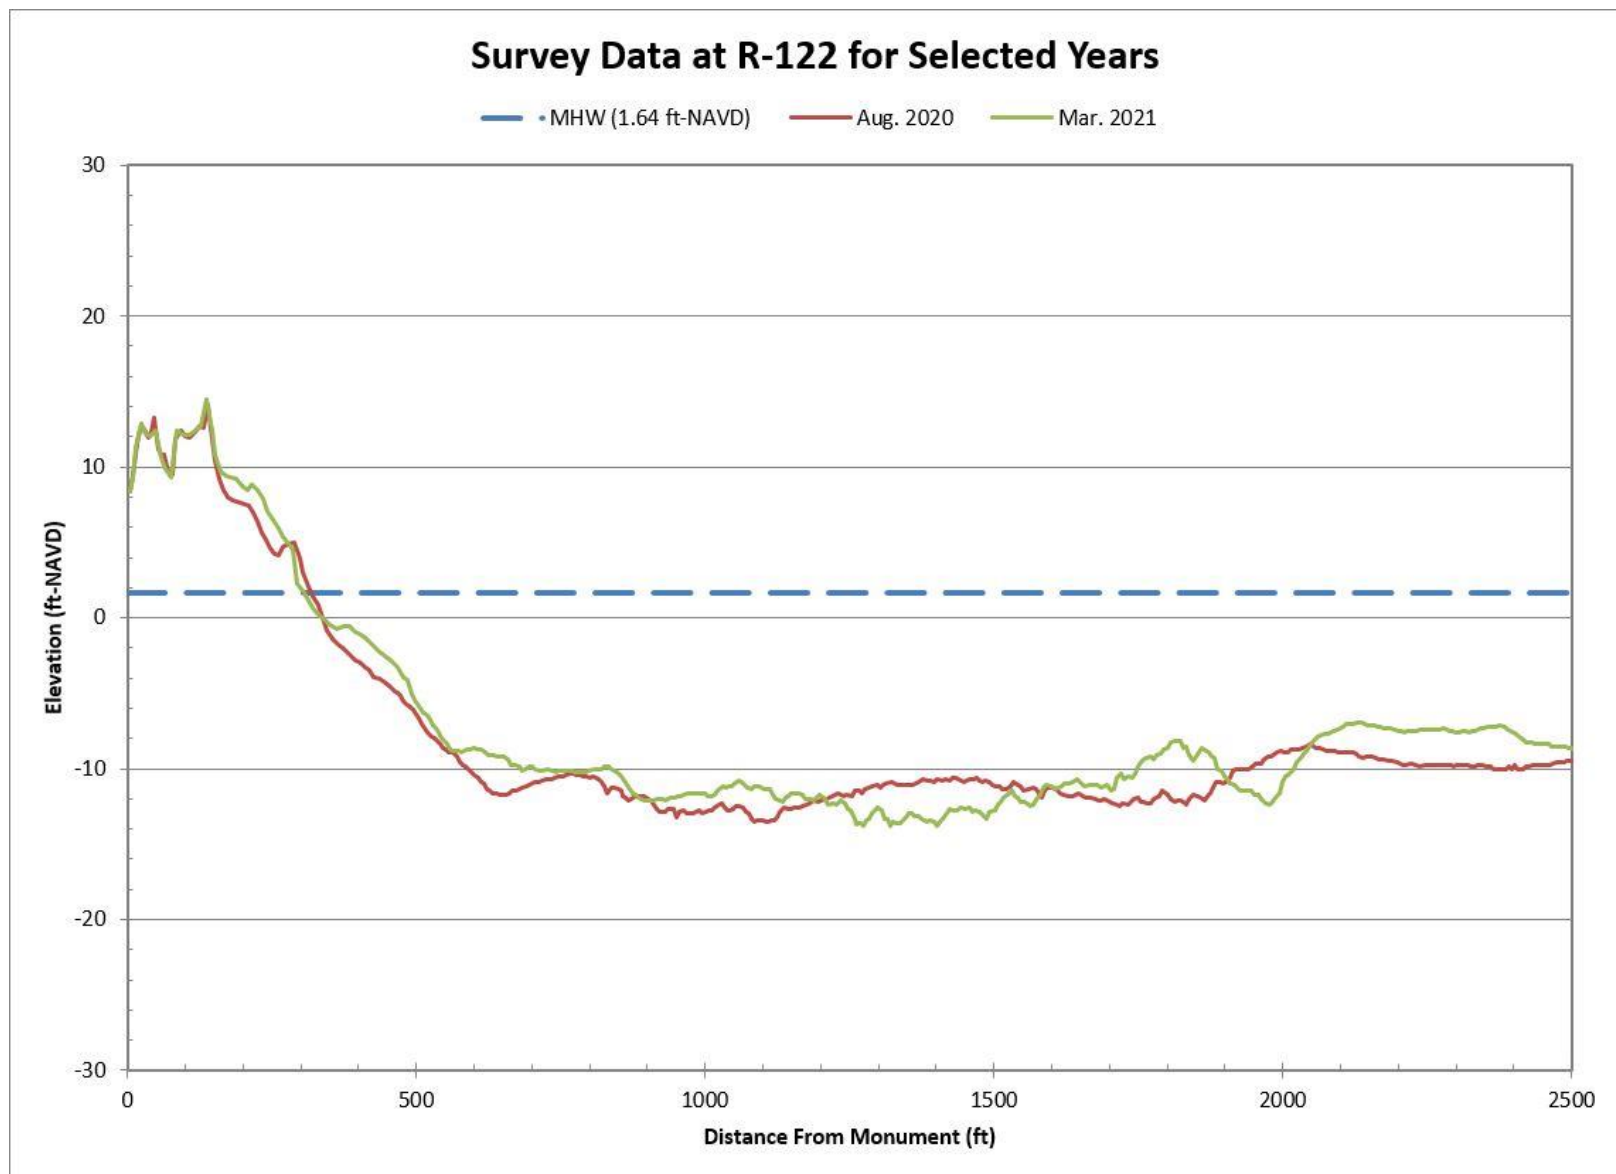
Figure B-43. Aug. 2020 Pre-Construction vs. Mar. 2021 Post-Construction Beach Profiles Along R-122
