## **Appendix B**

### **Beach Profile Plots**

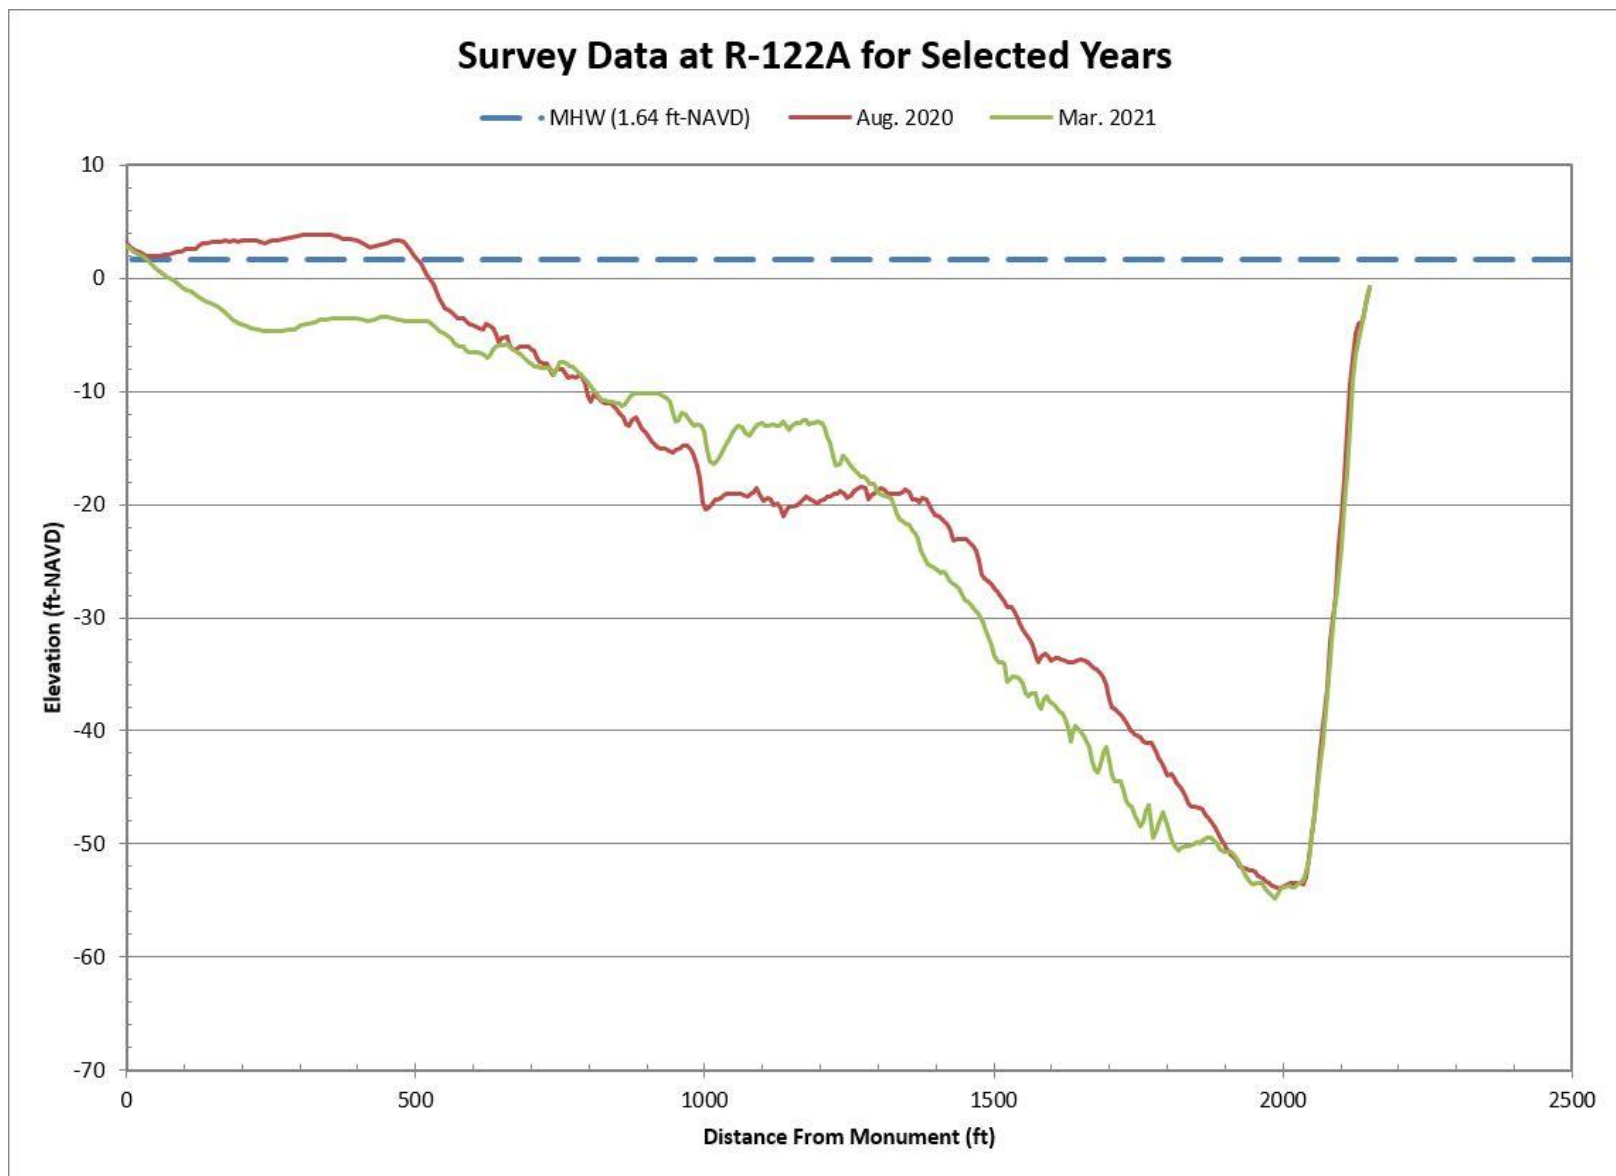
**Figure B-44. Aug. 2020 Pre-Construction vs. Mar. 2021 Post-Construction Beach Profiles Along R-122A**

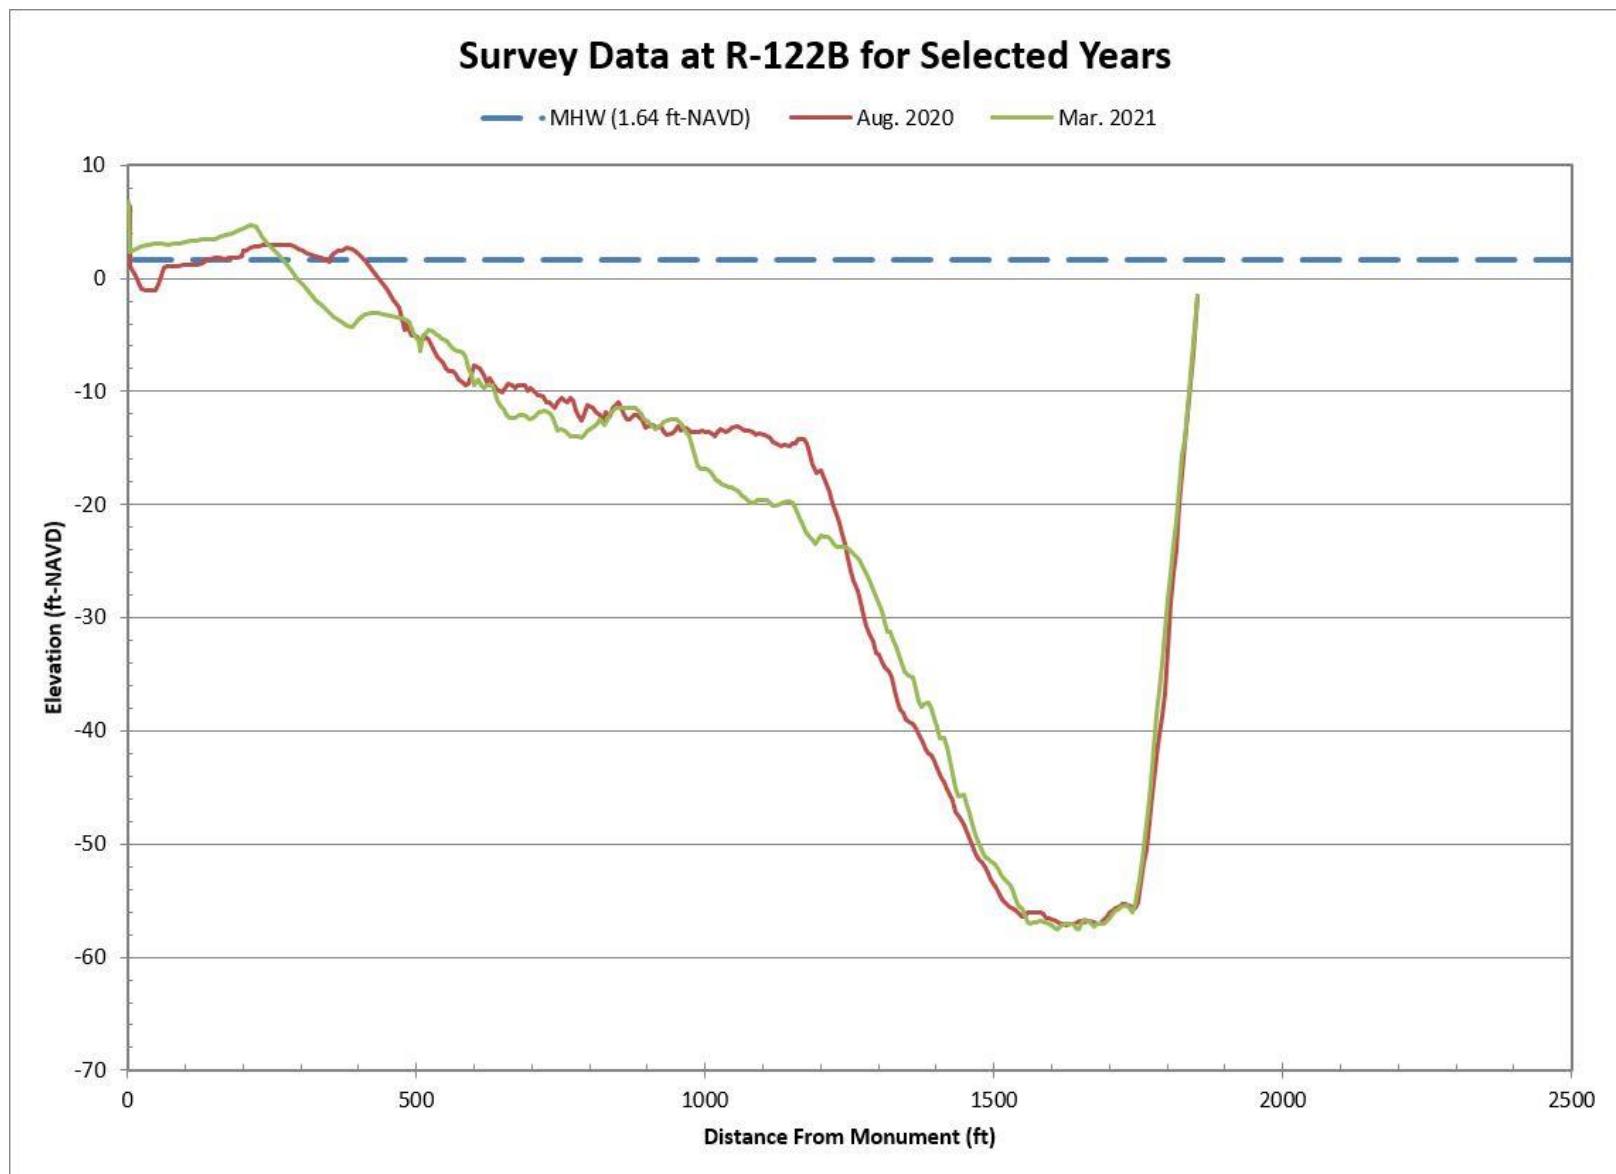
**Figure B-45. Aug. 2020 Pre-Construction vs. Mar. 2021 Post-Construction Beach Profiles Along R-122B**

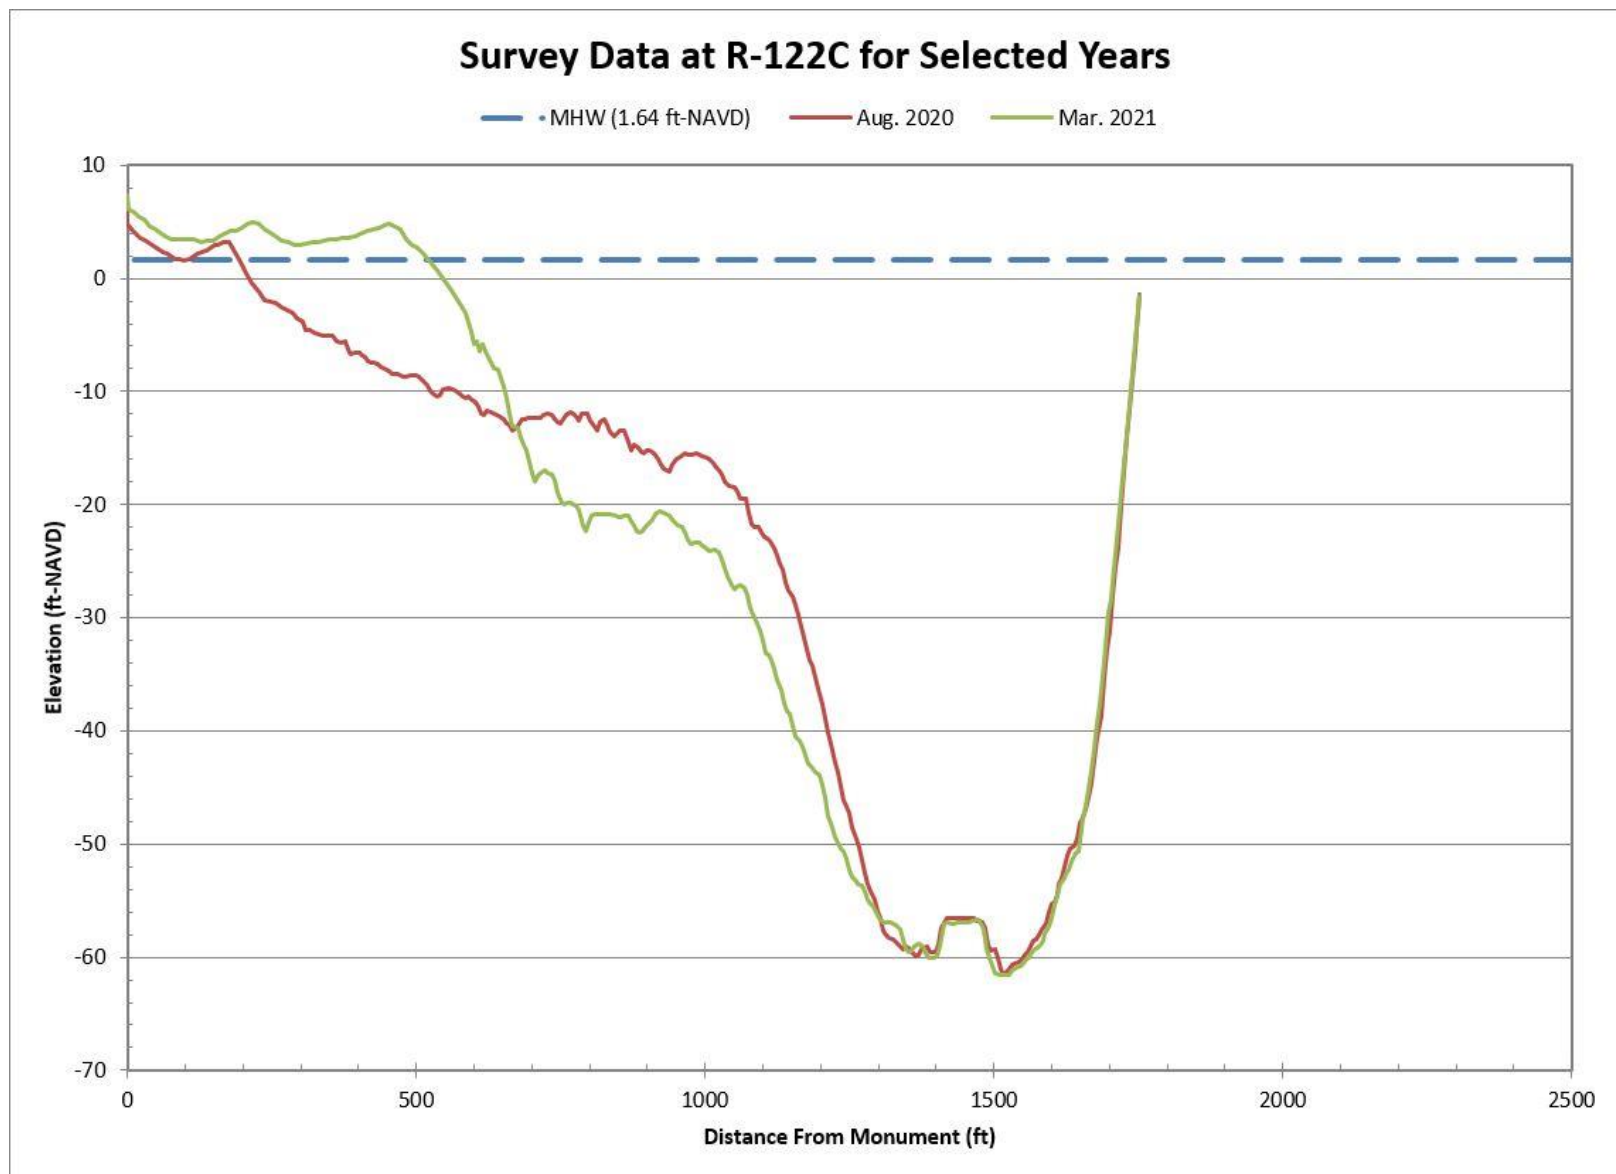
Figure B-46. Aug. 2020 Pre-Construction vs. Mar. 2021 Post-Construction Beach Profiles Along R-122C

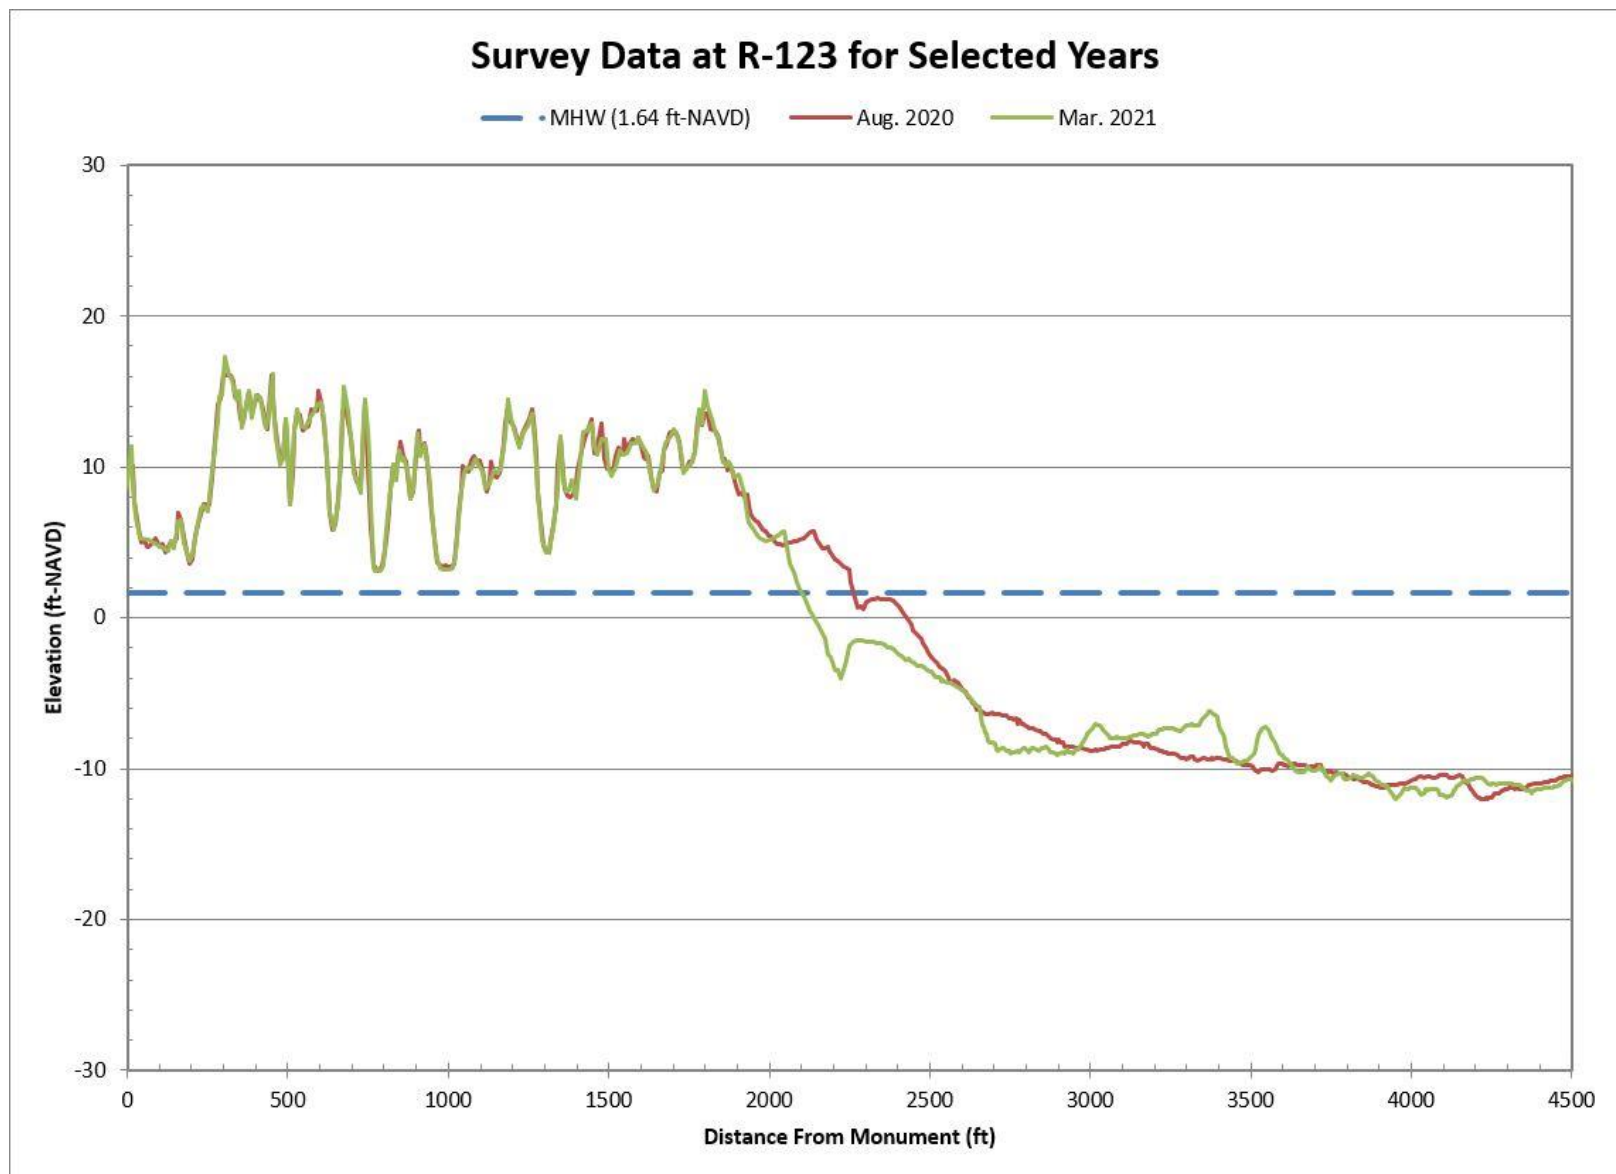
**Figure B-47. Aug. 2020 Pre-Construction vs. Mar. 2021 Post-Construction Beach Profiles Along R-123**

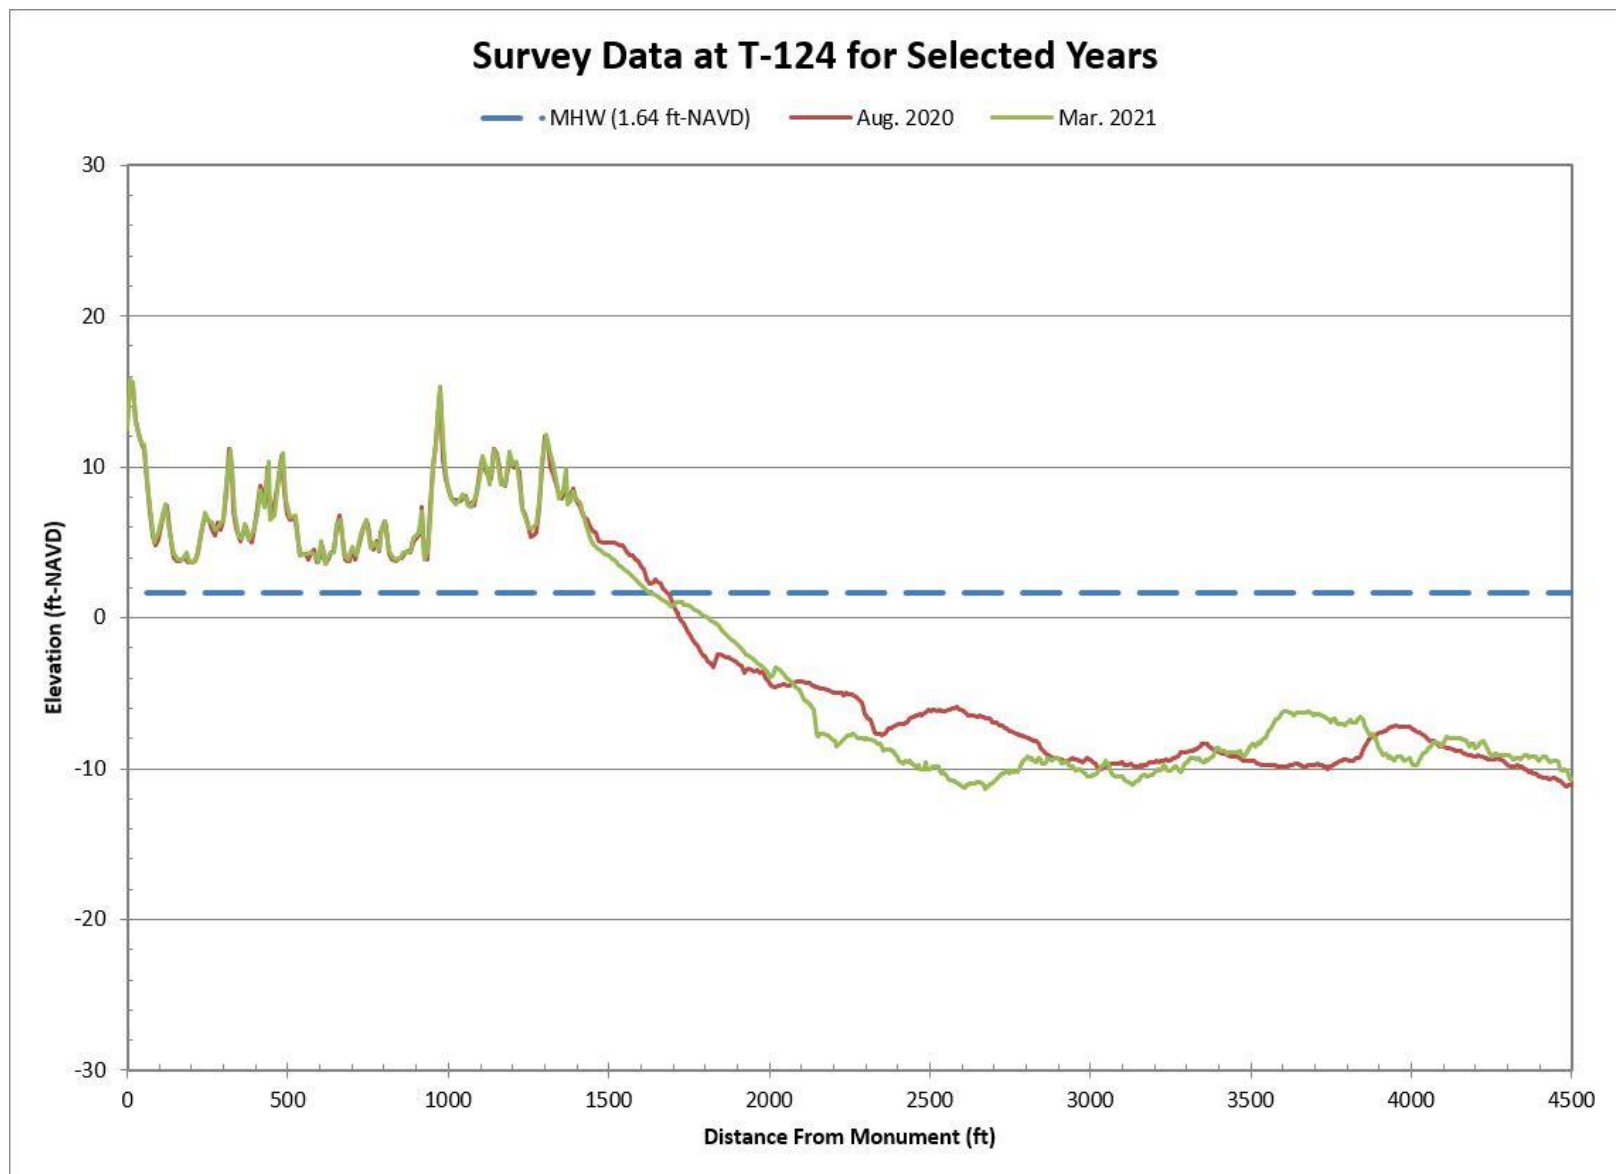
**Figure B-48. Aug. 2020 Pre-Construction vs. Mar. 2021 Post-Construction Beach Profiles Along T-124**

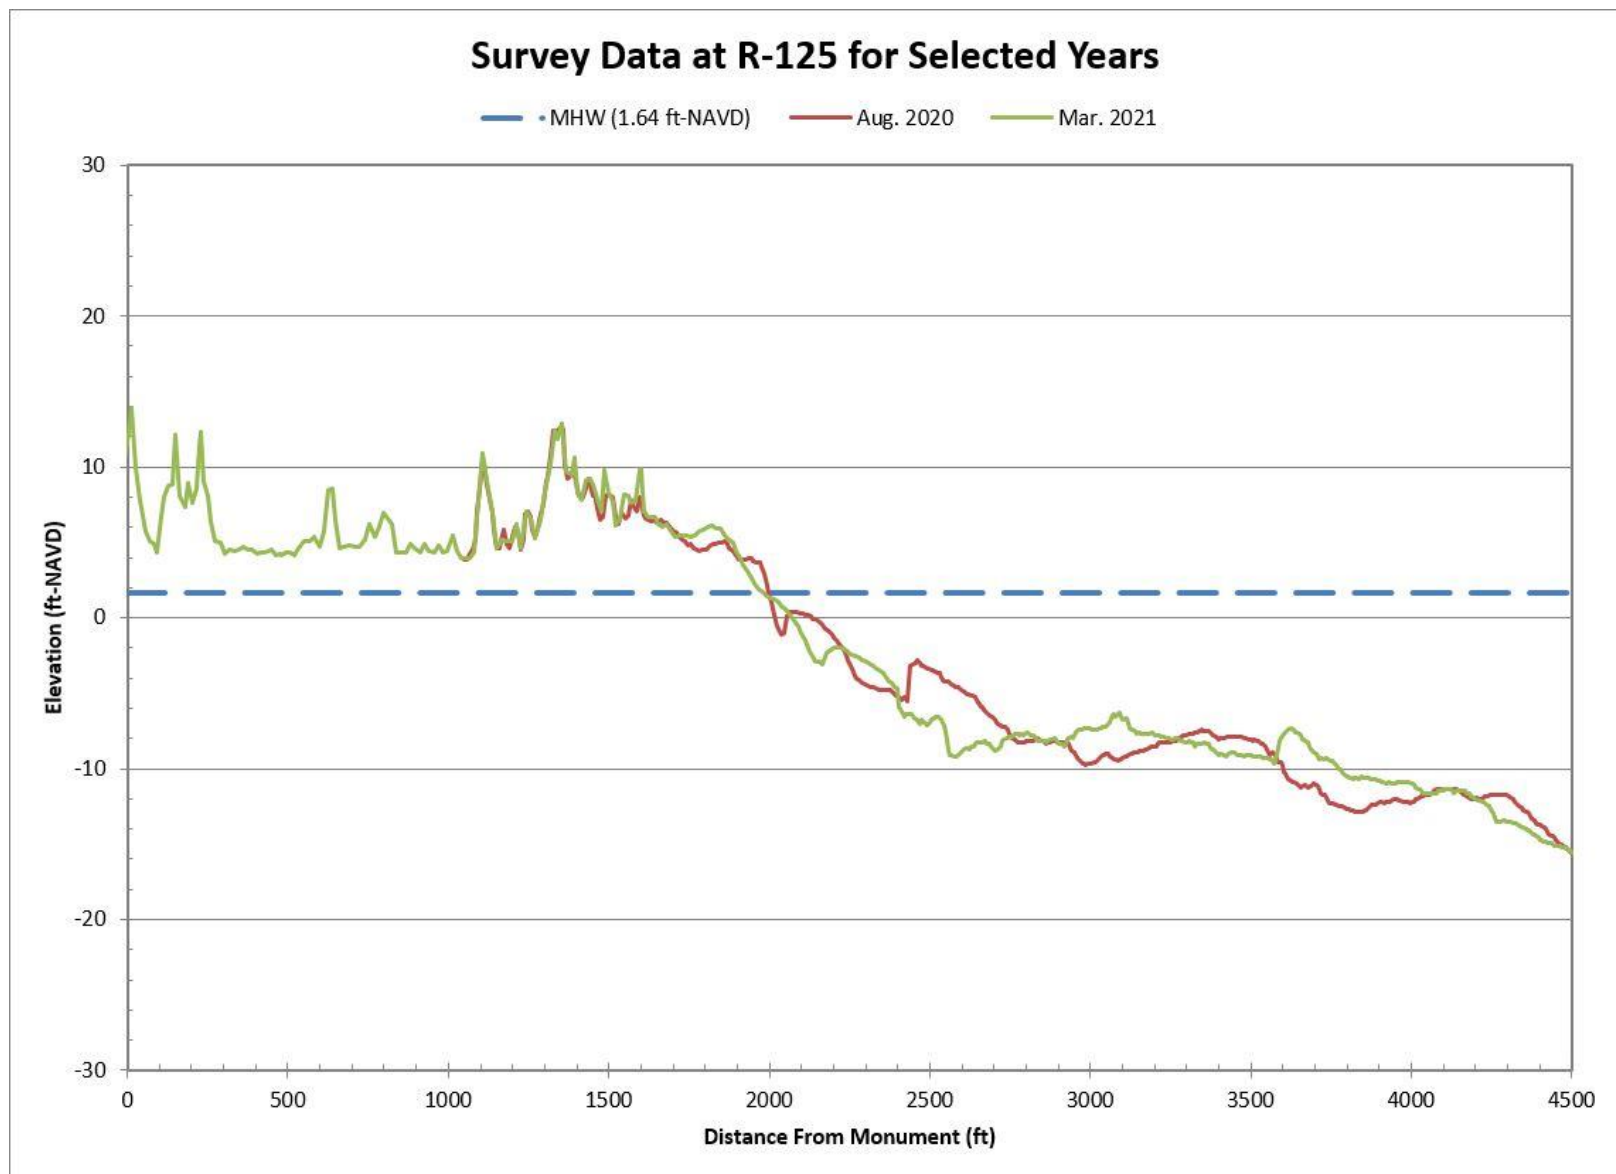
**Figure B-49. Aug. 2020 Pre-Construction vs. Mar. 2021 Post-Construction Beach Profiles Along R-125**

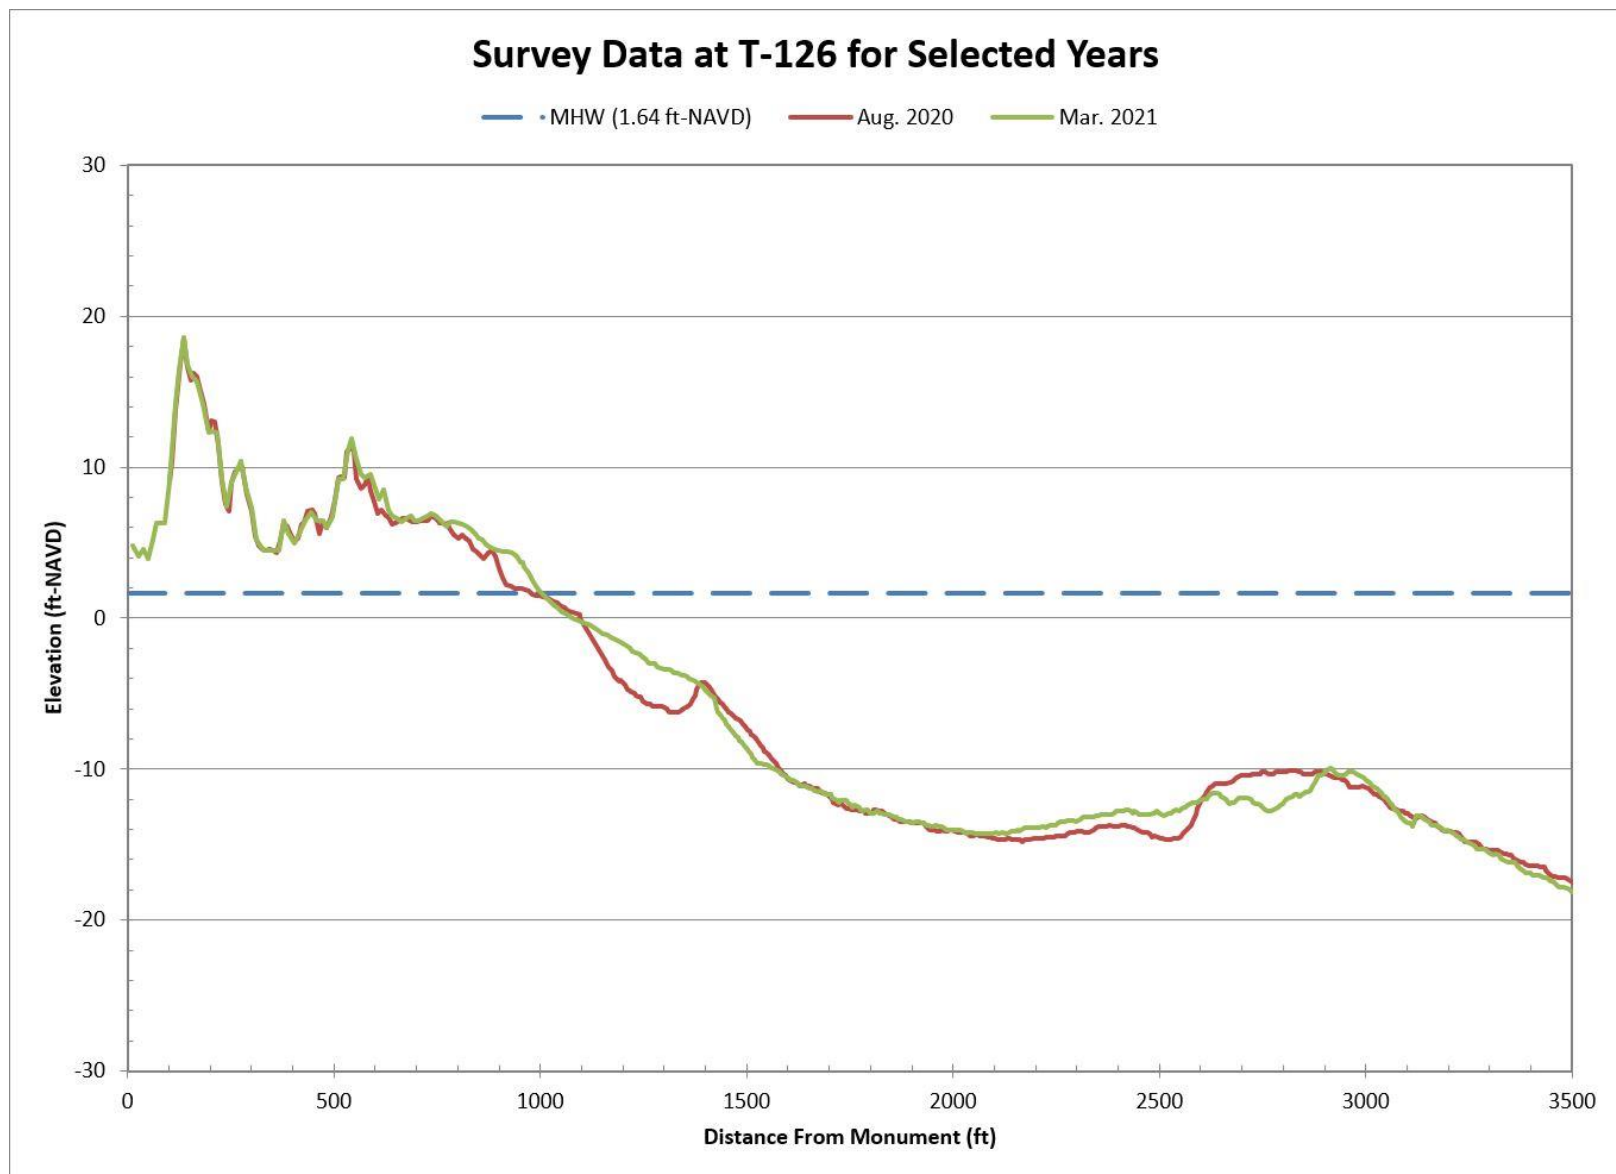
Figure B-50. Aug. 2020 Pre-Construction vs. Mar. 2021 Post-Construction Beach Profiles Along T-126

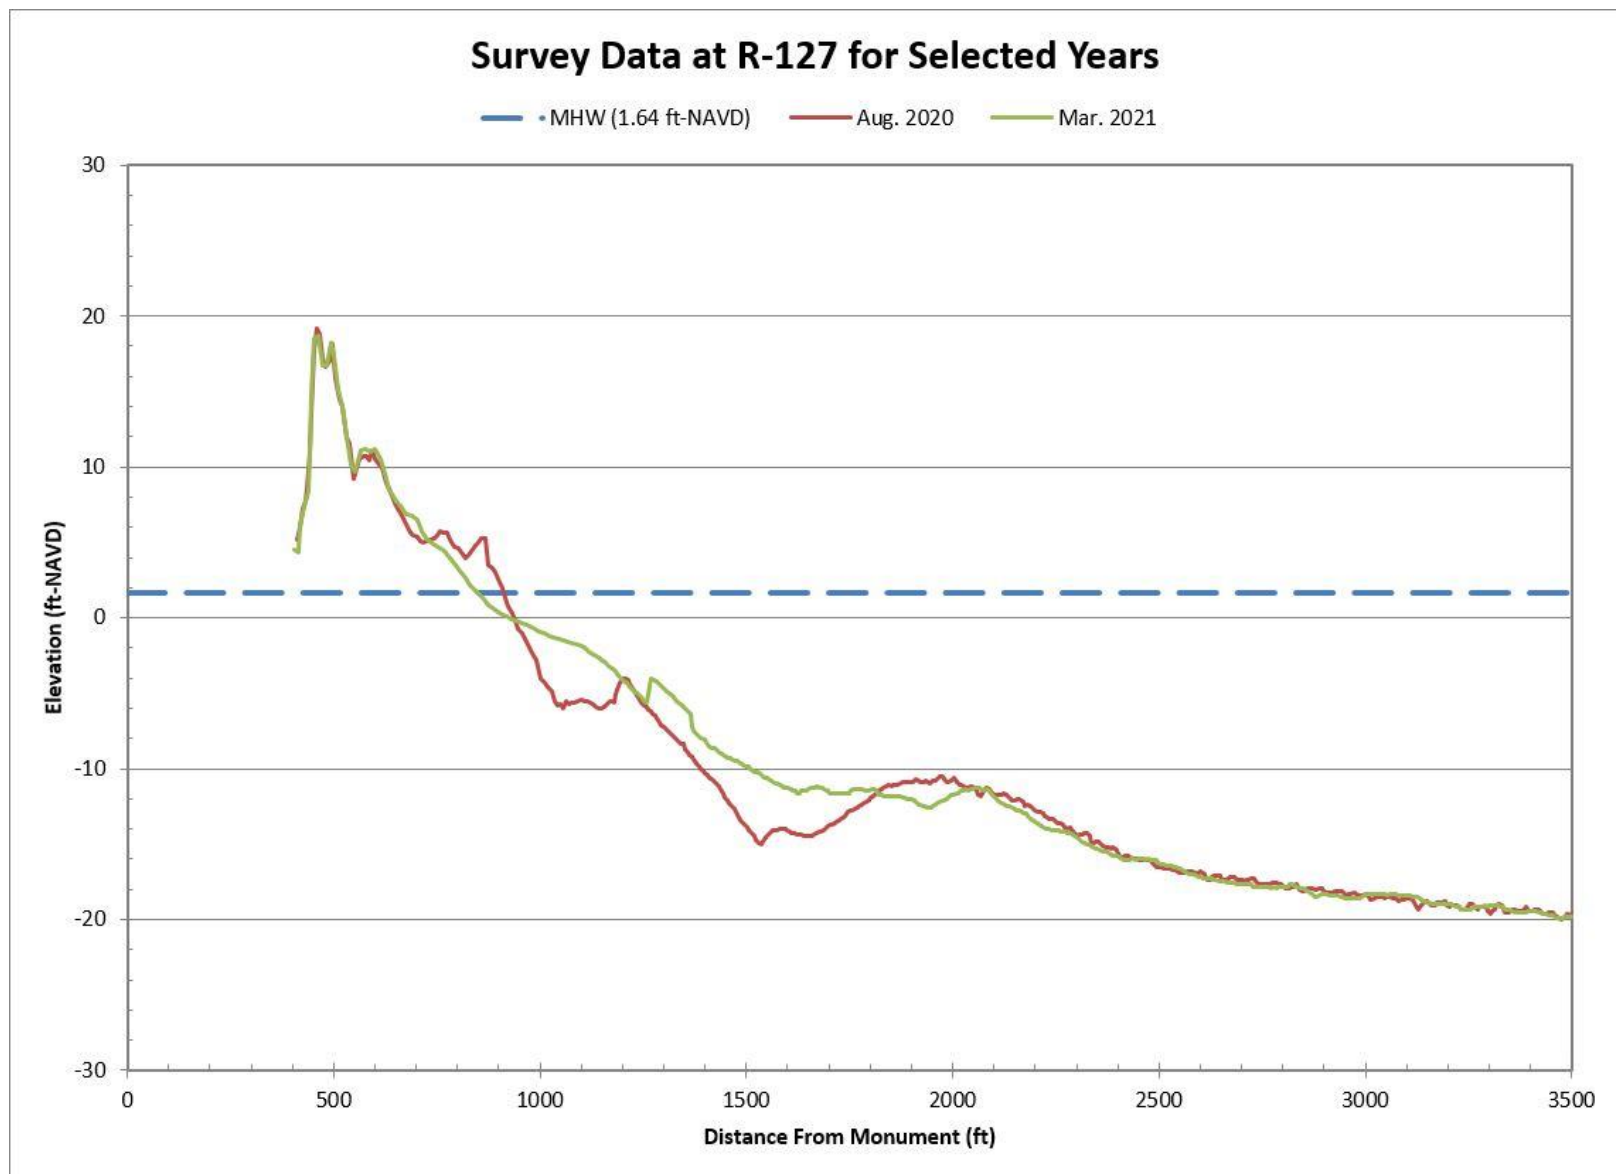
Figure B-51. Aug. 2020 Pre-Construction vs. Mar. 2021 Post-Construction Beach Profiles Along R-127

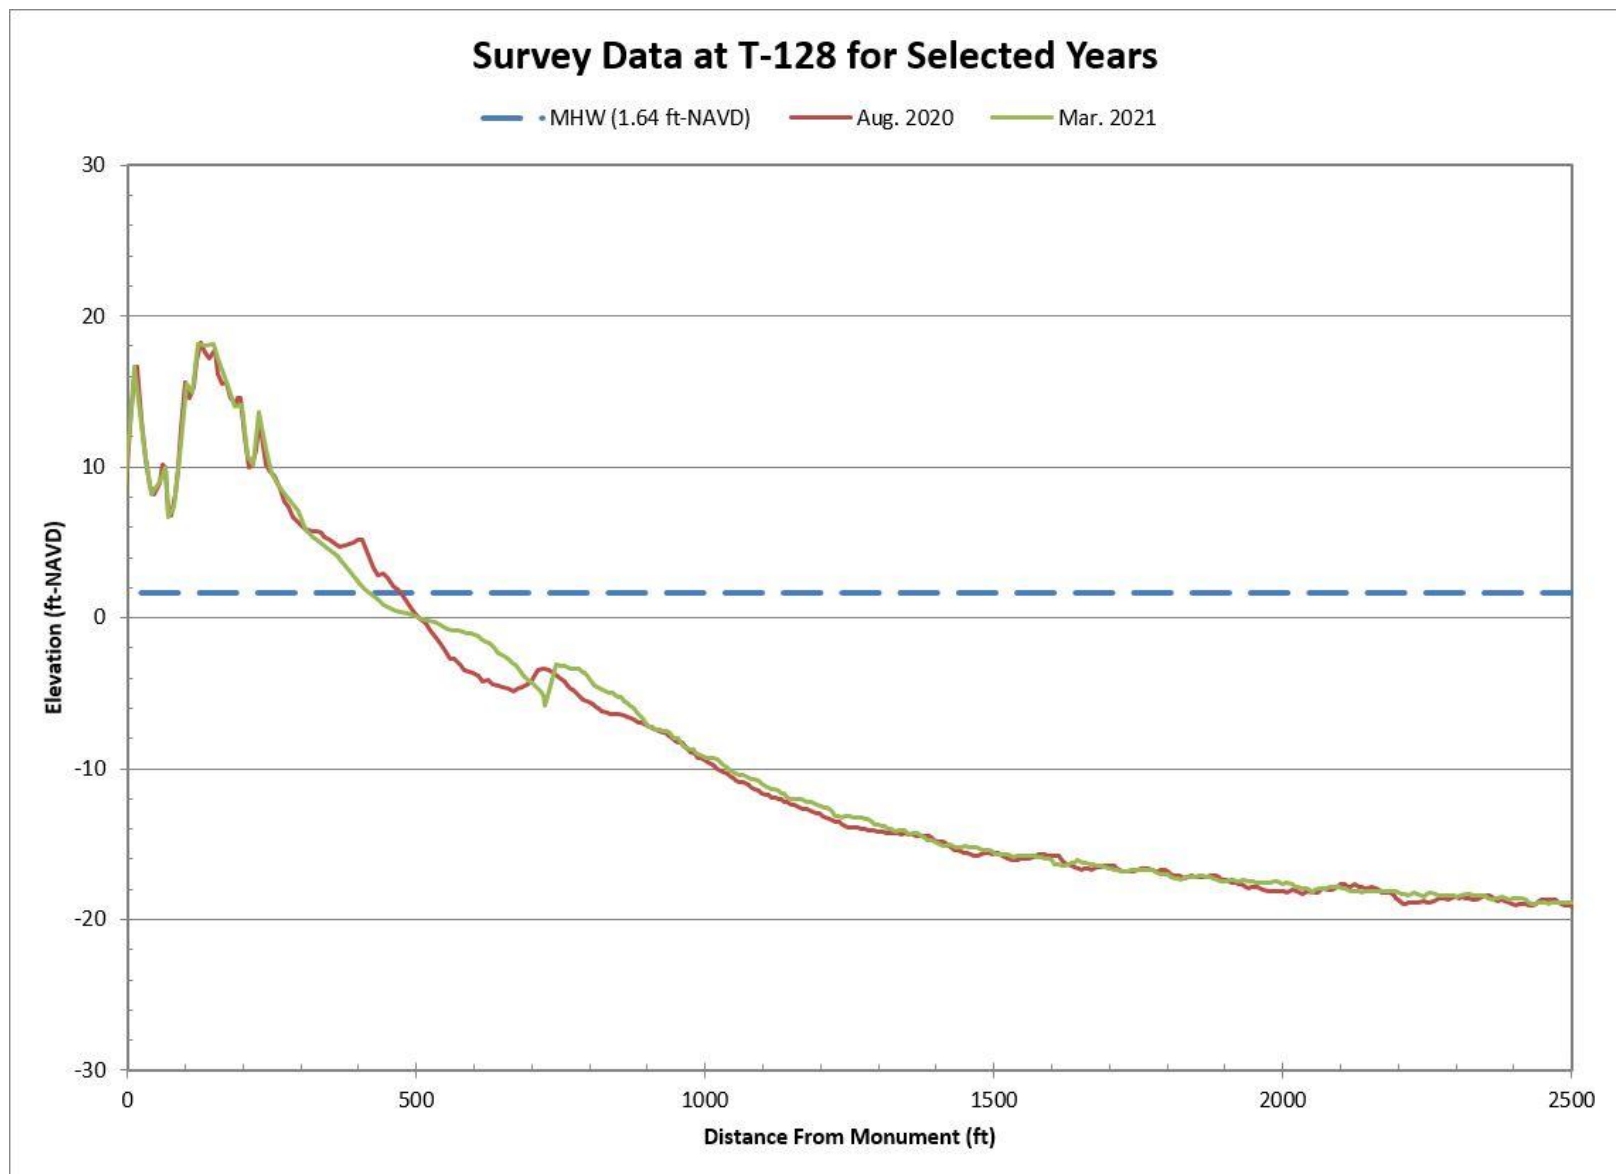
Figure B-52. Aug. 2020 Pre-Construction vs. Mar. 2021 Post-Construction Beach Profiles Along T-128

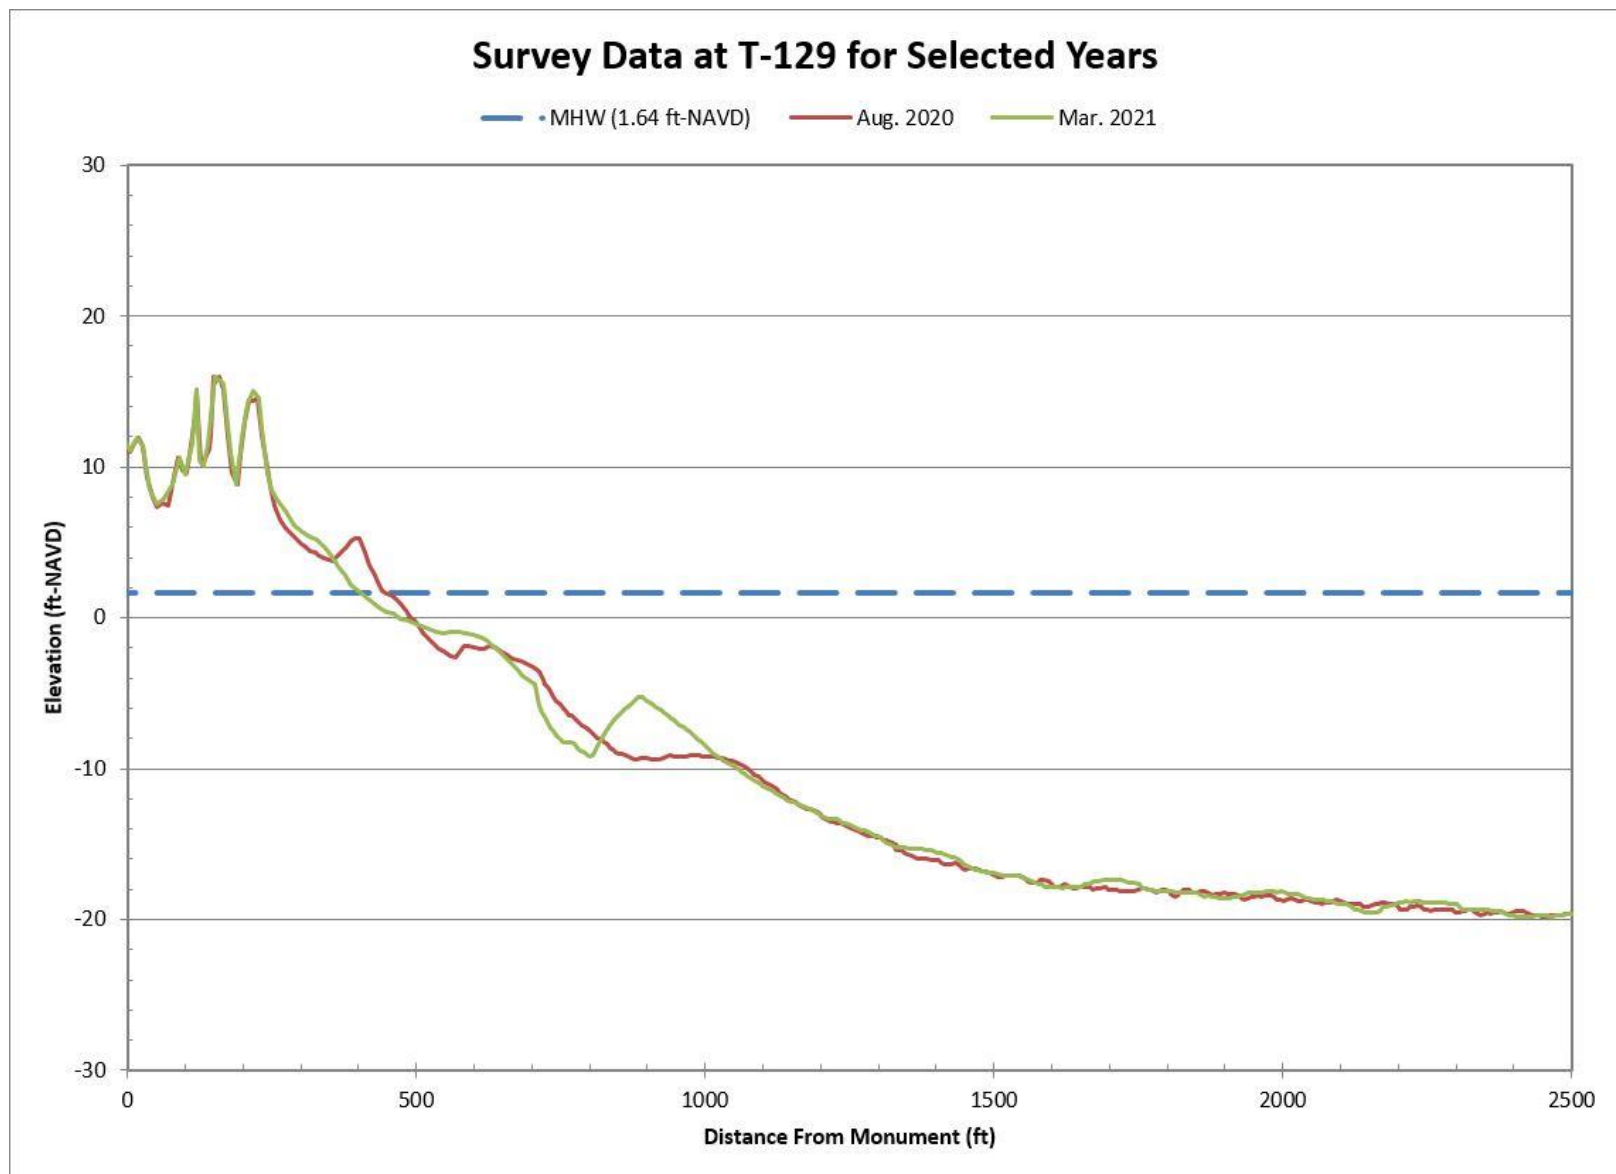
Figure B-53. Aug. 2020 Pre-Construction vs. Mar. 2021 Post-Construction Beach Profiles Along T-129

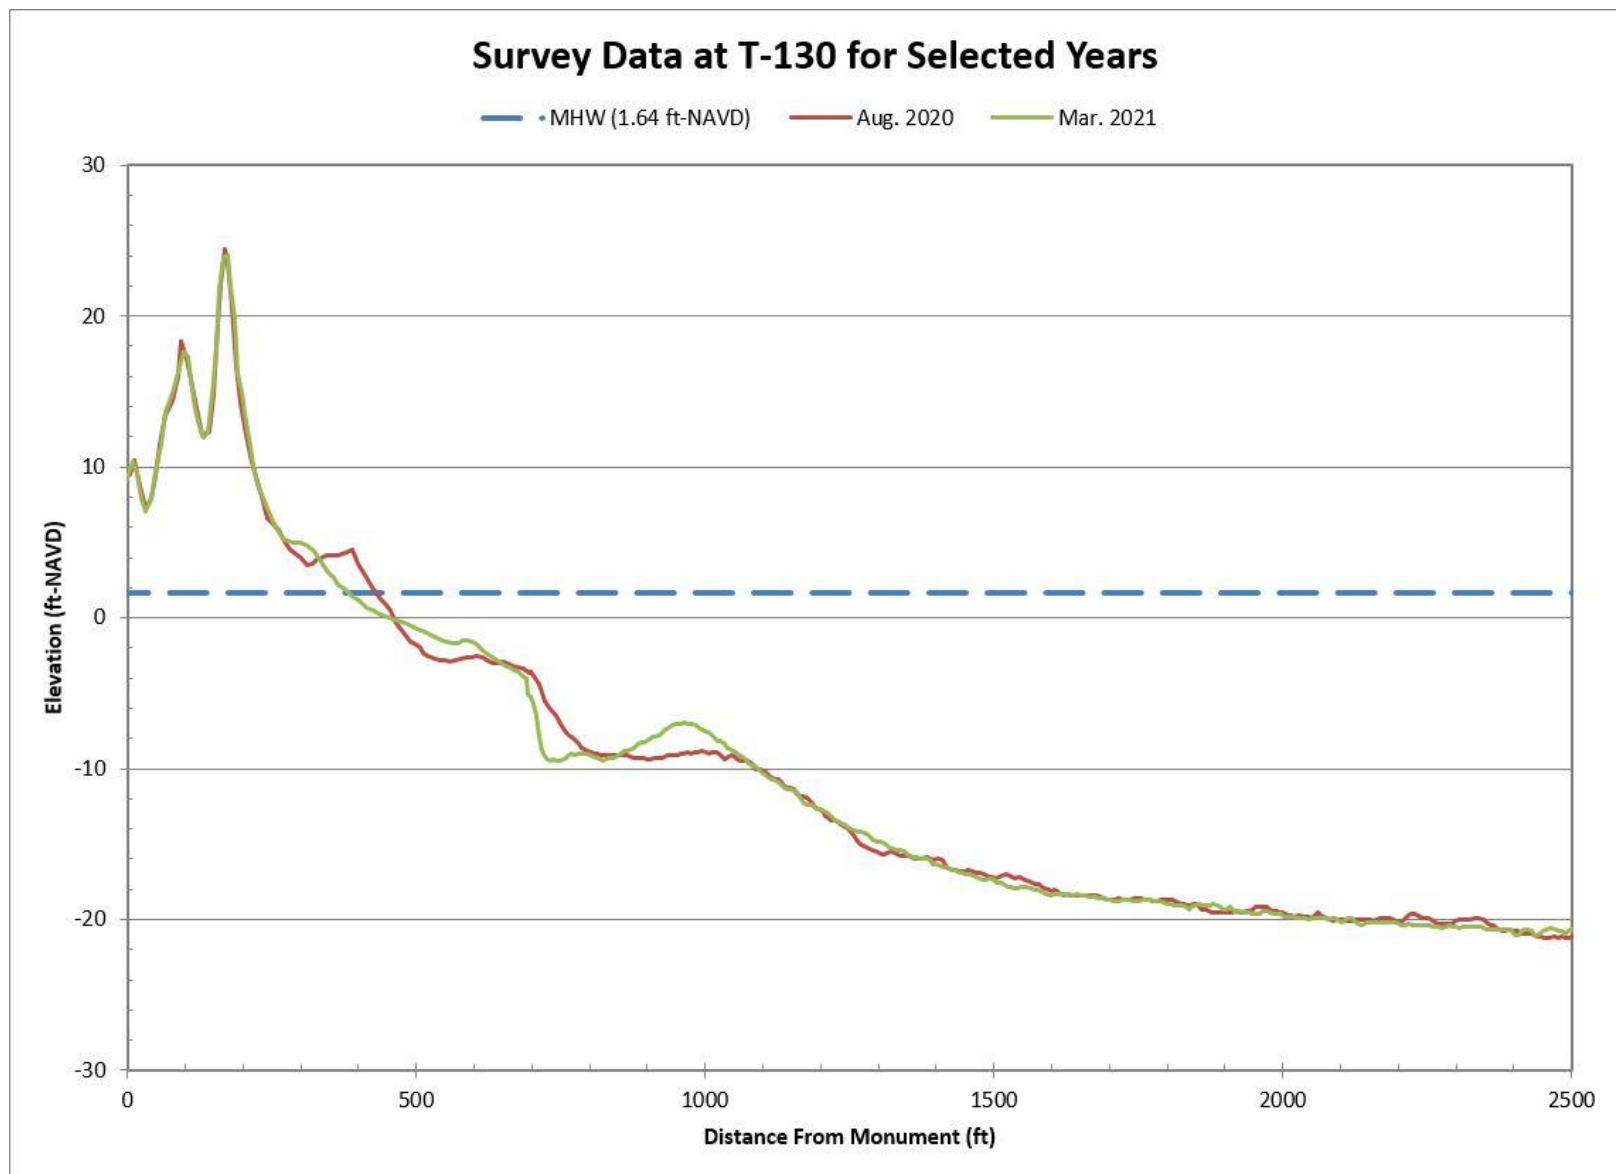
Figure B-54. Aug. 2020 Pre-Construction vs. Mar. 2021 Post-Construction Beach Profiles Along T-130

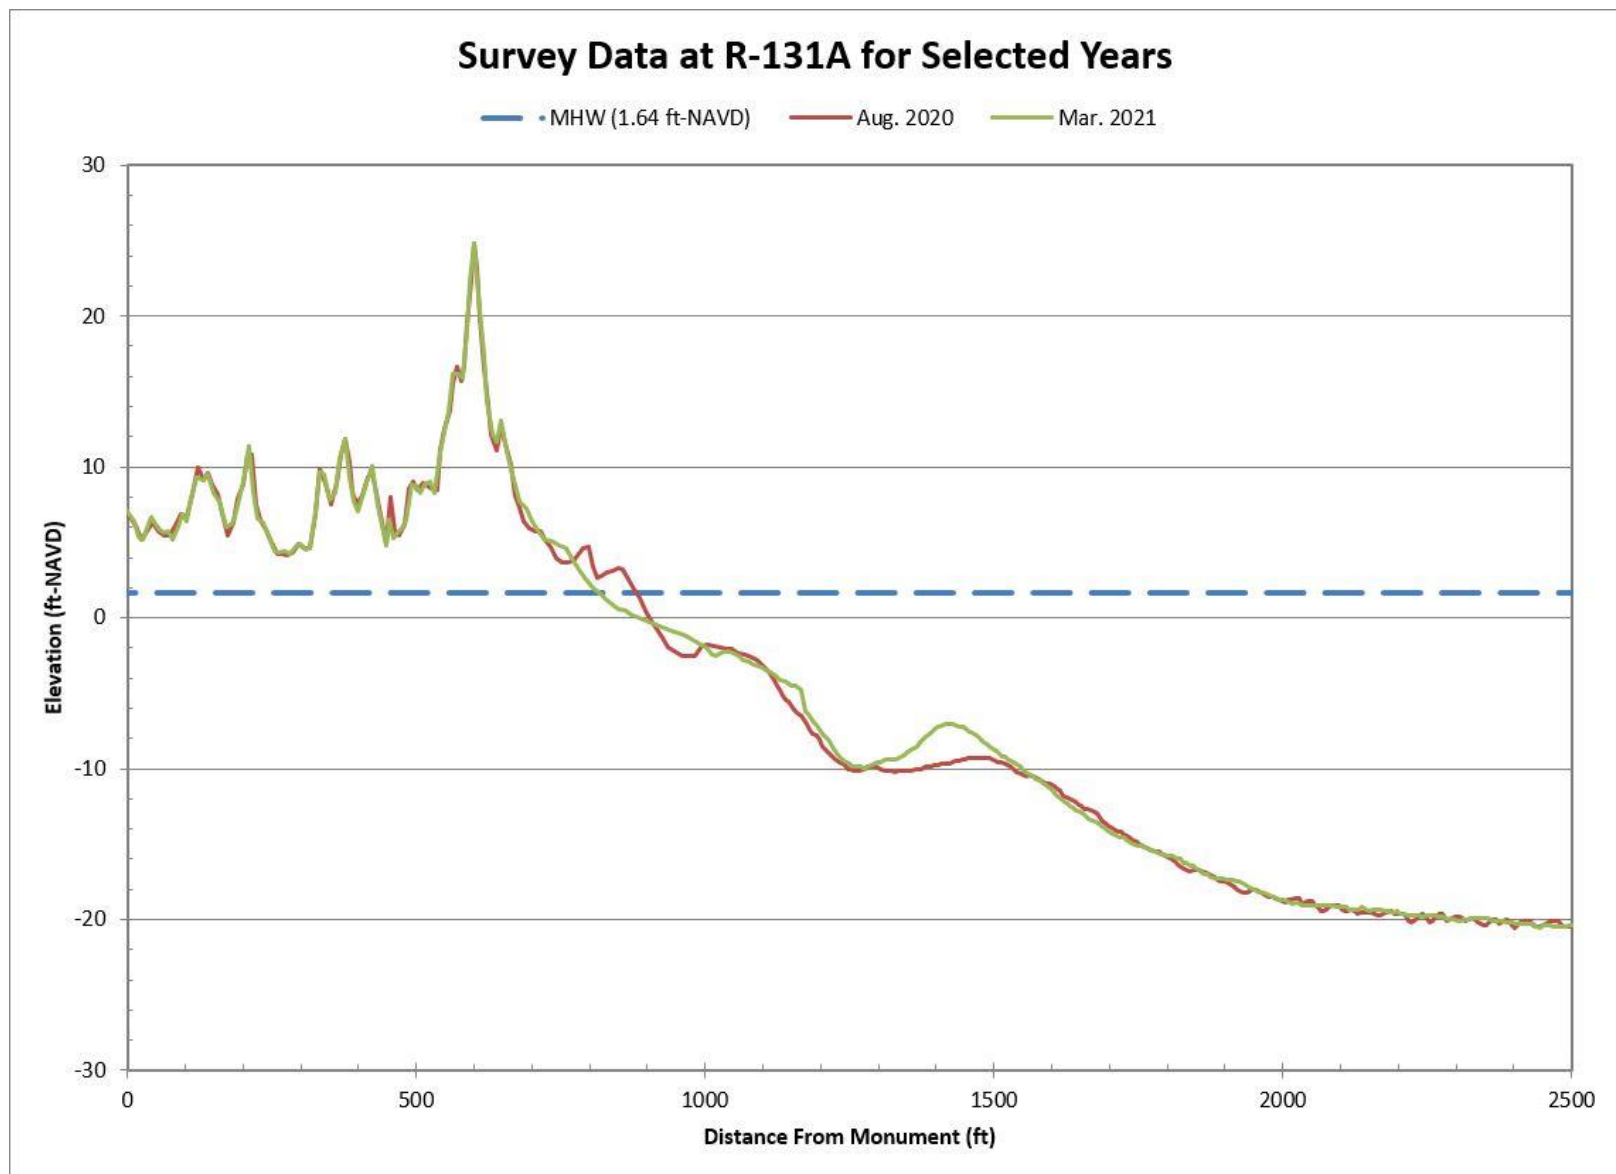
Figure B-55. Aug. 2020 Pre-Construction vs. Mar. 2021 Post-Construction Beach Profiles Along R-131A
