## **Appendix B**

### **Beach Profile Plots**

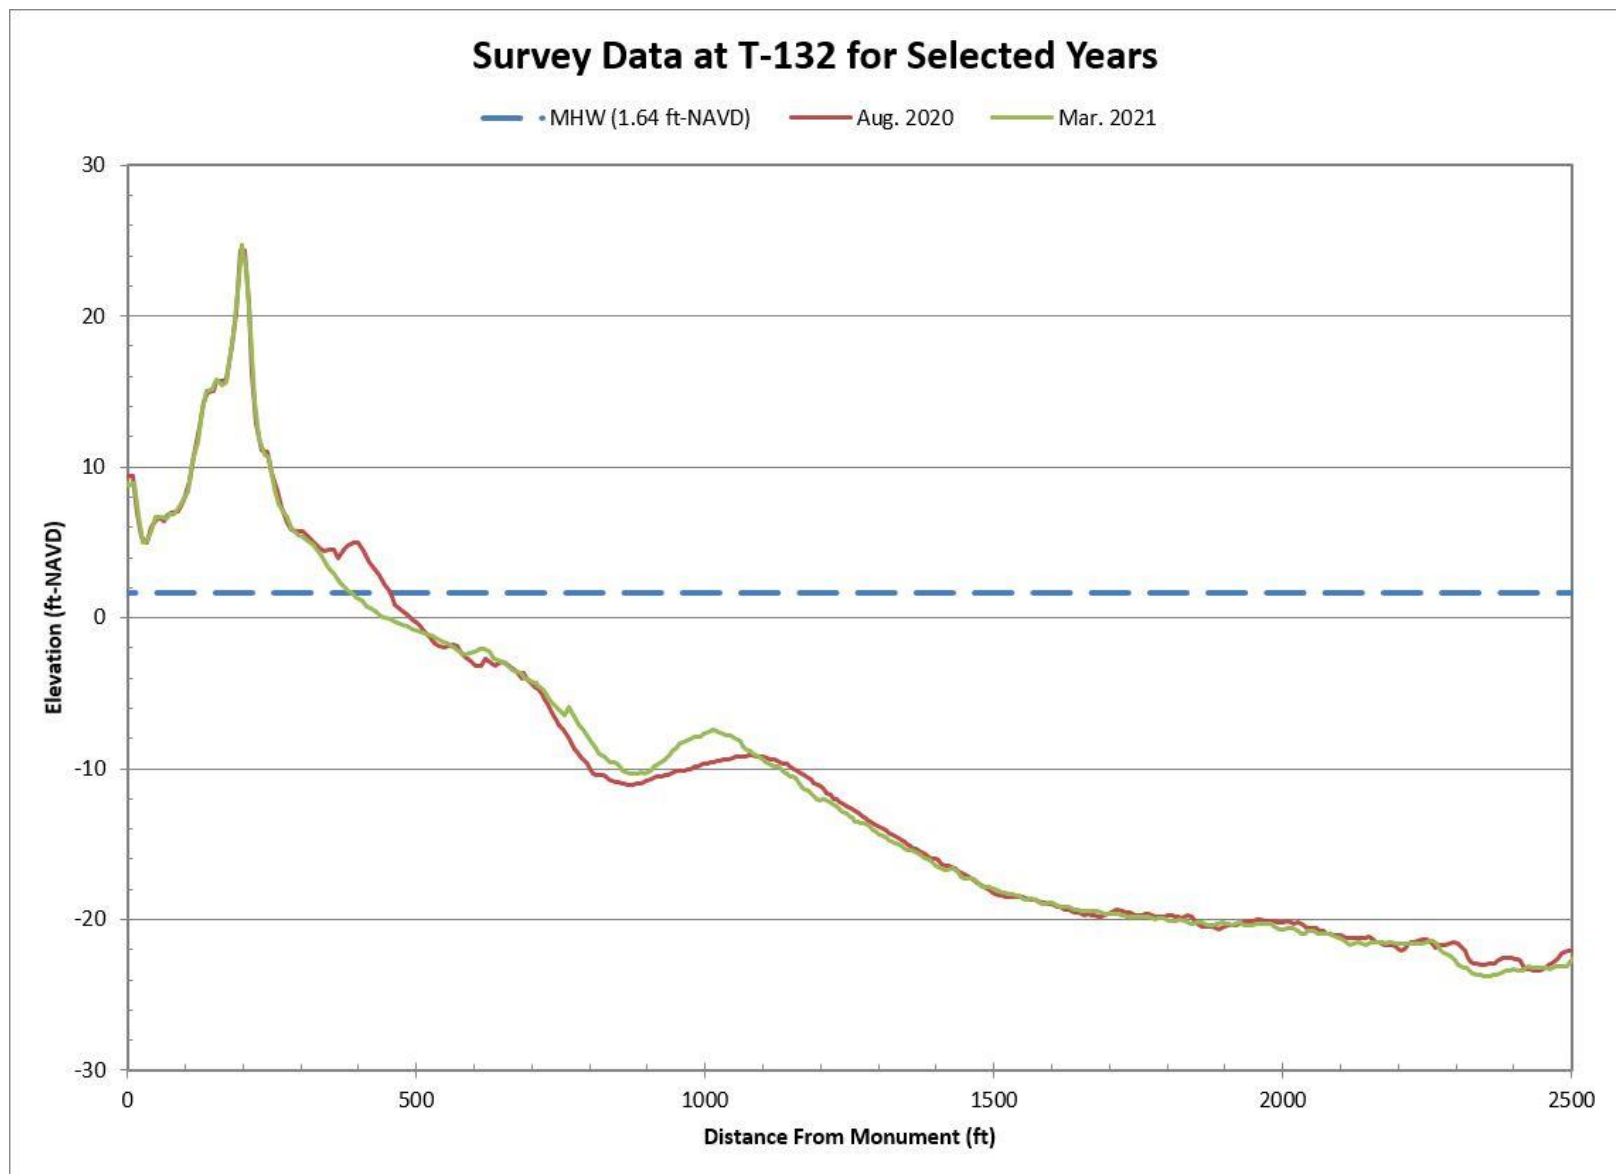
Figure B-56. Aug. 2020 Pre-Construction vs. Mar. 2021 Post-Construction Beach Profiles Along T-132

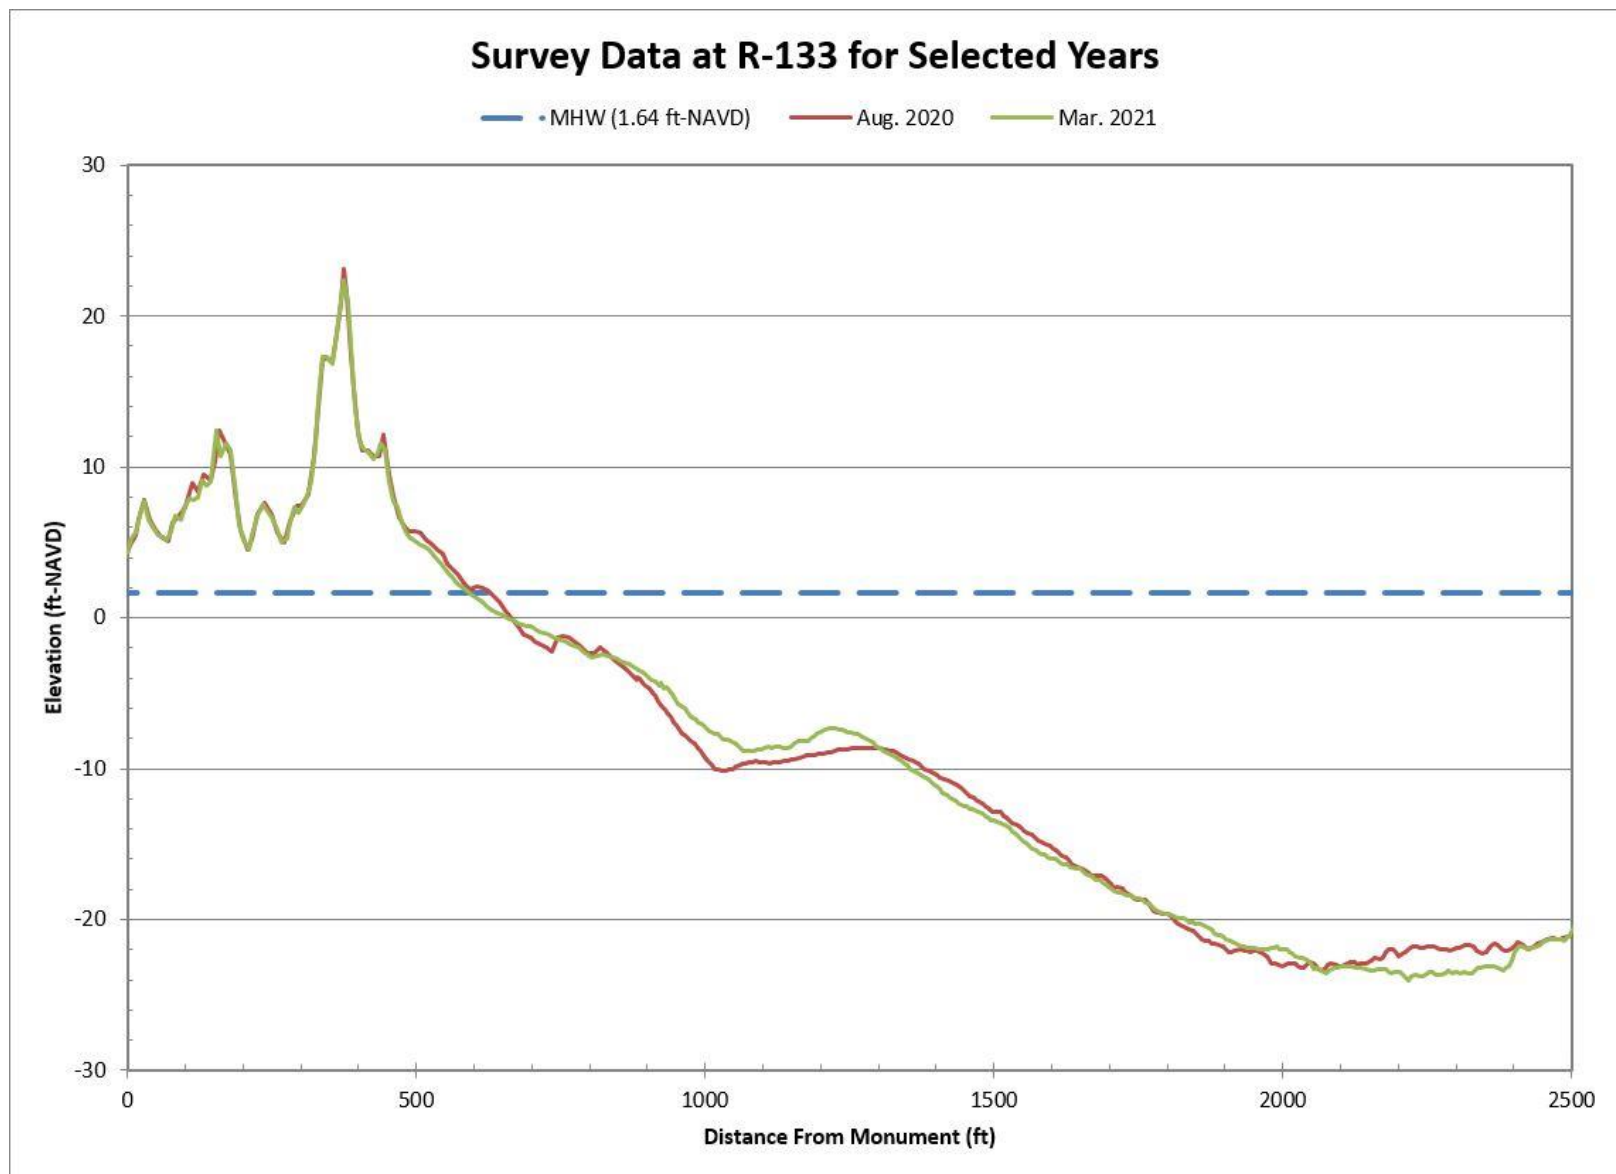
**Figure B-57. Aug. 2020 Pre-Construction vs. Mar. 2021 Post-Construction Beach Profiles Along R-133**

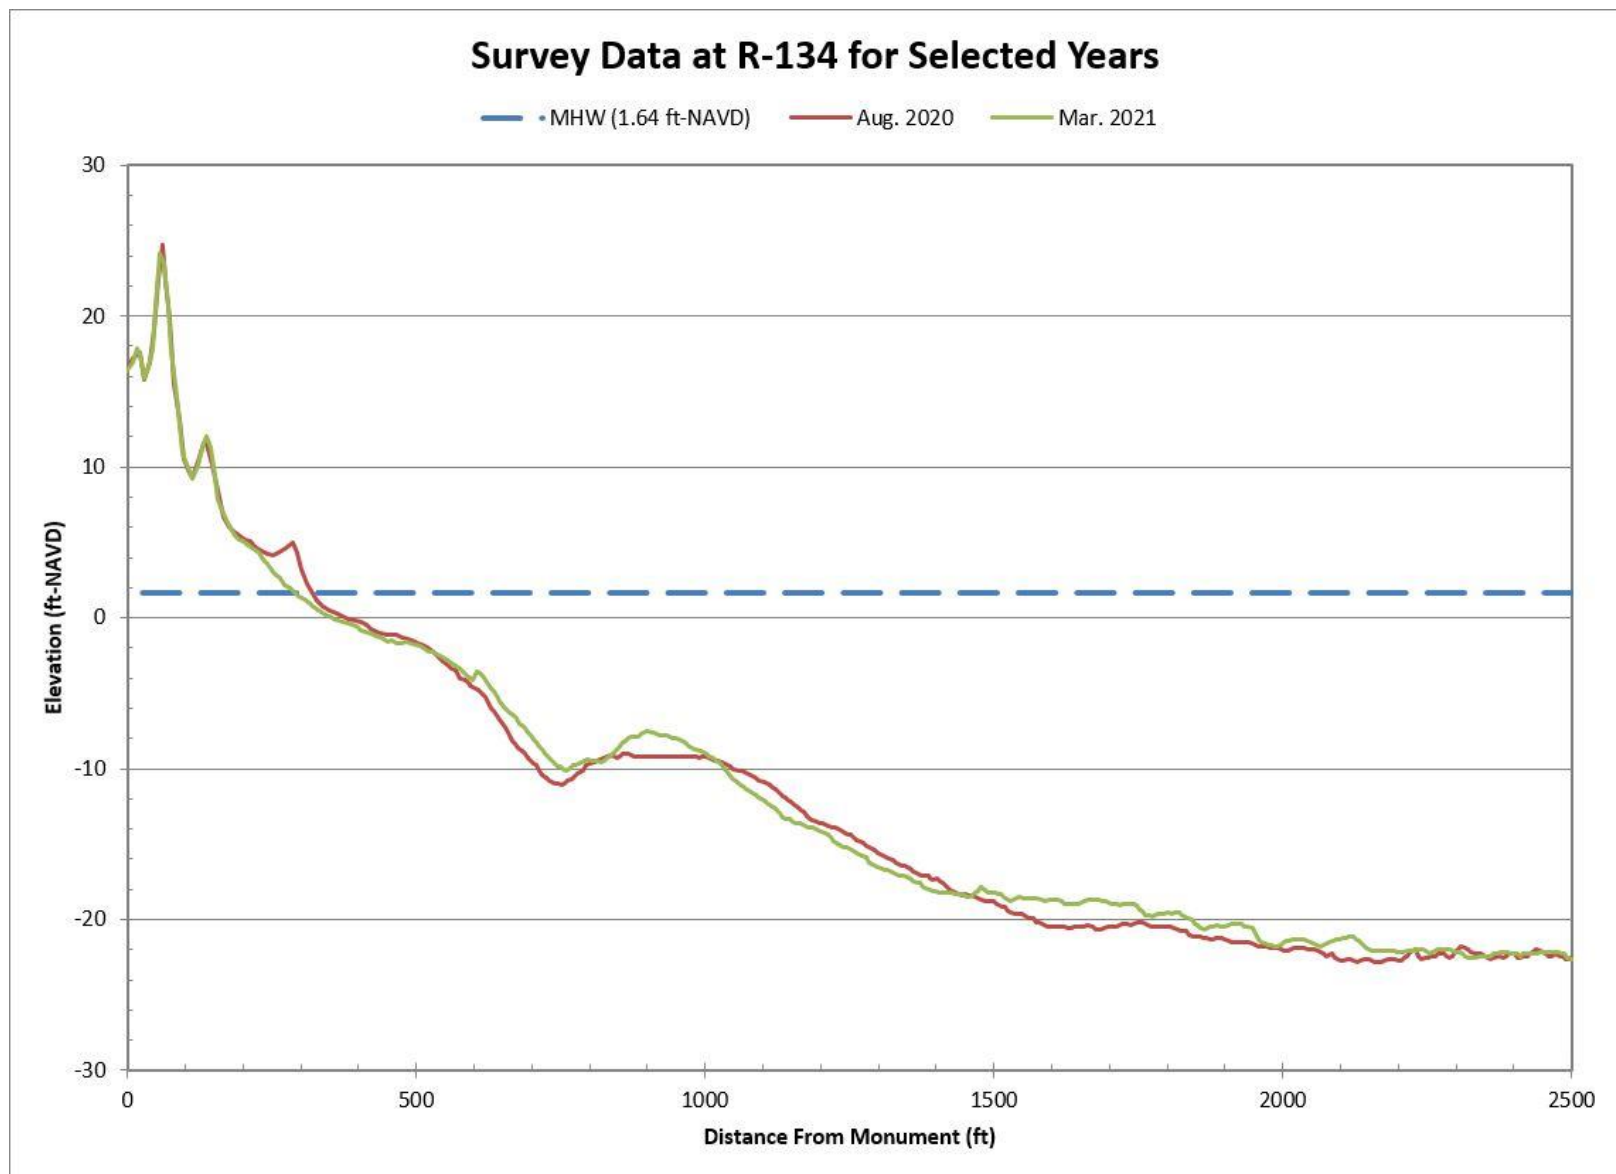
**Figure B-58. Aug. 2020 Pre-Construction vs. Mar. 2021 Post-Construction Beach Profiles Along R-134**

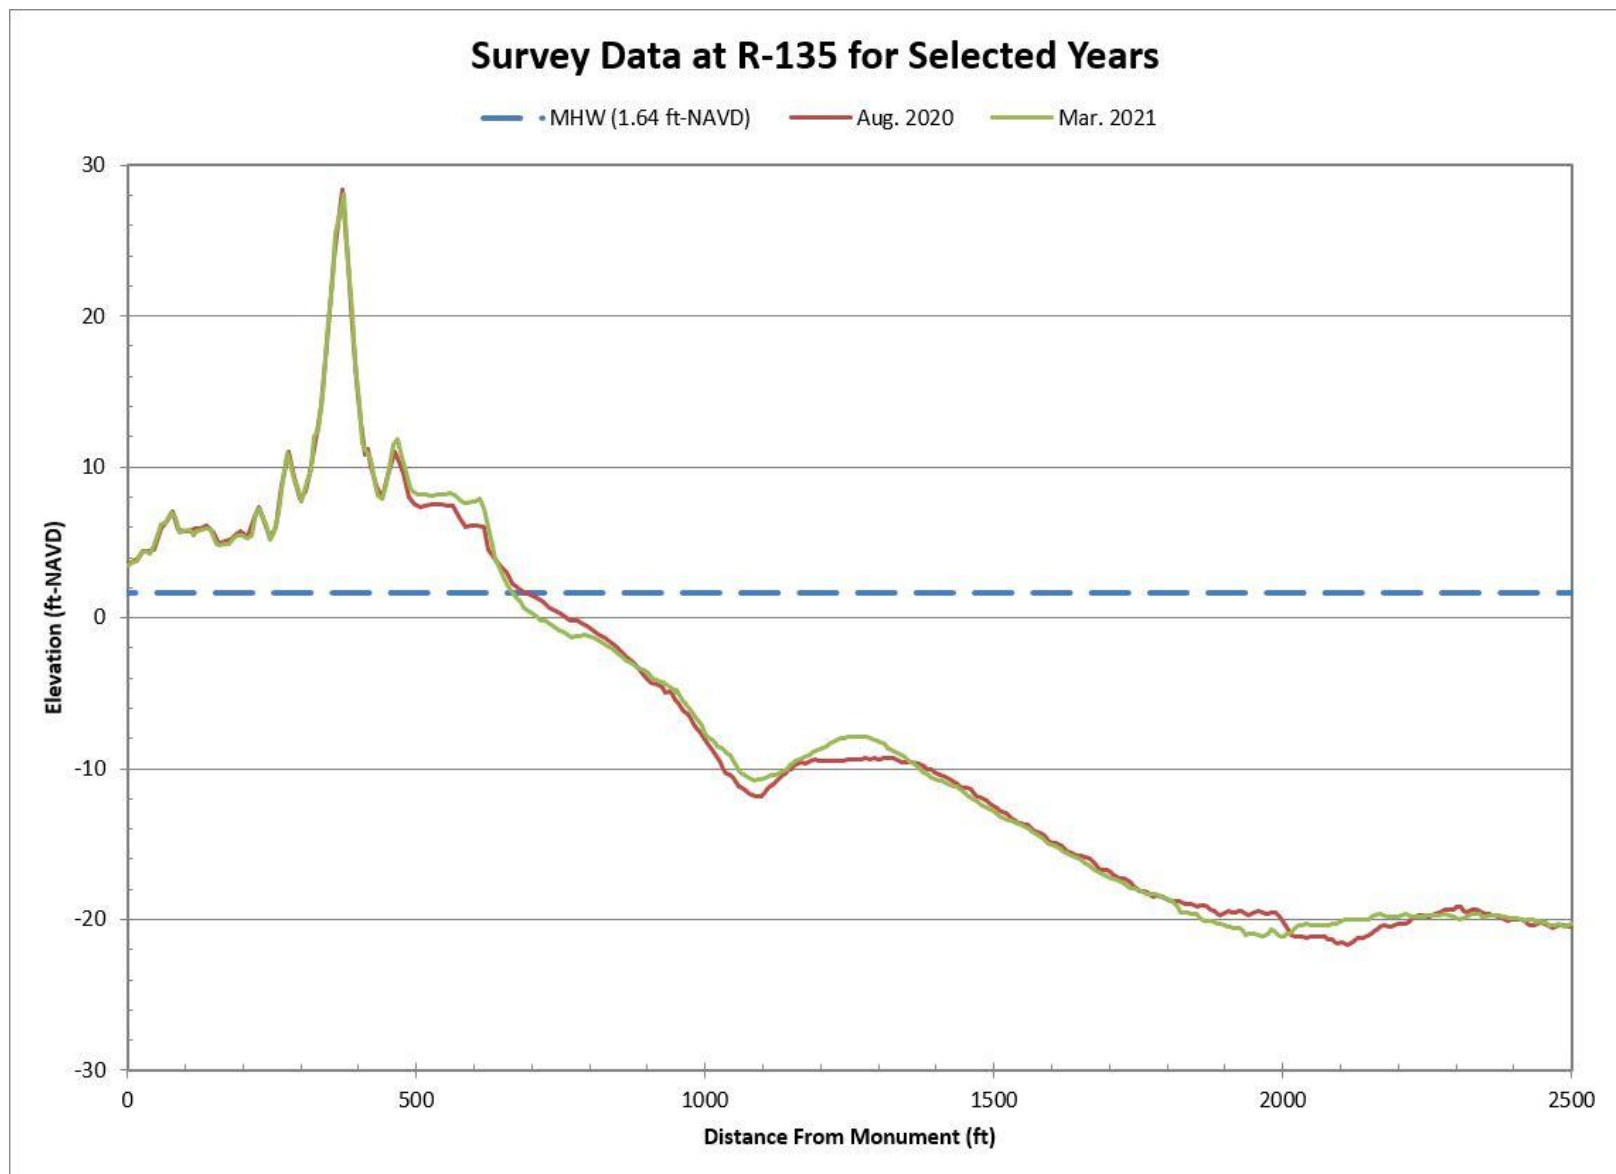
Figure B-59. Aug. 2020 Pre-Construction vs. Mar. 2021 Post-Construction Beach Profiles Along R-135

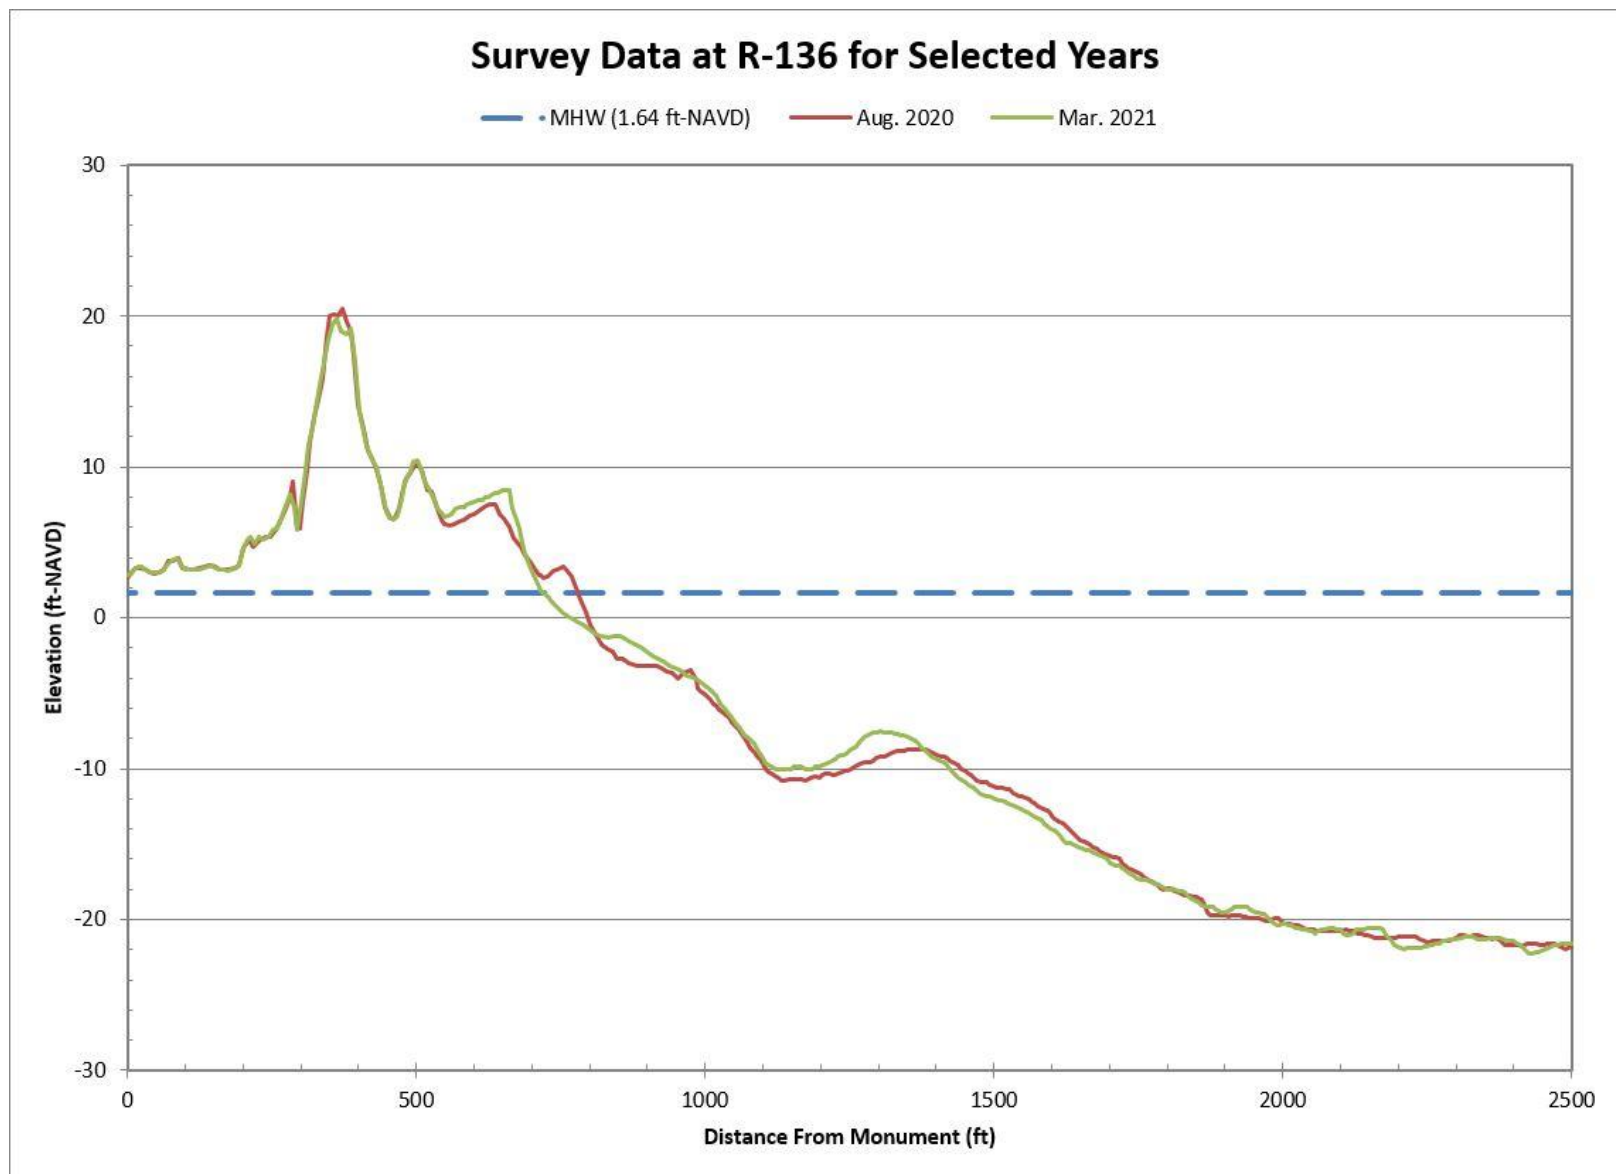
**Figure B-60. Aug. 2020 Pre-Construction vs. Mar. 2021 Post-Construction Beach Profiles Along R-136**

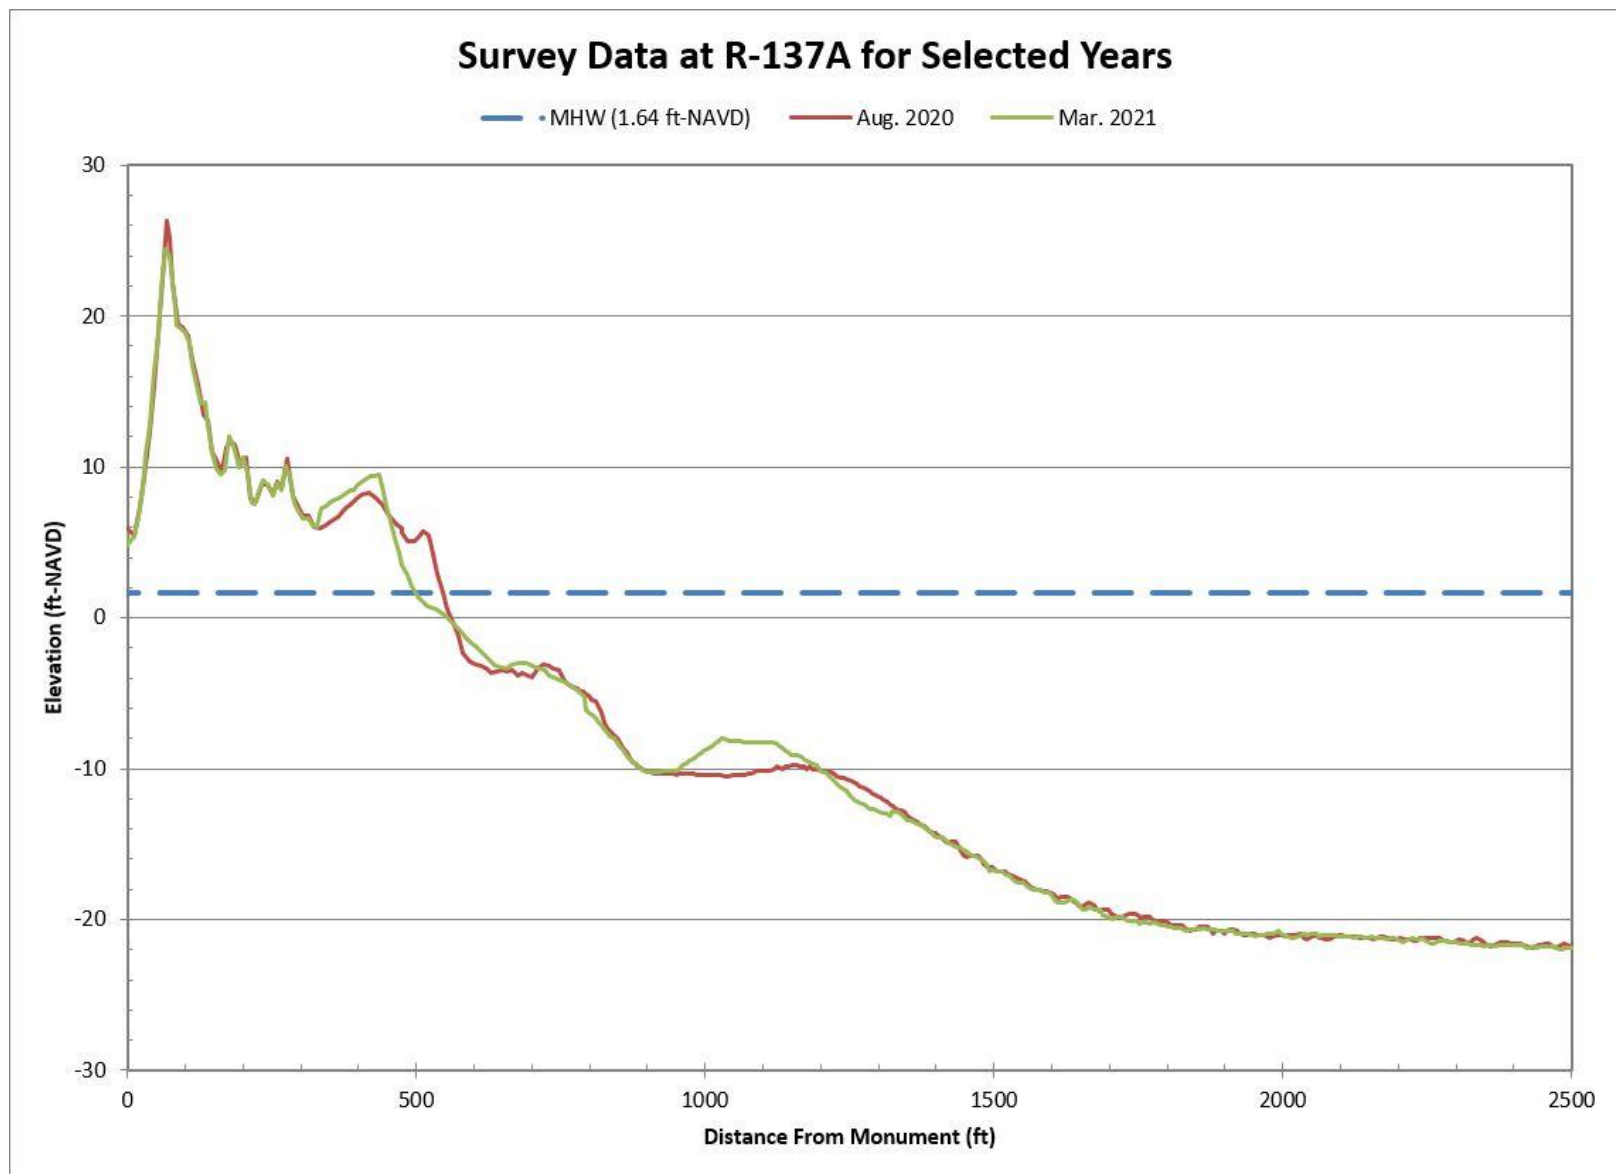
Figure B-61. Aug. 2020 Pre-Construction vs. Mar. 2021 Post-Construction Beach Profiles Along R-137A

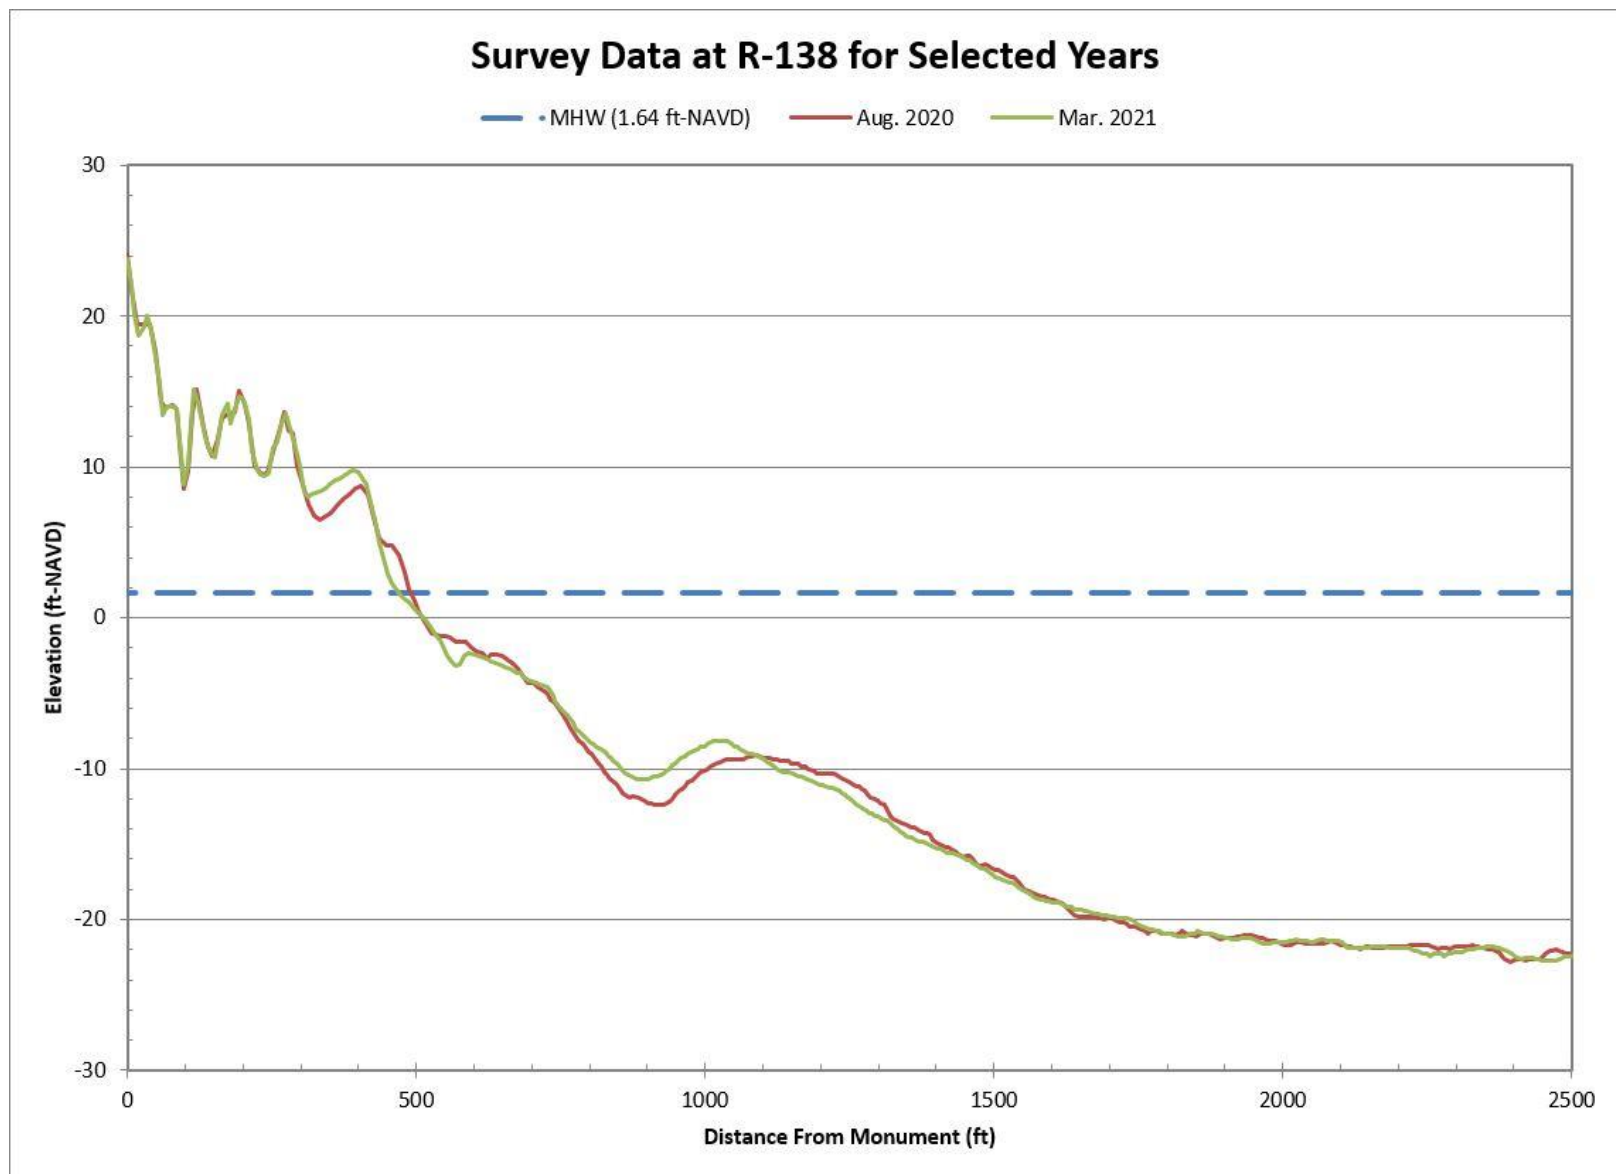
**Figure B-62. Aug. 2020 Pre-Construction vs. Mar. 2021 Post-Construction Beach Profiles Along R-138**

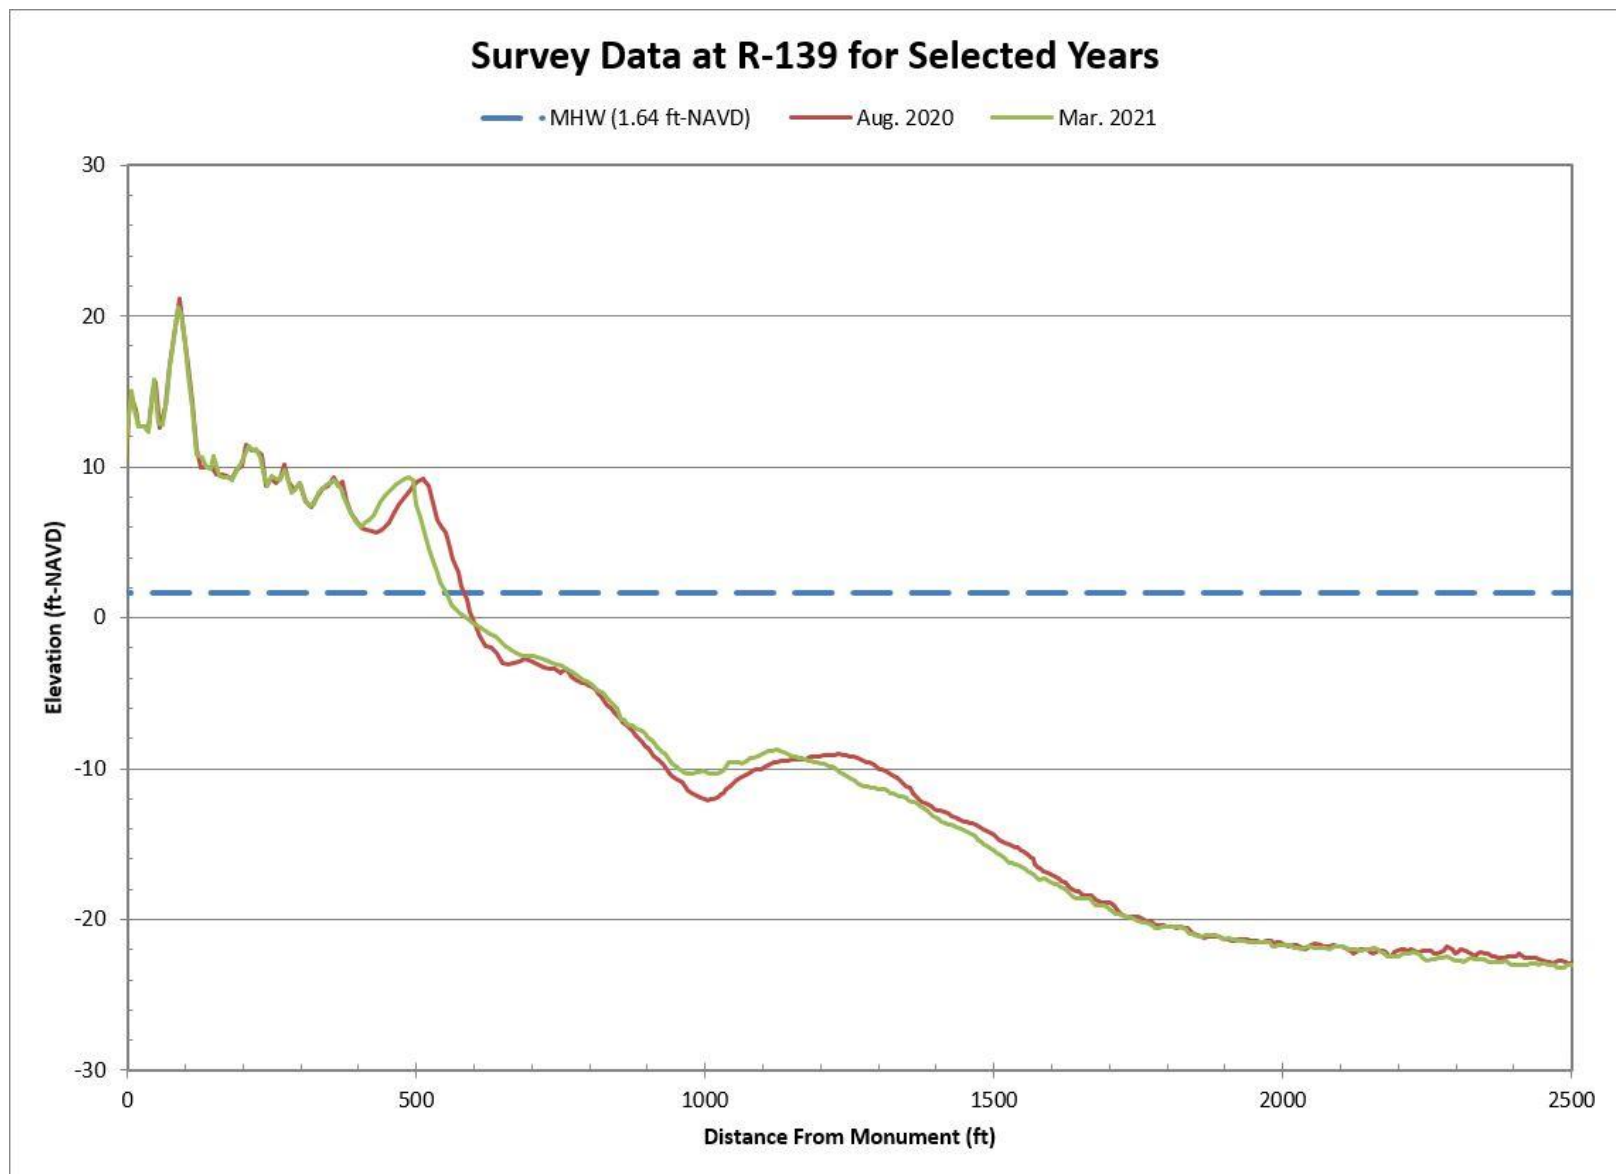
Figure B-63. Aug. 2020 Pre-Construction vs. Mar. 2021 Post-Construction Beach Profiles Along R-139

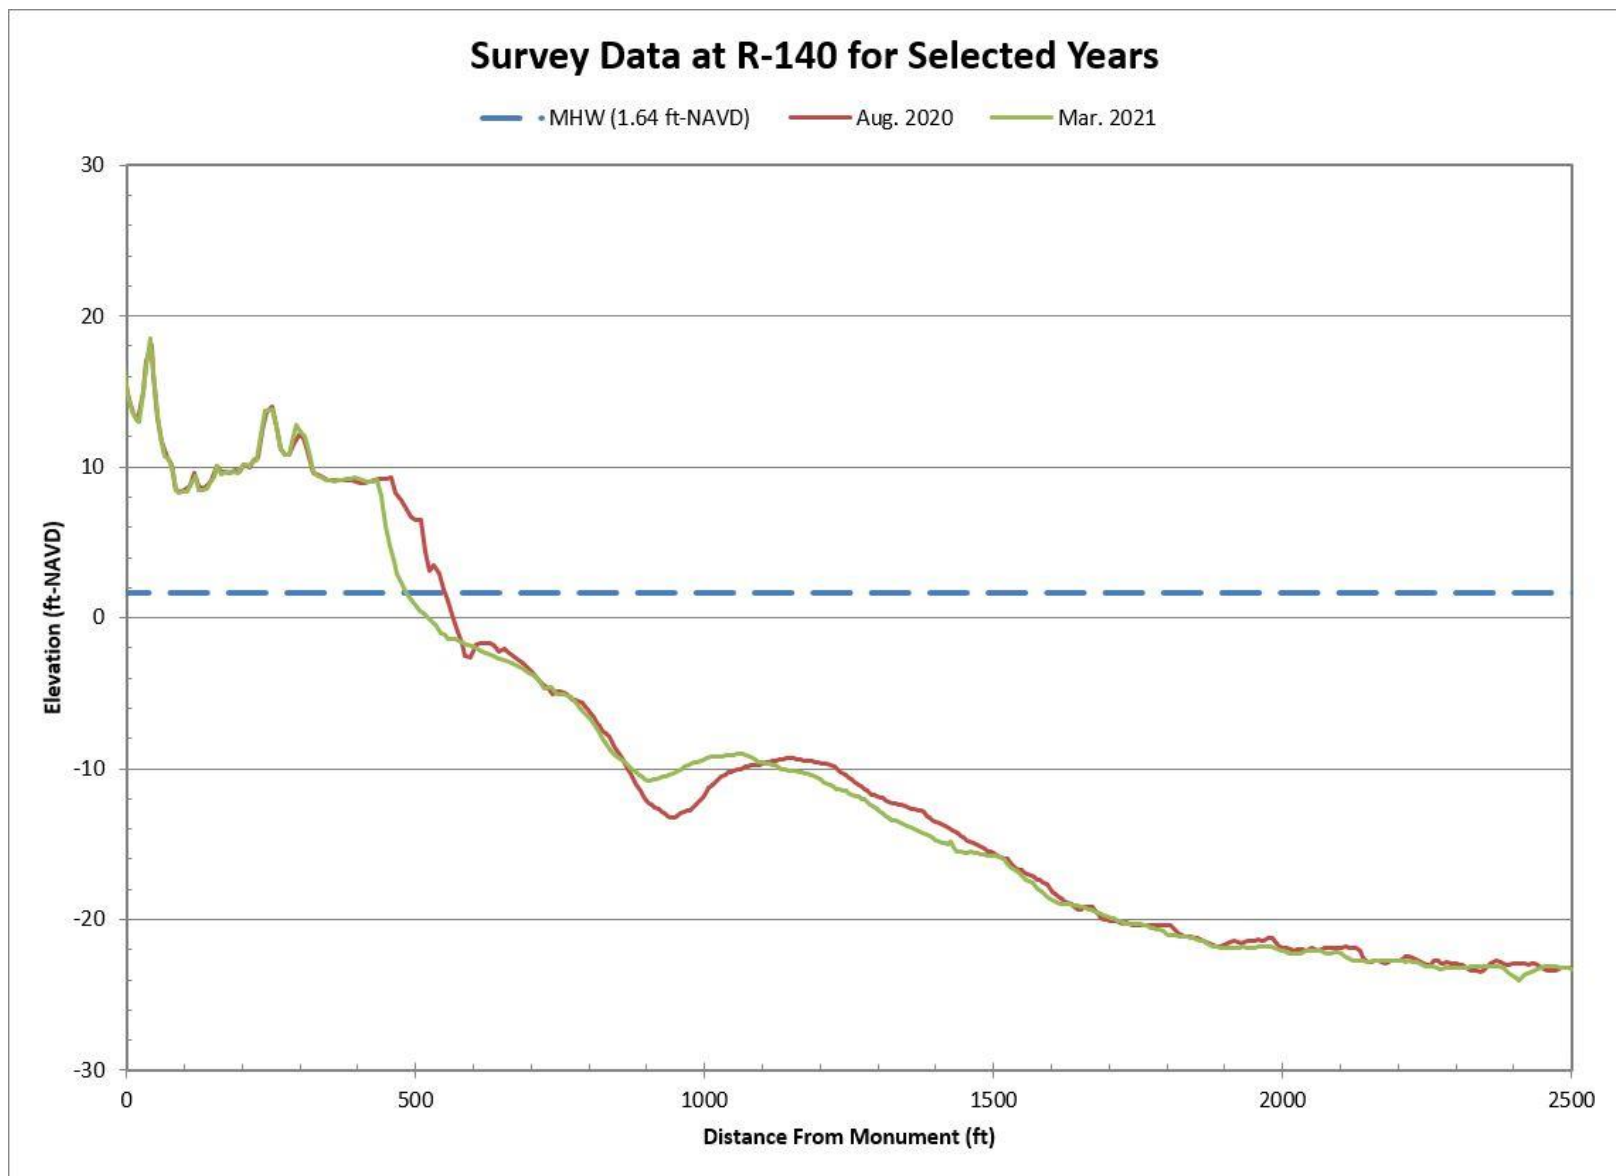
**Figure B-64. Aug. 2020 Pre-Construction vs. Mar. 2021 Post-Construction Beach Profiles Along R-140**

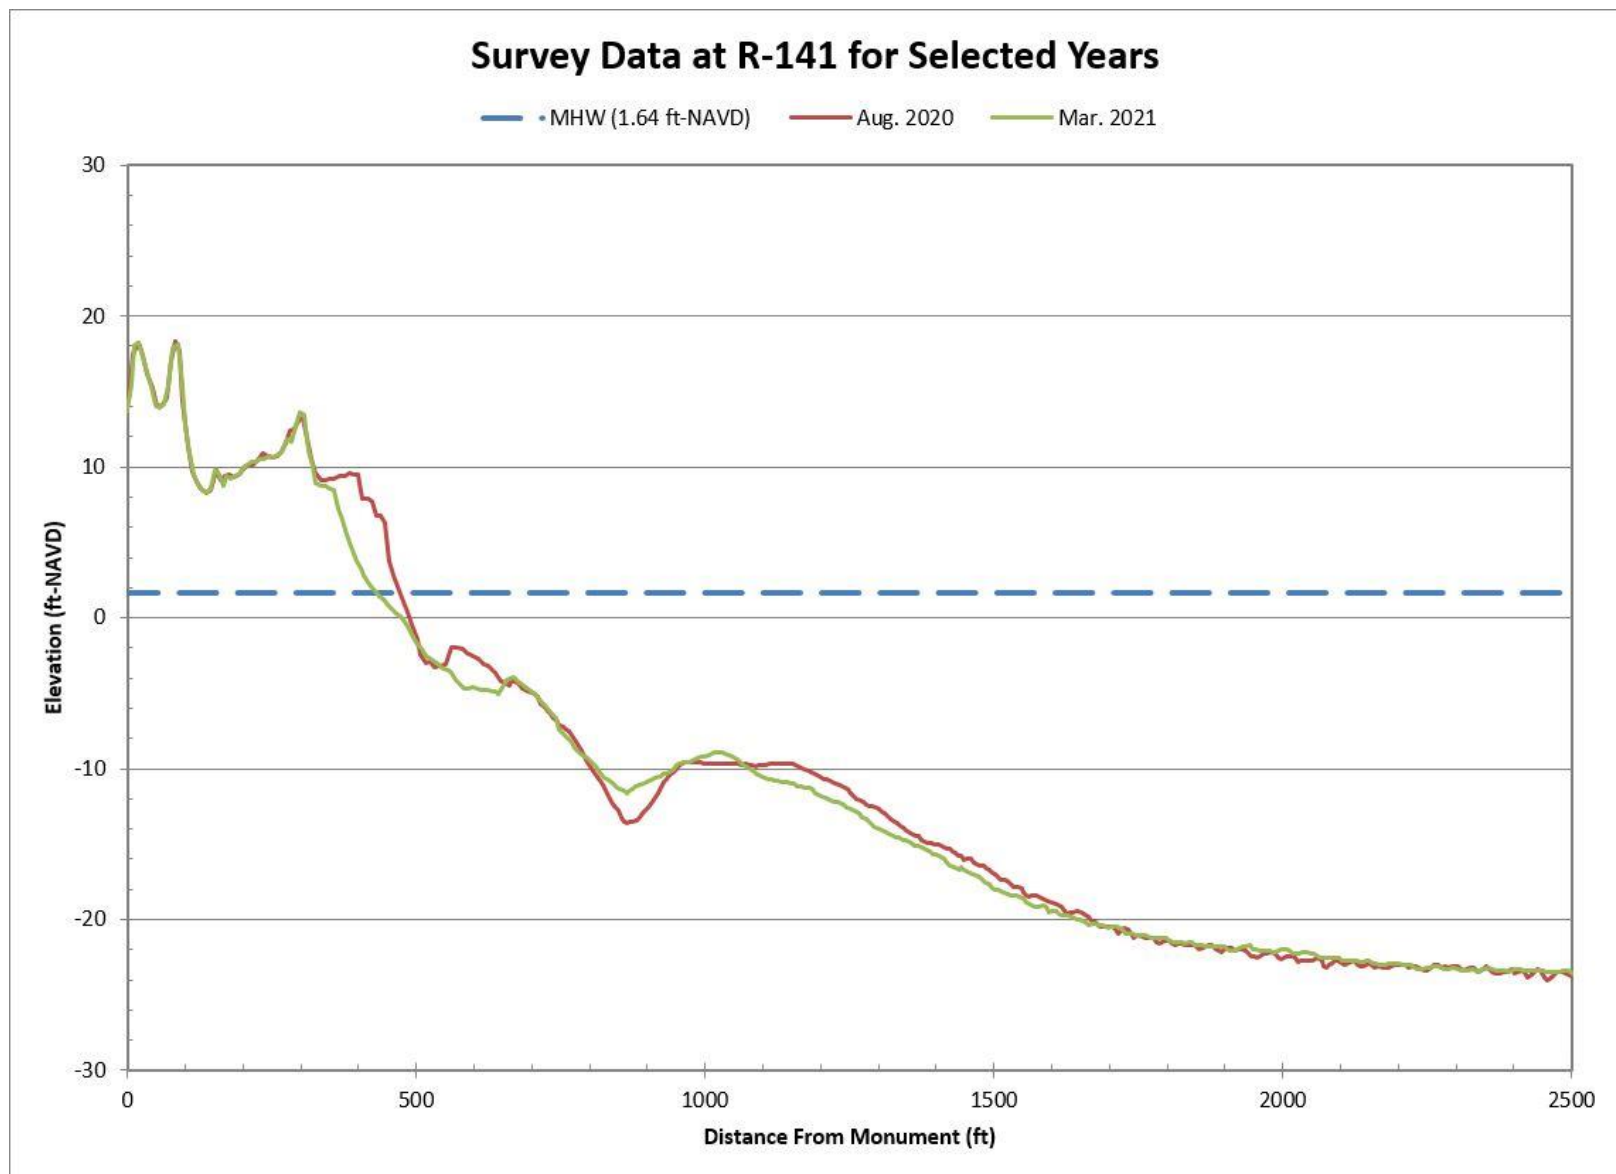
Figure B-65. Aug. 2020 Pre-Construction vs. Mar. 2021 Post-Construction Beach Profiles Along R-141

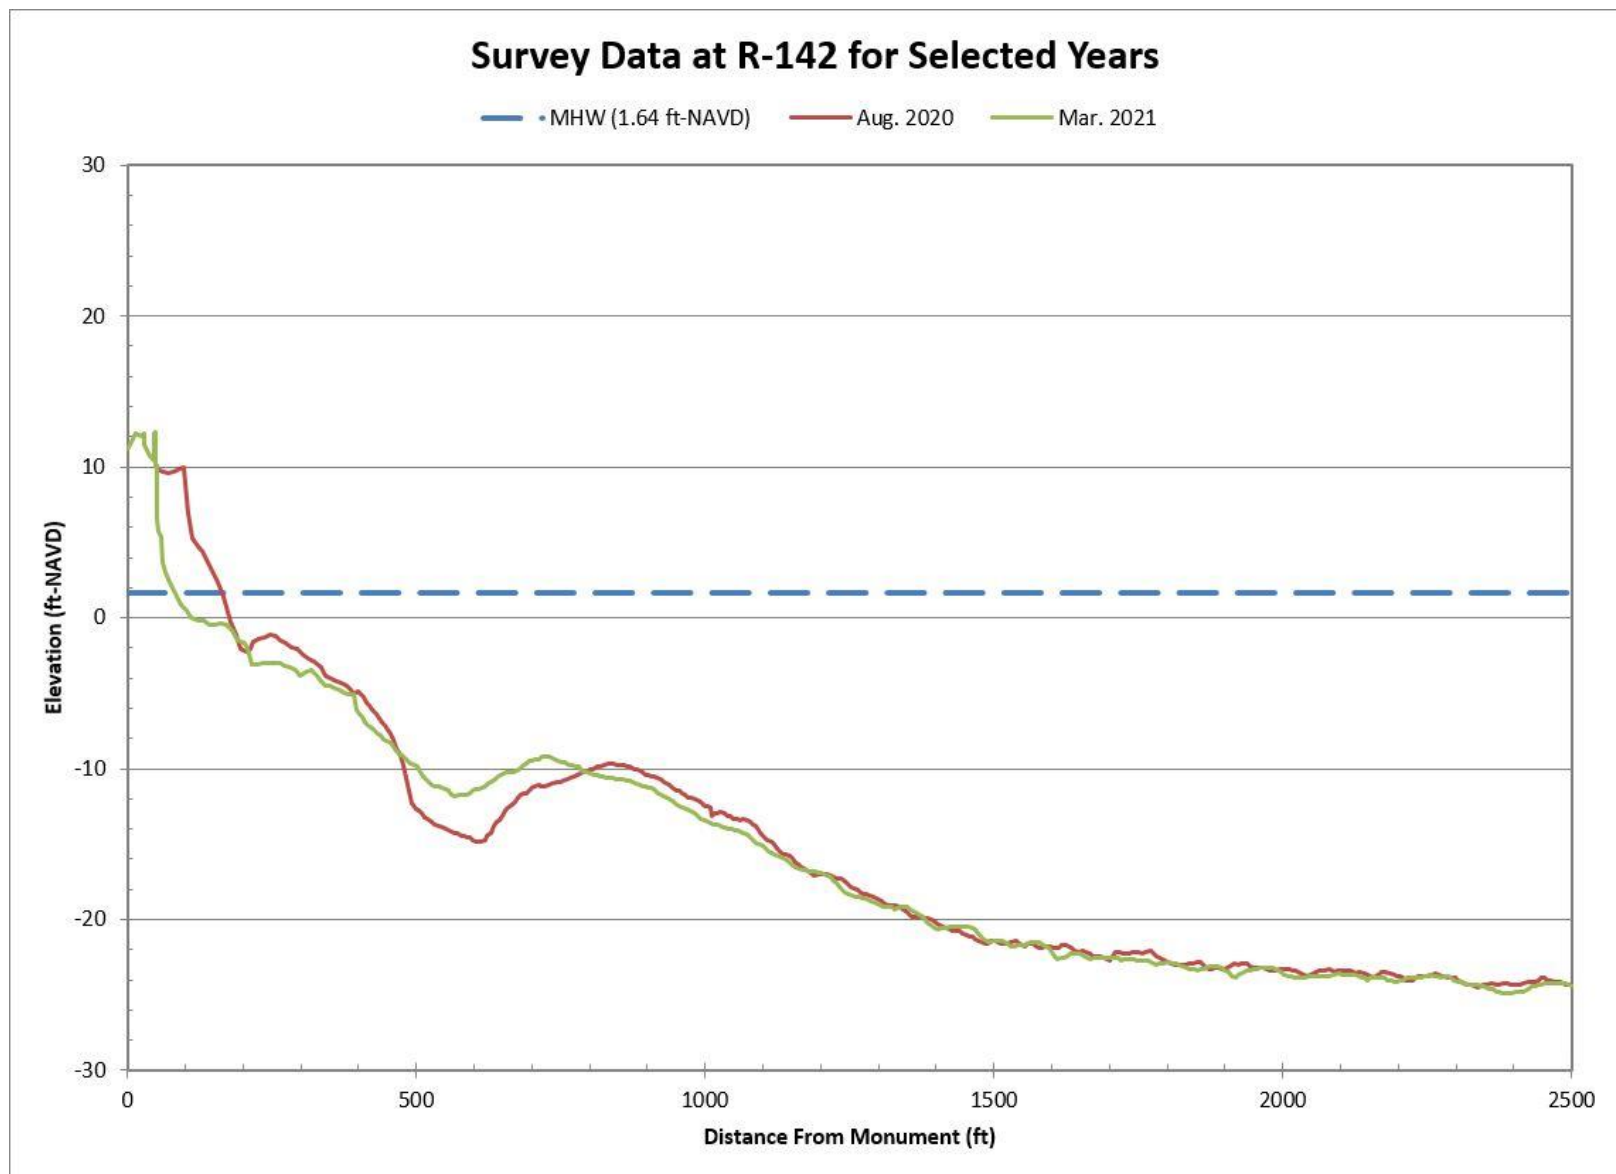
**Figure B-66. Aug. 2020 Pre-Construction vs. Mar. 2021 Post-Construction Beach Profiles Along R-142**

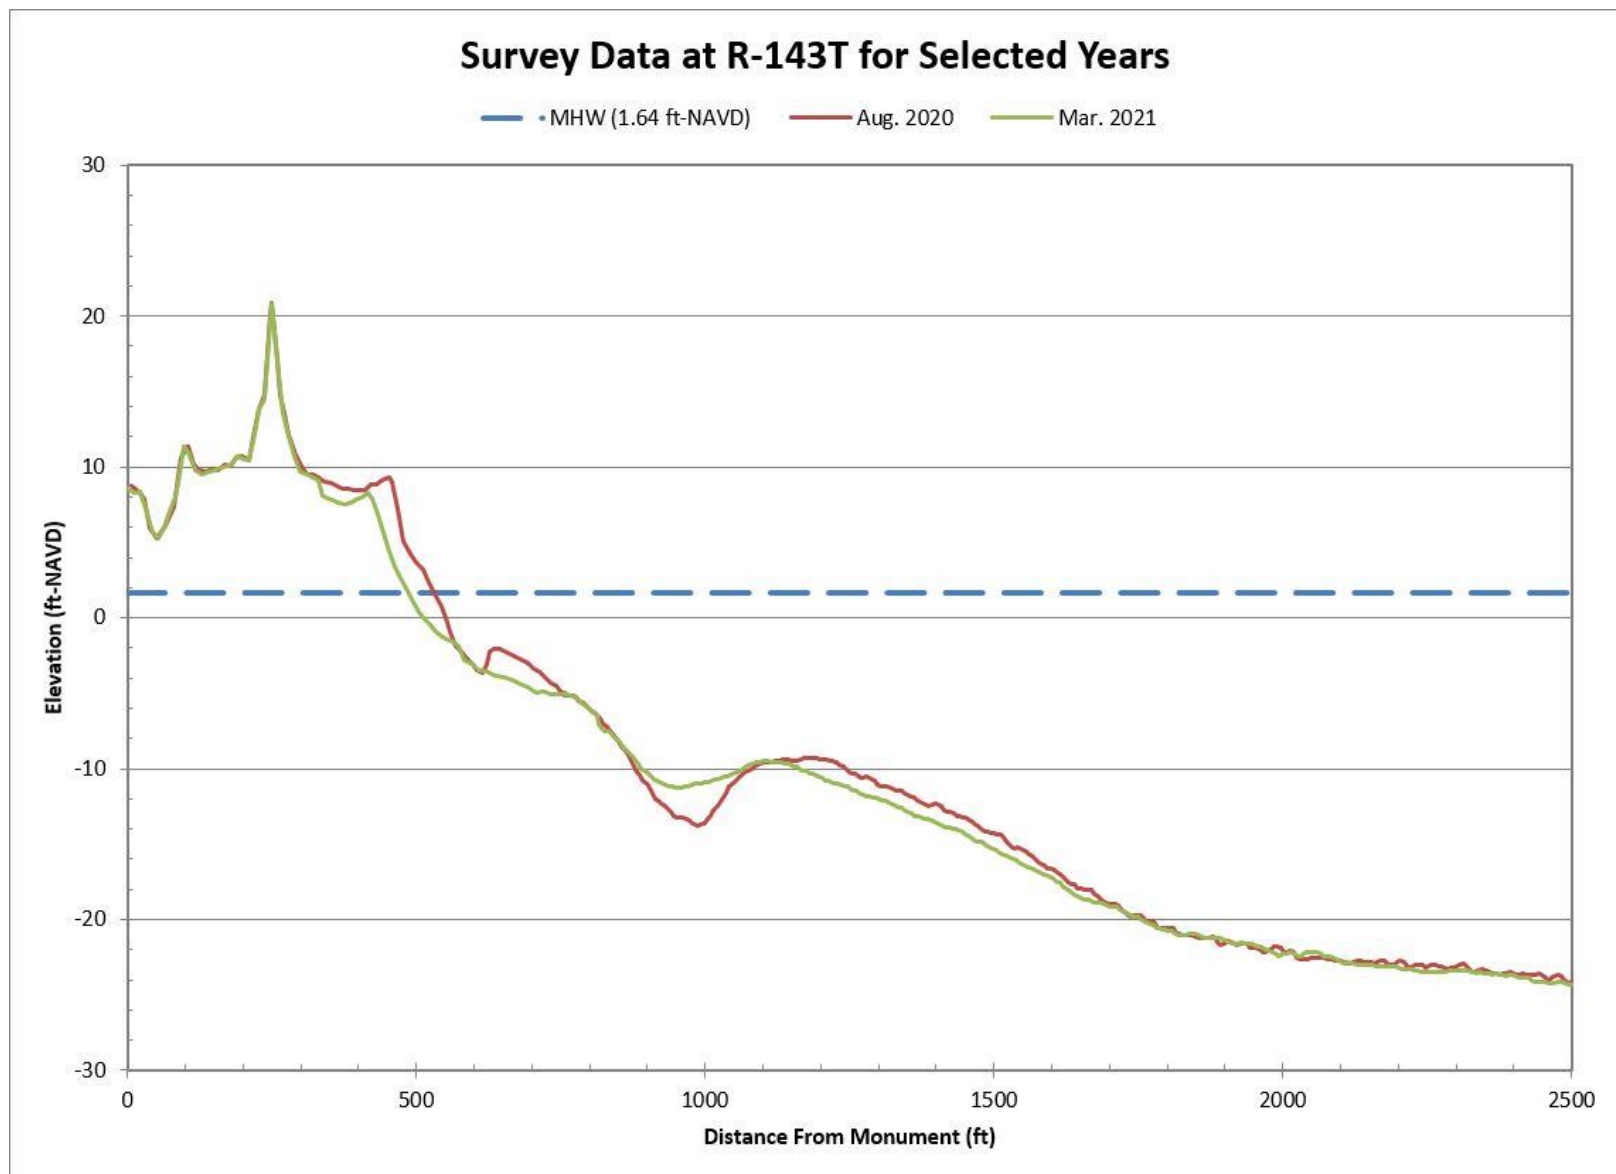
Figure B-67. Aug. 2020 Pre-Construction vs. Mar. 2021 Post-Construction Beach Profiles Along R-143T
