## **Appendix B**

### **Beach Profile Plots**

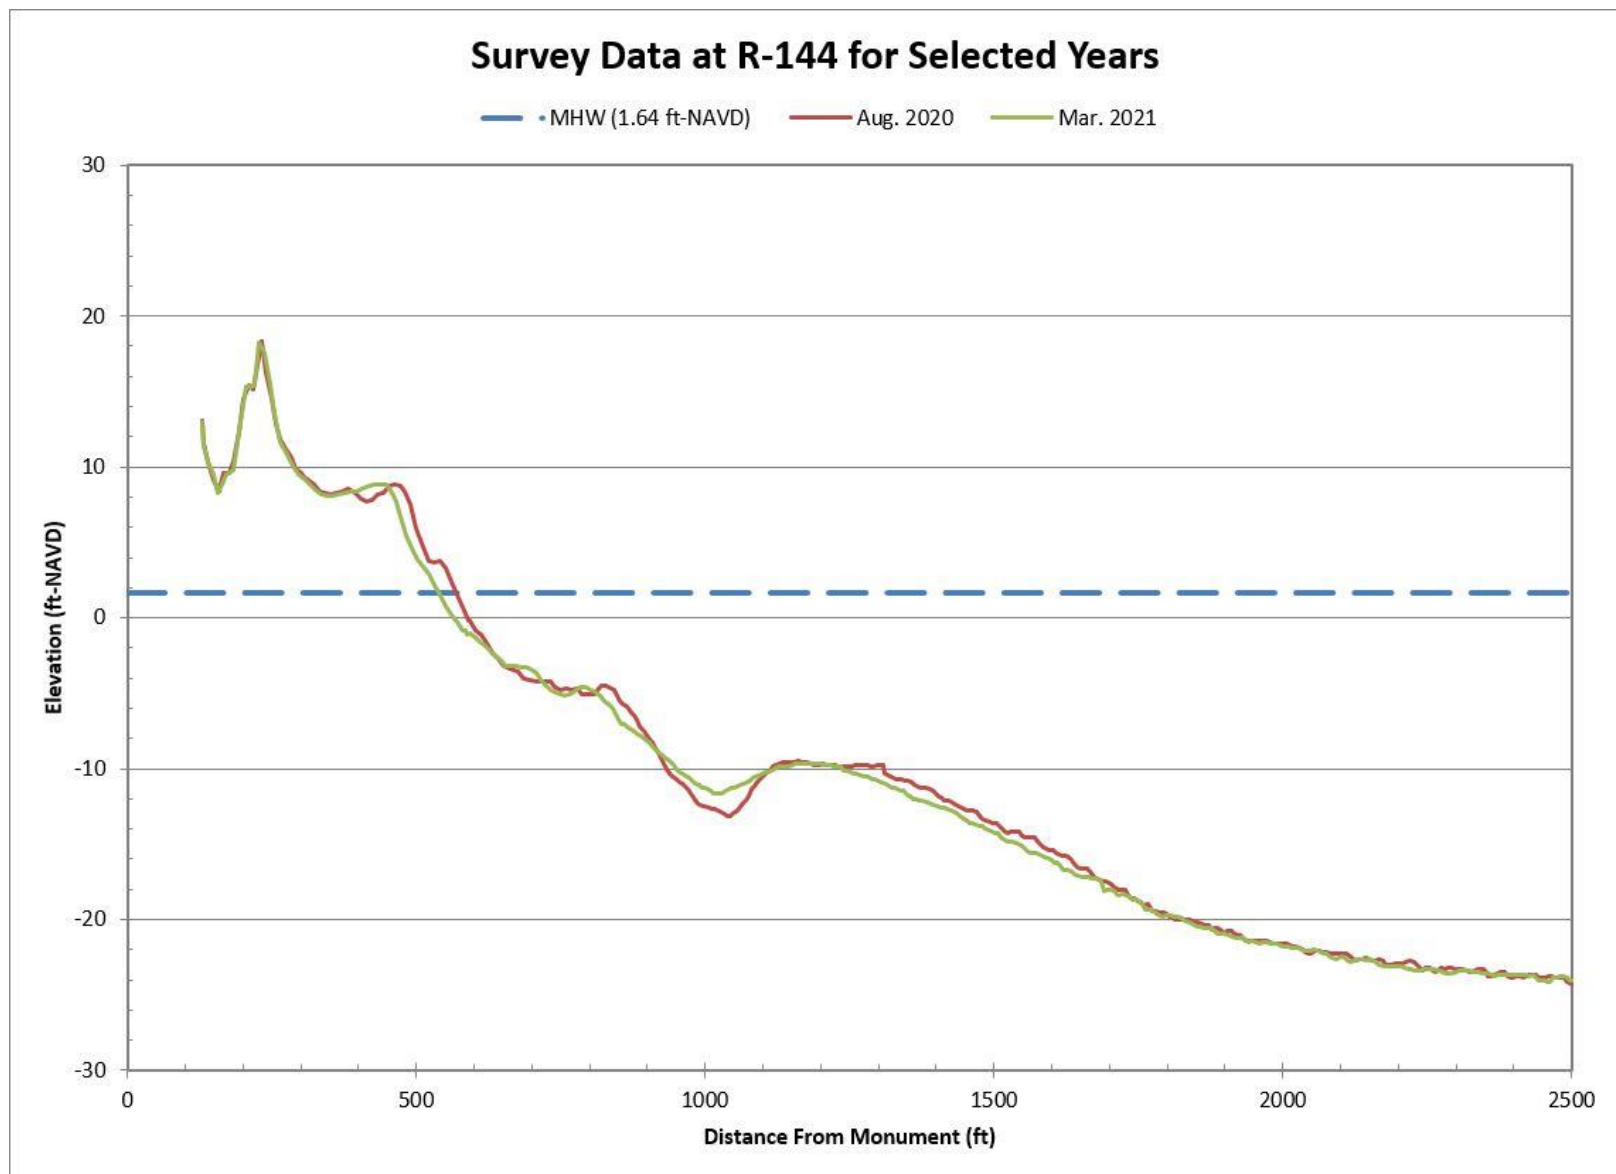
**Figure B-68. Aug. 2020 Pre-Construction vs. Mar. 2021 Post-Construction Beach Profiles Along R-144**

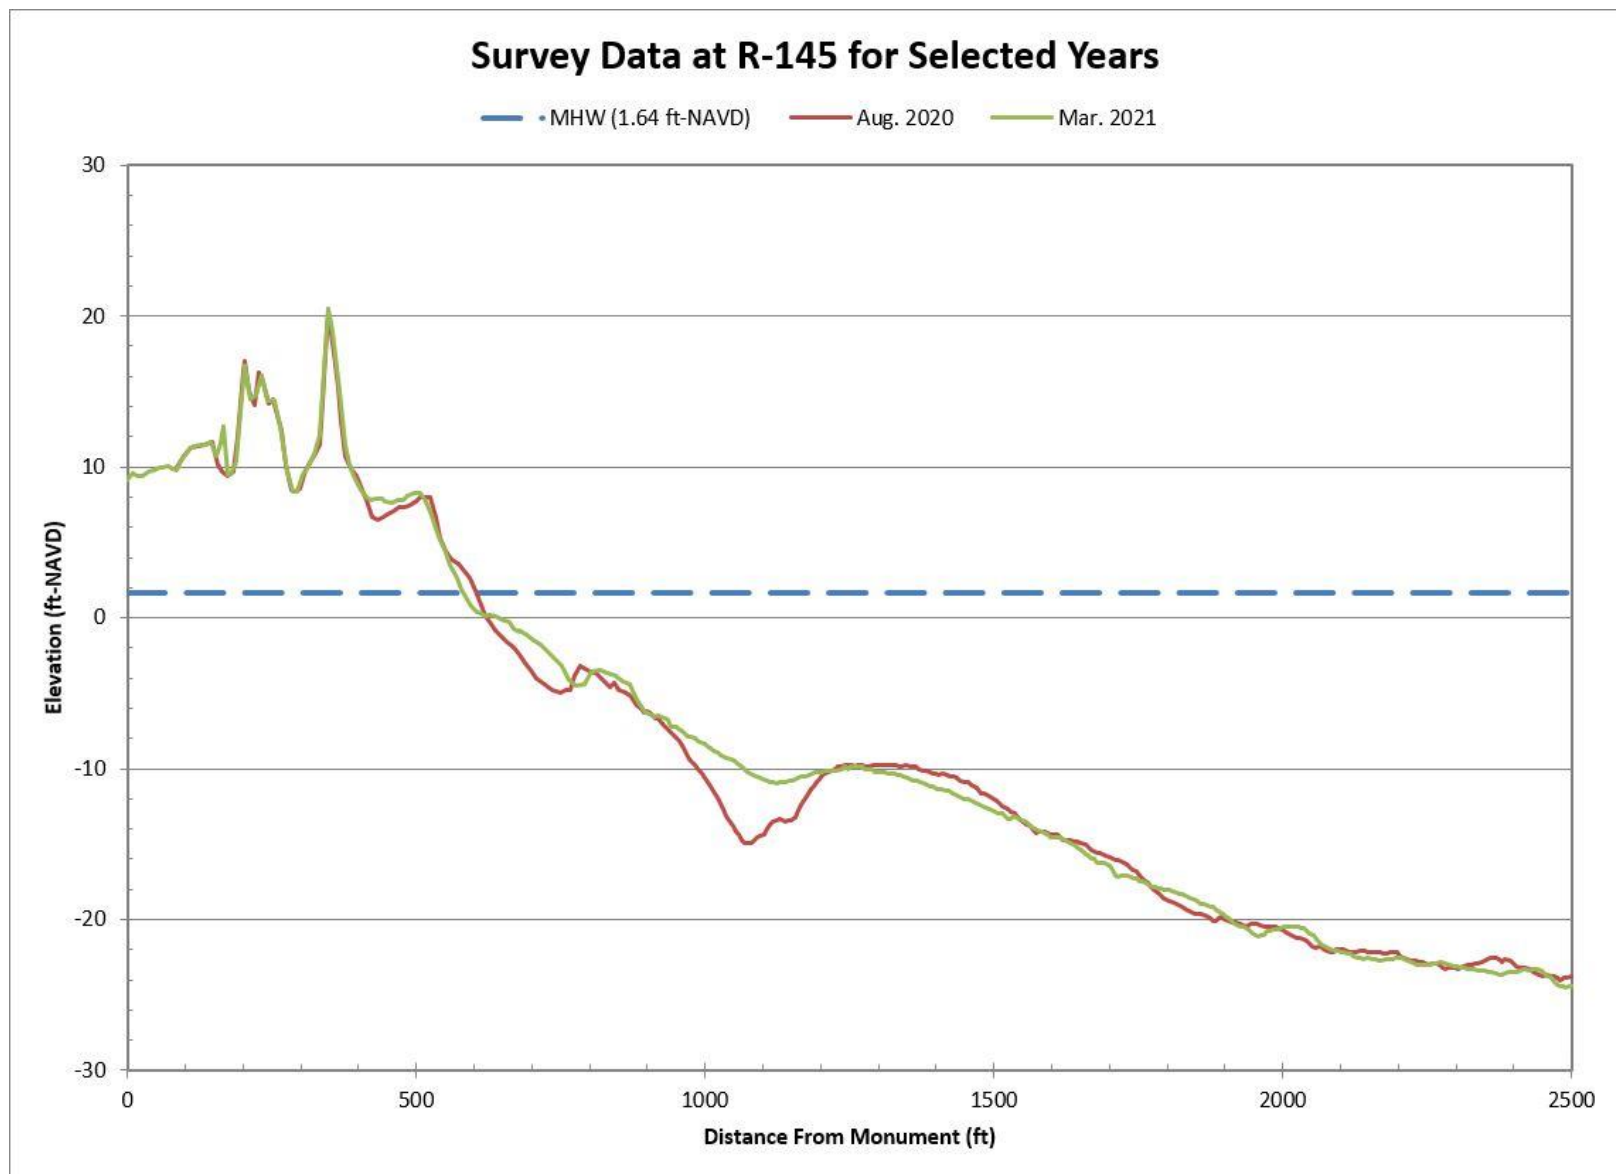
**Figure B-69. Aug. 2020 Pre-Construction vs. Mar. 2021 Post-Construction Beach Profiles Along R-145**

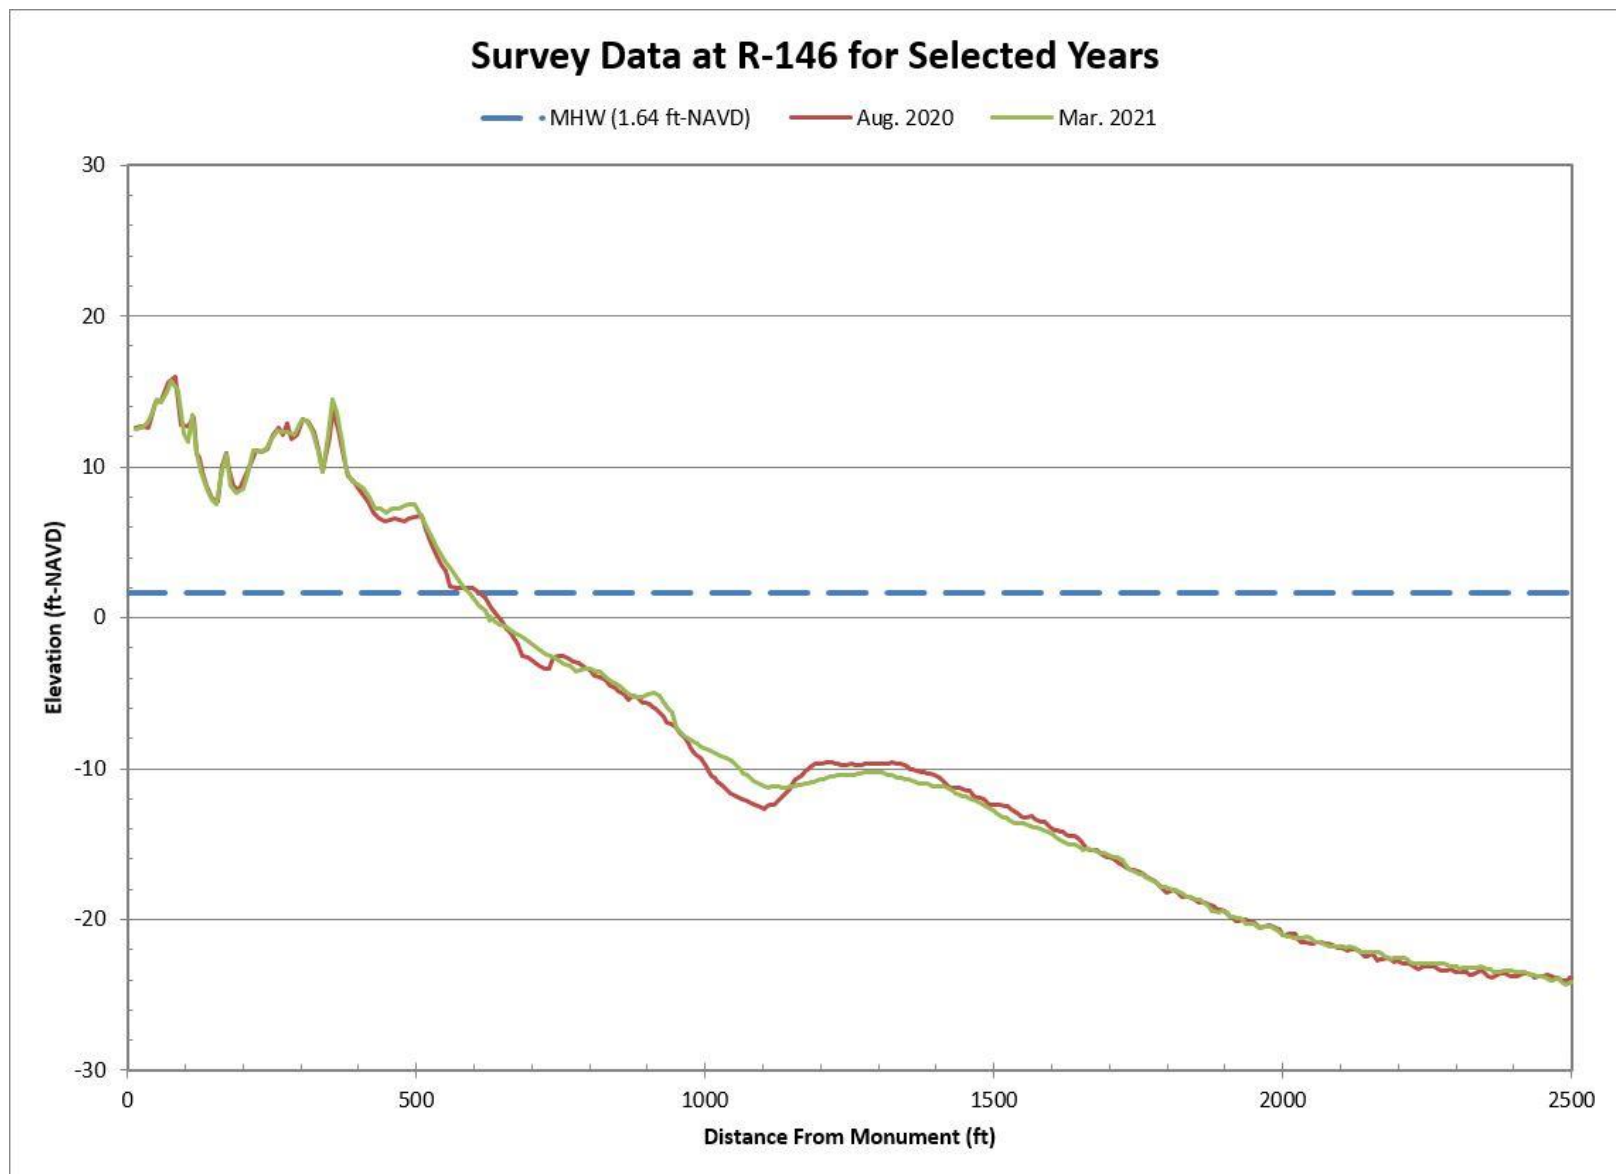
**Figure B-70. Aug. 2020 Pre-Construction vs. Mar. 2021 Post-Construction Beach Profiles Along R-146**

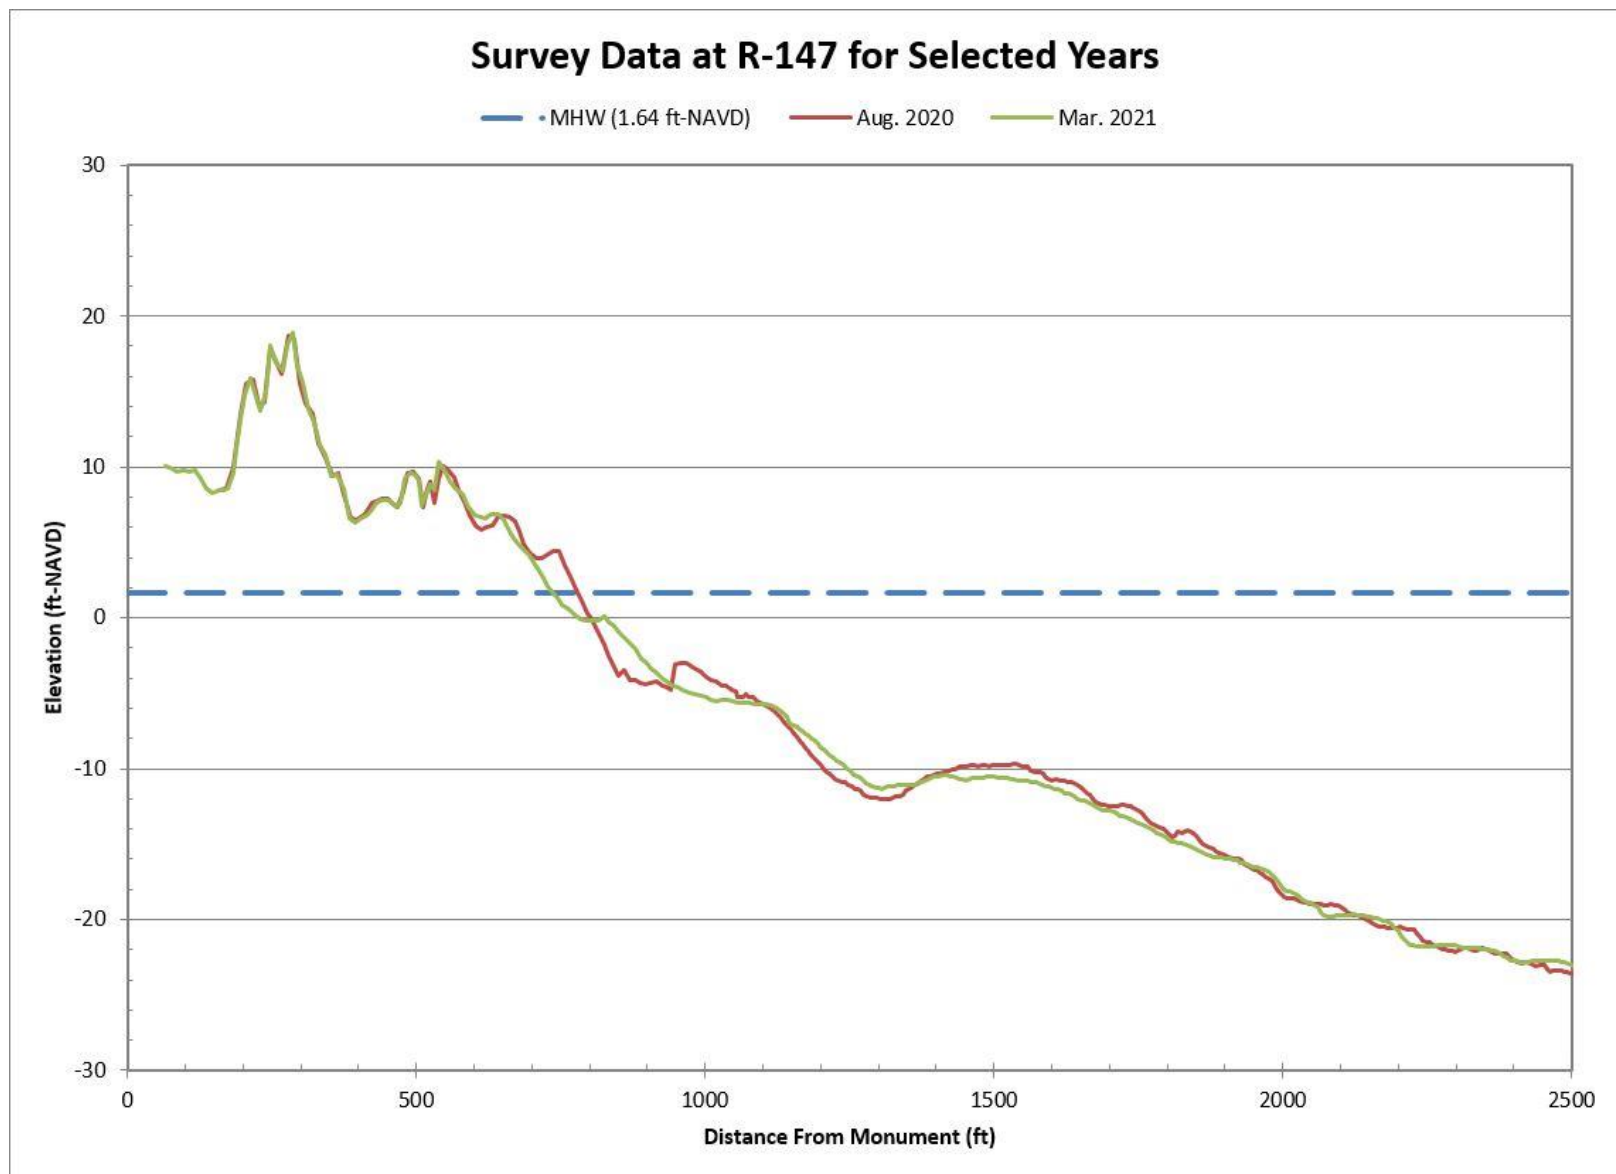
**Figure B-71. Aug. 2020 Pre-Construction vs. Mar. 2021 Post-Construction Beach Profiles Along R-147**

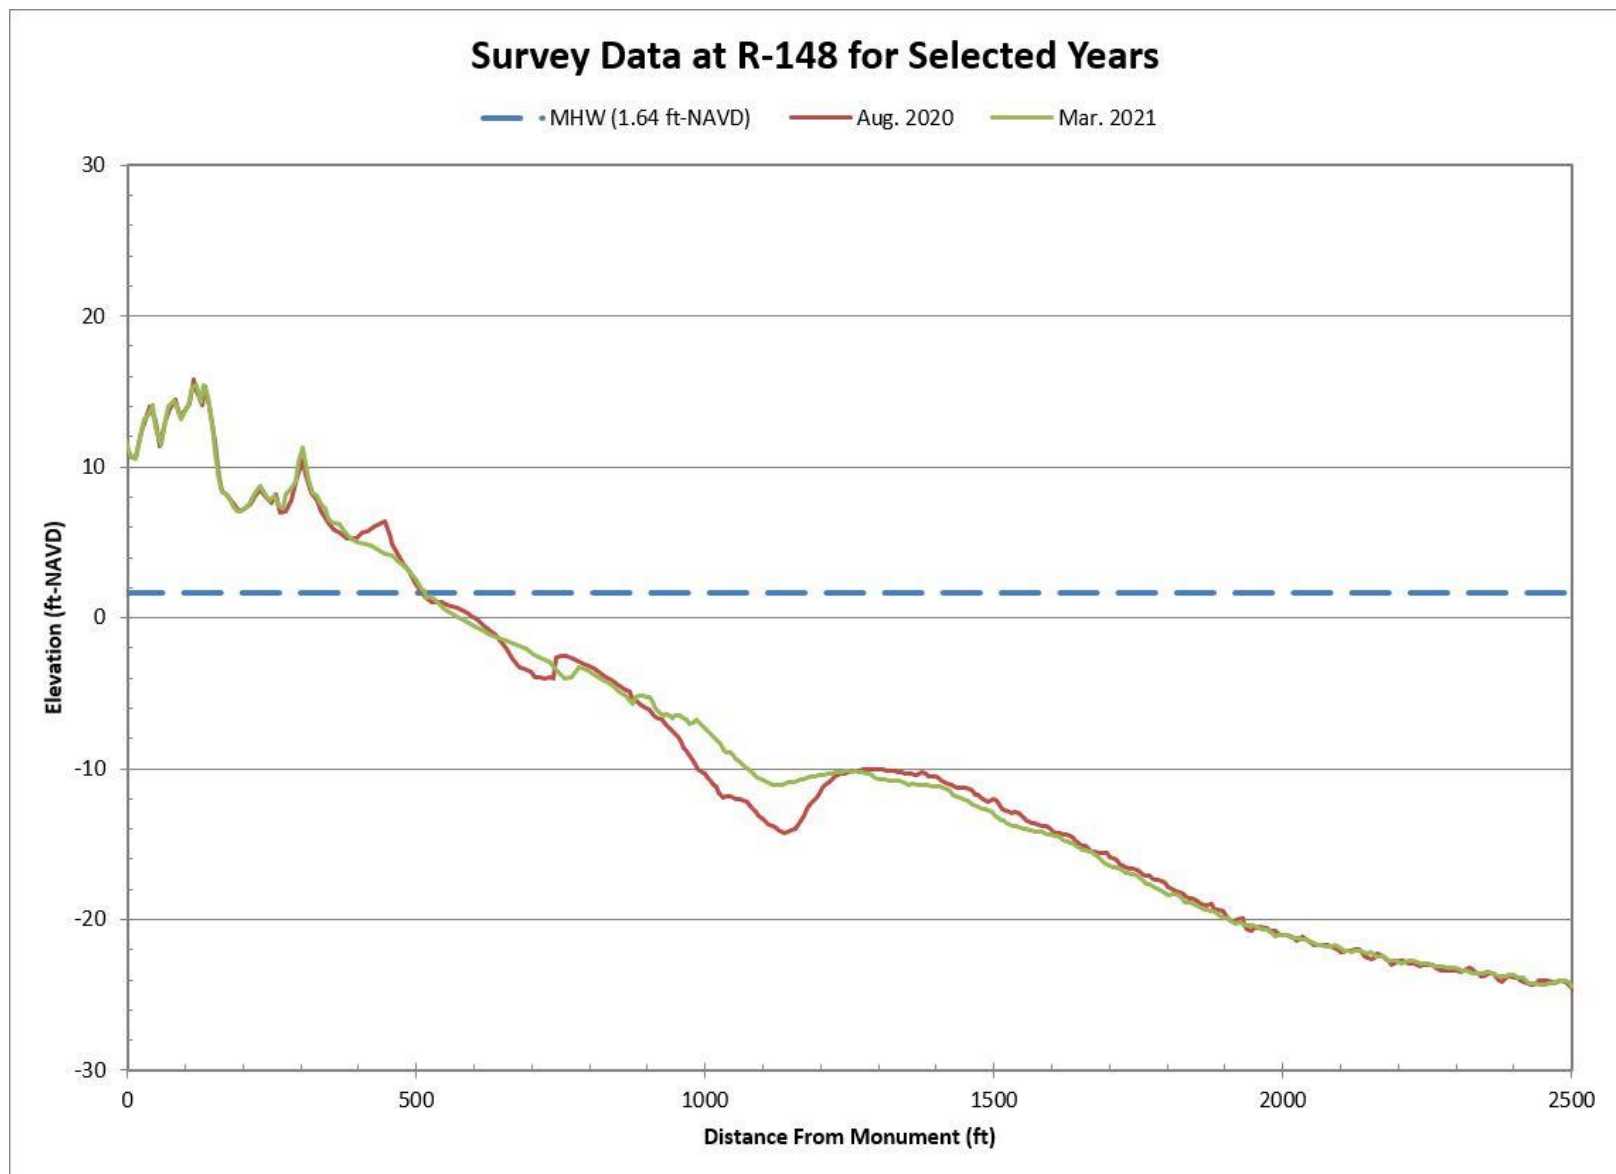
**Figure B-72. Aug. 2020 Pre-Construction vs. Mar. 2021 Post-Construction Beach Profiles Along R-148**

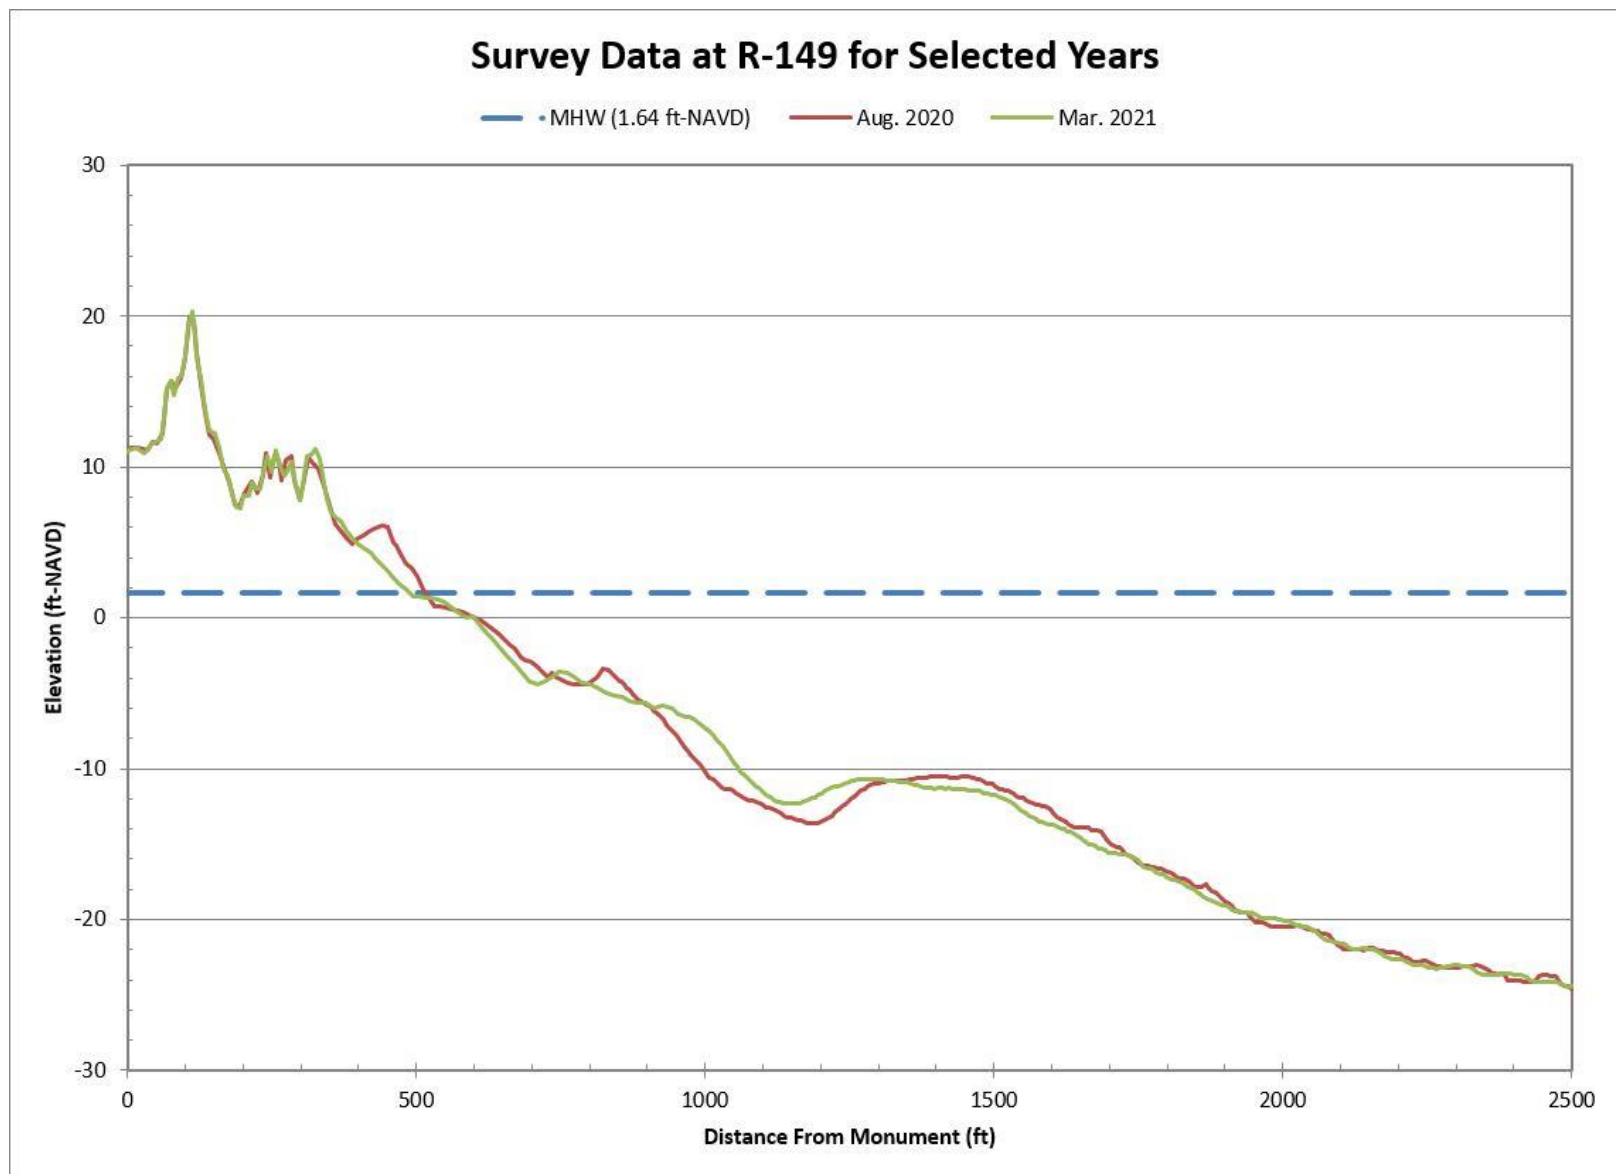
**Figure B-73. Aug. 2020 Pre-Construction vs. Mar. 2021 Post-Construction Beach Profiles Along R-149**

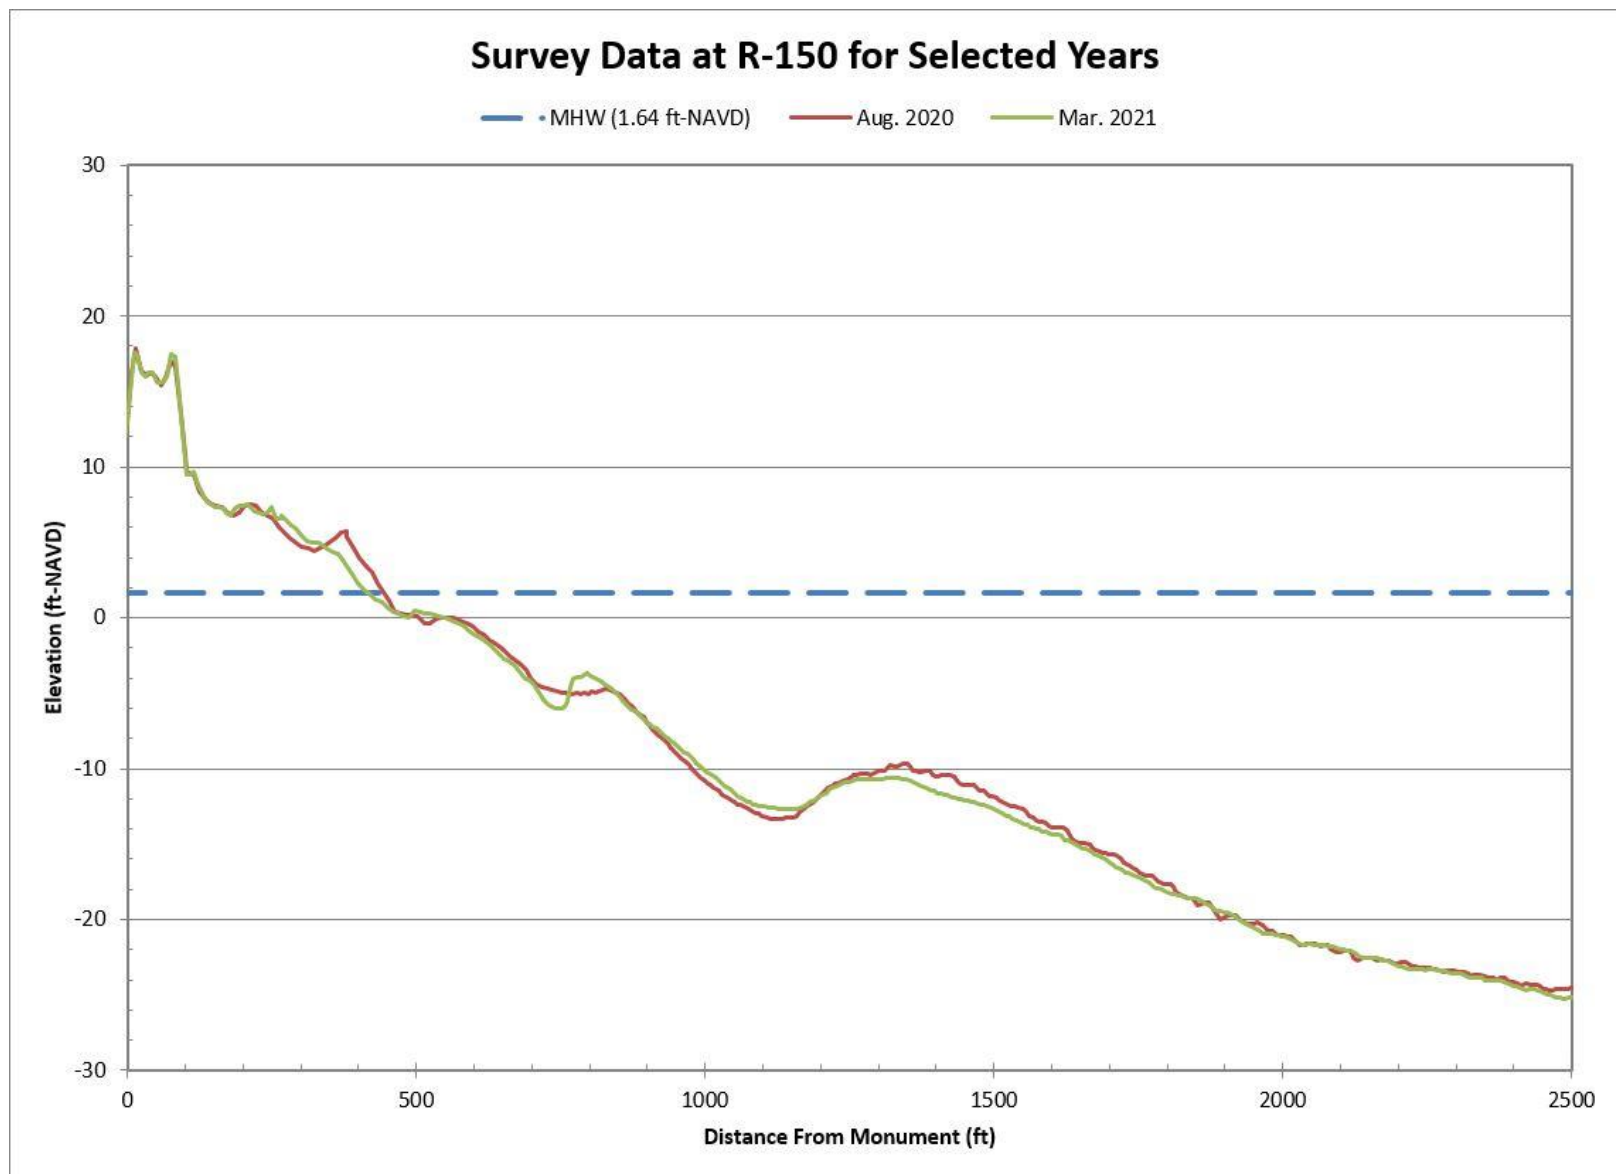
**Figure B-74. Aug. 2020 Pre-Construction vs. Mar. 2021 Post-Construction Beach Profiles Along R-150**

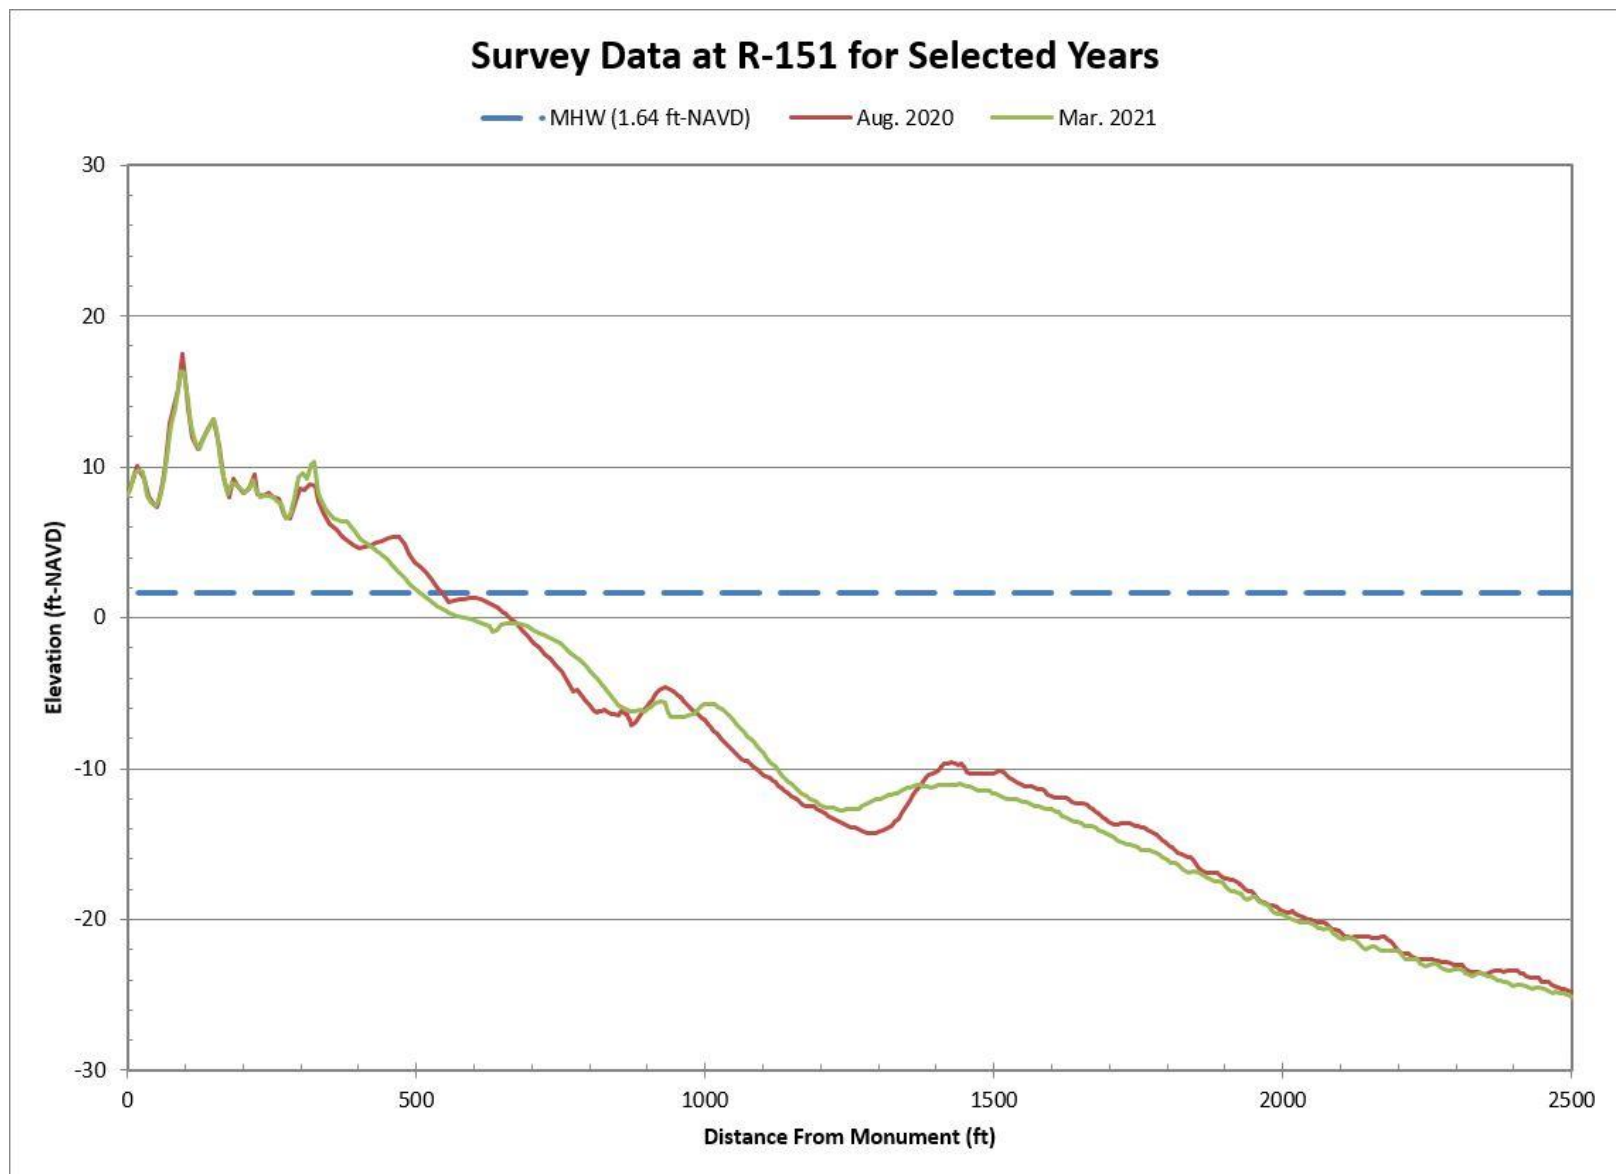
**Figure B-75. Aug. 2020 Pre-Construction vs. Mar. 2021 Post-Construction Beach Profiles Along R-151**

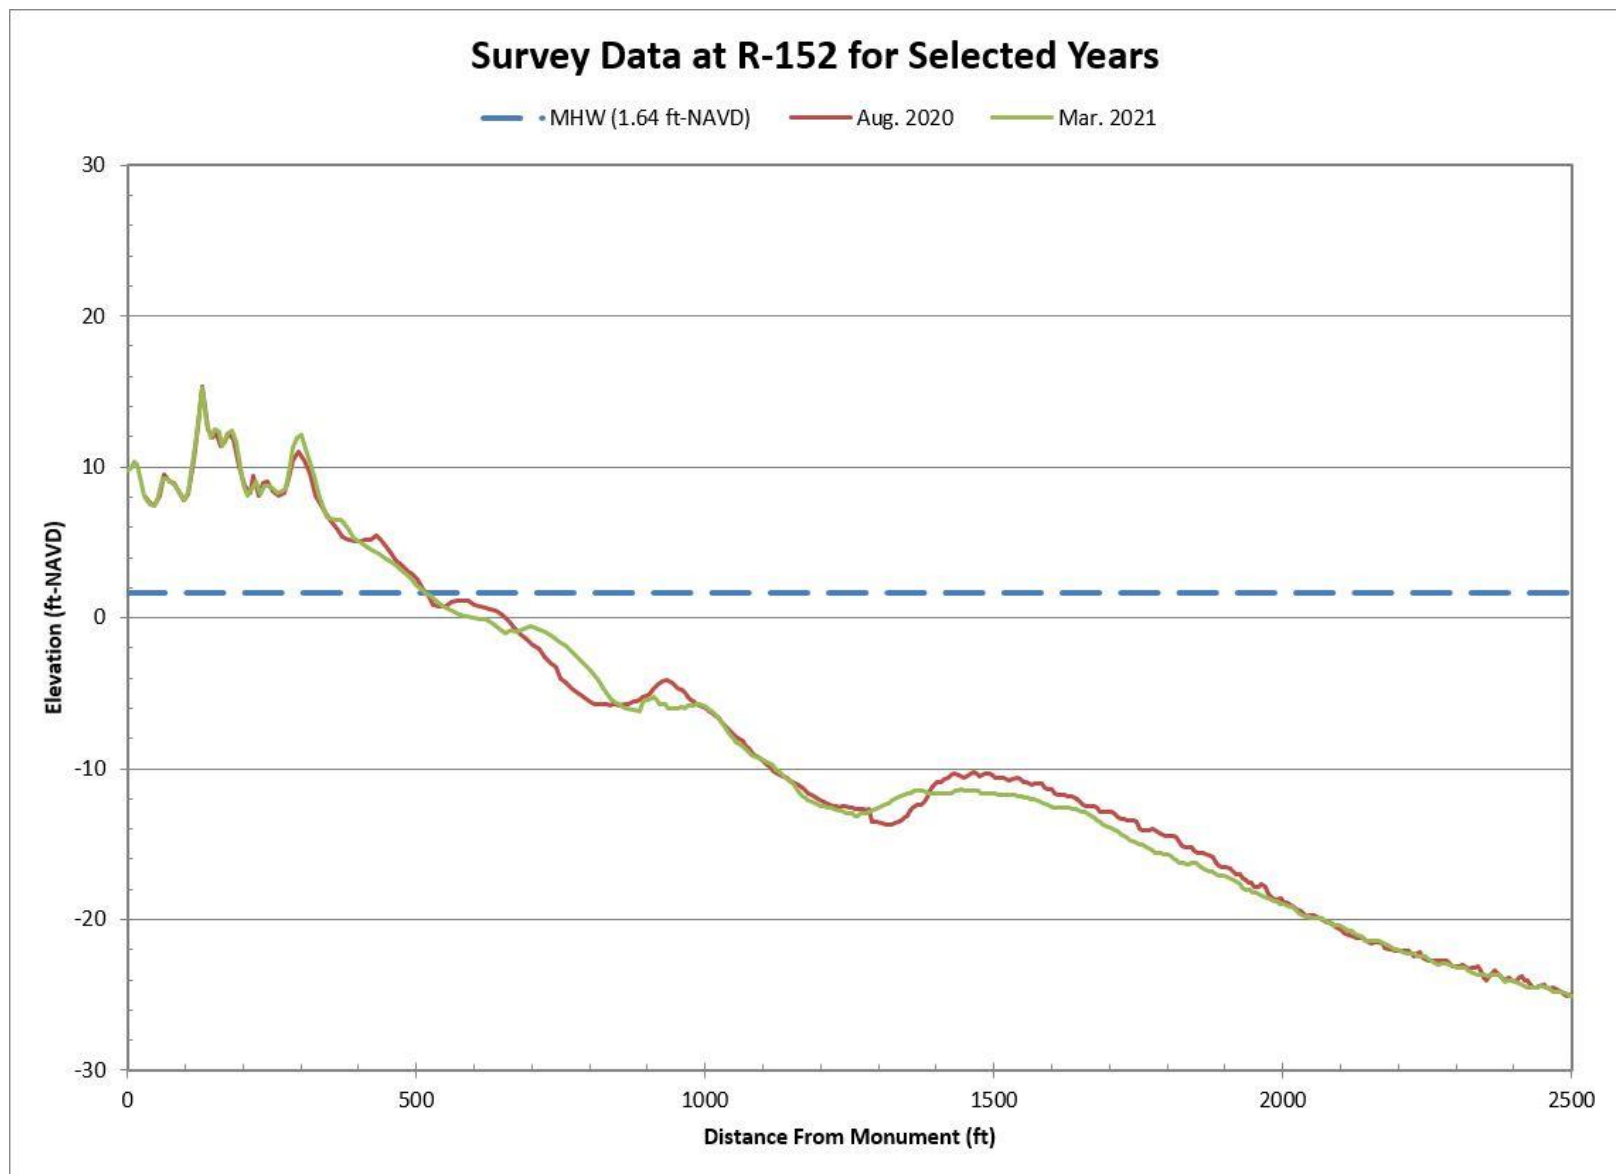
**Figure B-76. Aug. 2020 Pre-Construction vs. Mar. 2021 Post-Construction Beach Profiles Along R-152**

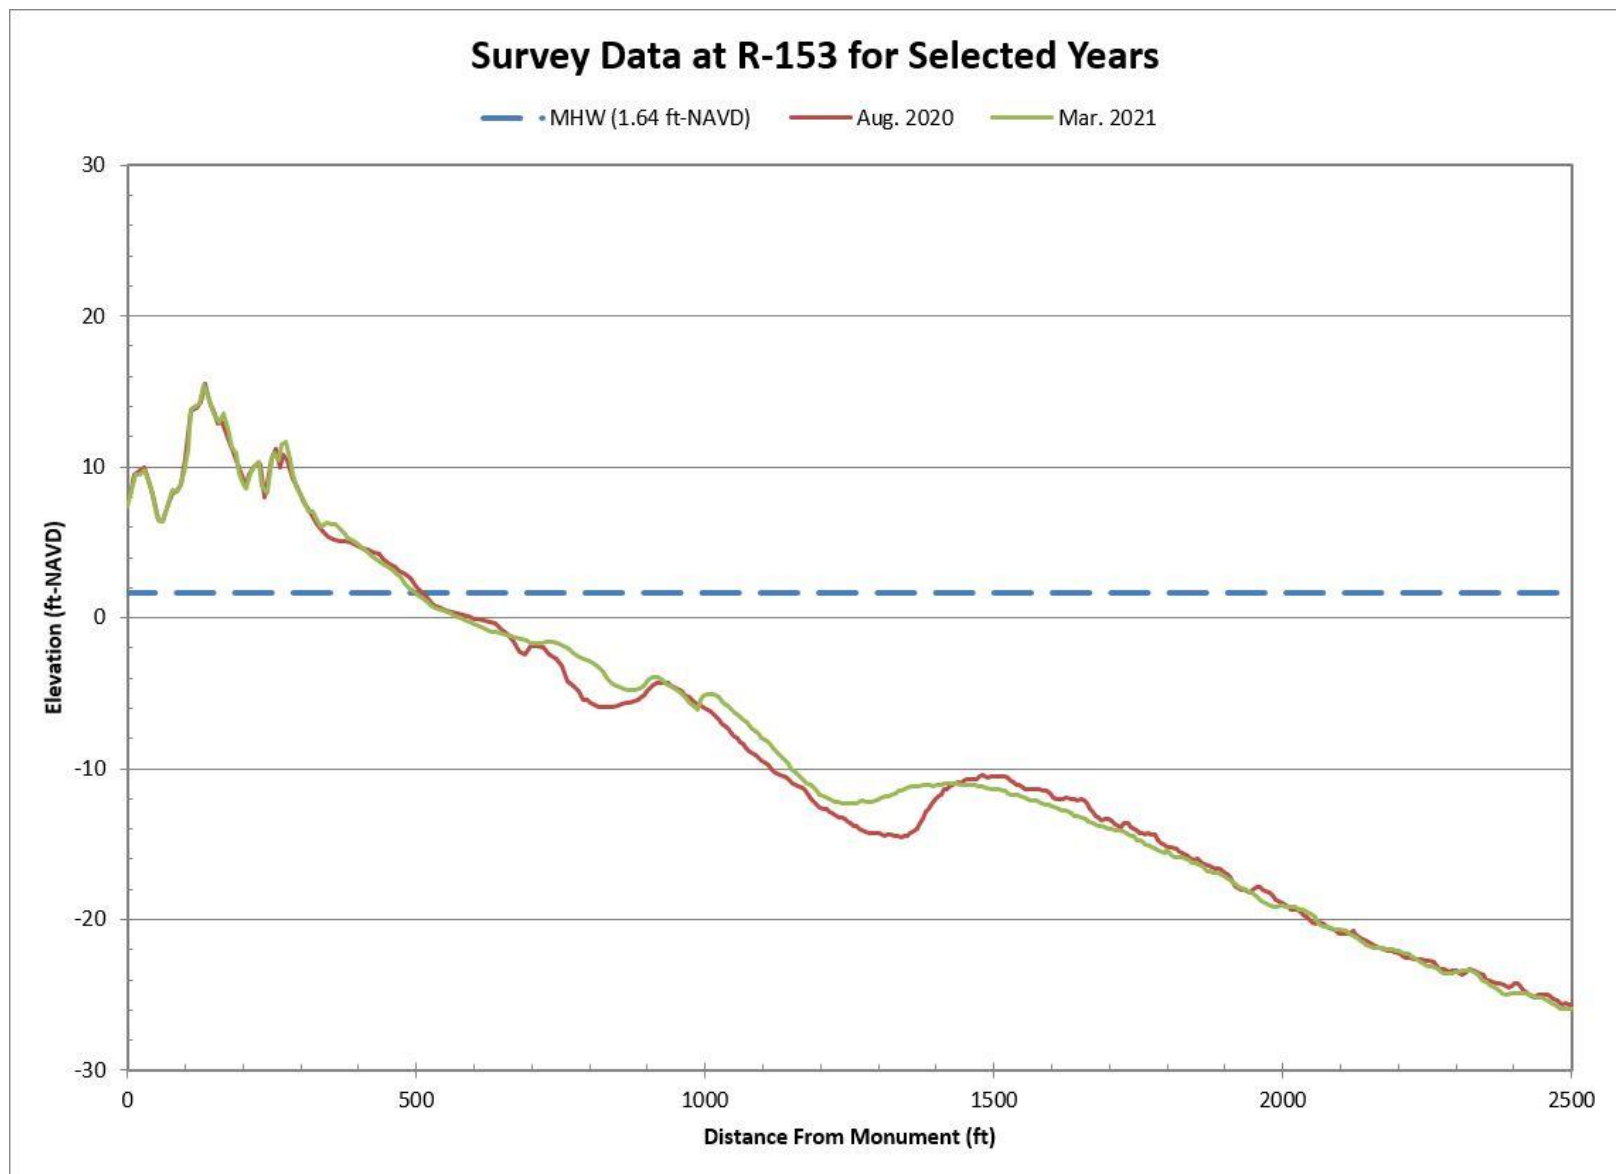
**Figure B-77. Aug. 2020 Pre-Construction vs. Mar. 2021 Post-Construction Beach Profiles Along R-153**
