## Florida Keys Canal Water Quality Issues

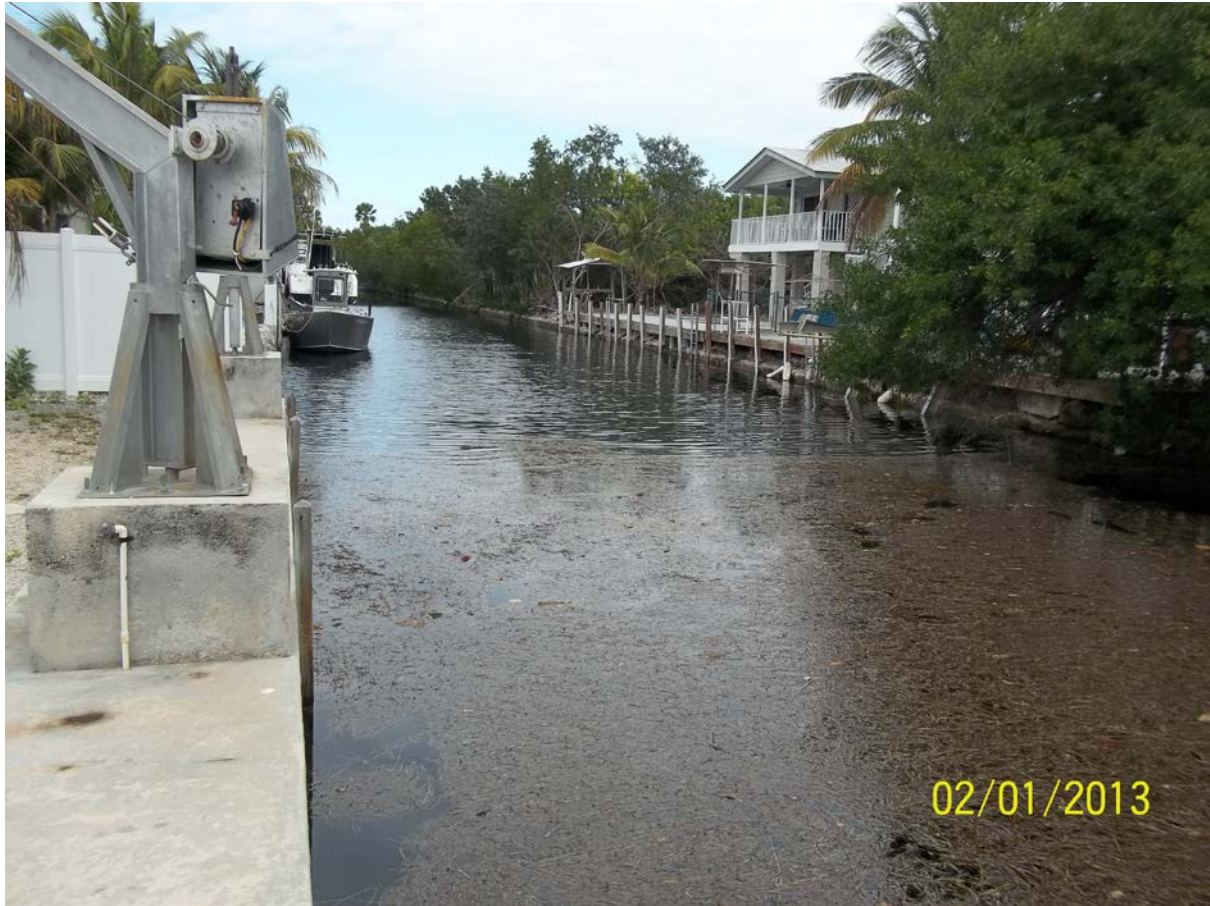
Accumulation of seaweed in many Keys canals causes water quality impairments such as anoxic conditions and low visibility. Additionally, methane and hydrogen sulfide gases are released during decomposition.

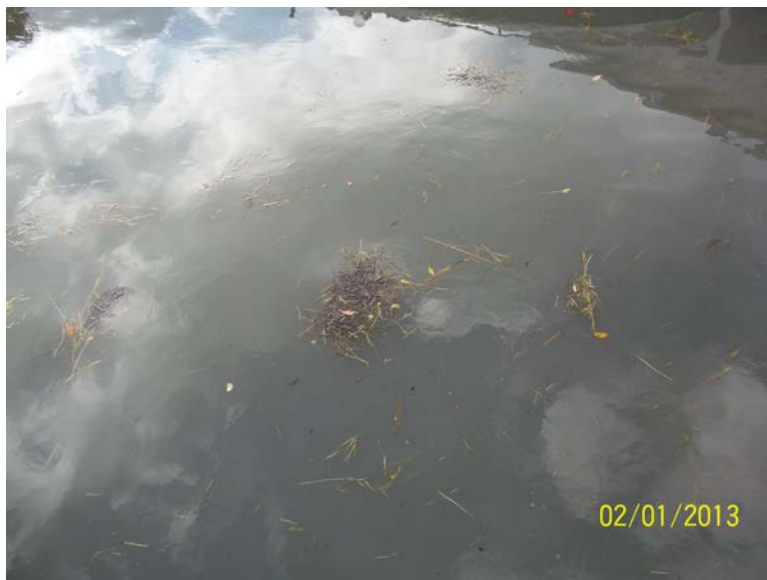
Canal water quality impacted by seaweed and lack of flushing.

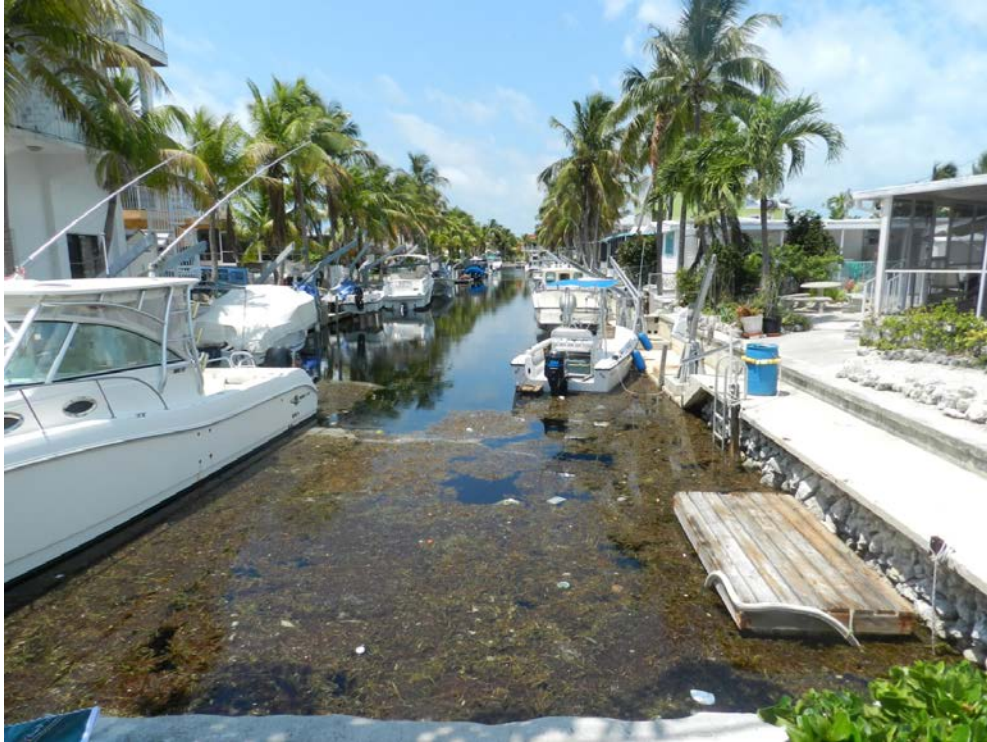
Dead end finger canals accumulate seaweed and other flotsam that become trapped and ultimately decay impacting water quality. This is a problem throughout the Keys. This photo was taken in the Upper Keys. Below photo was take in the Middle Keys.

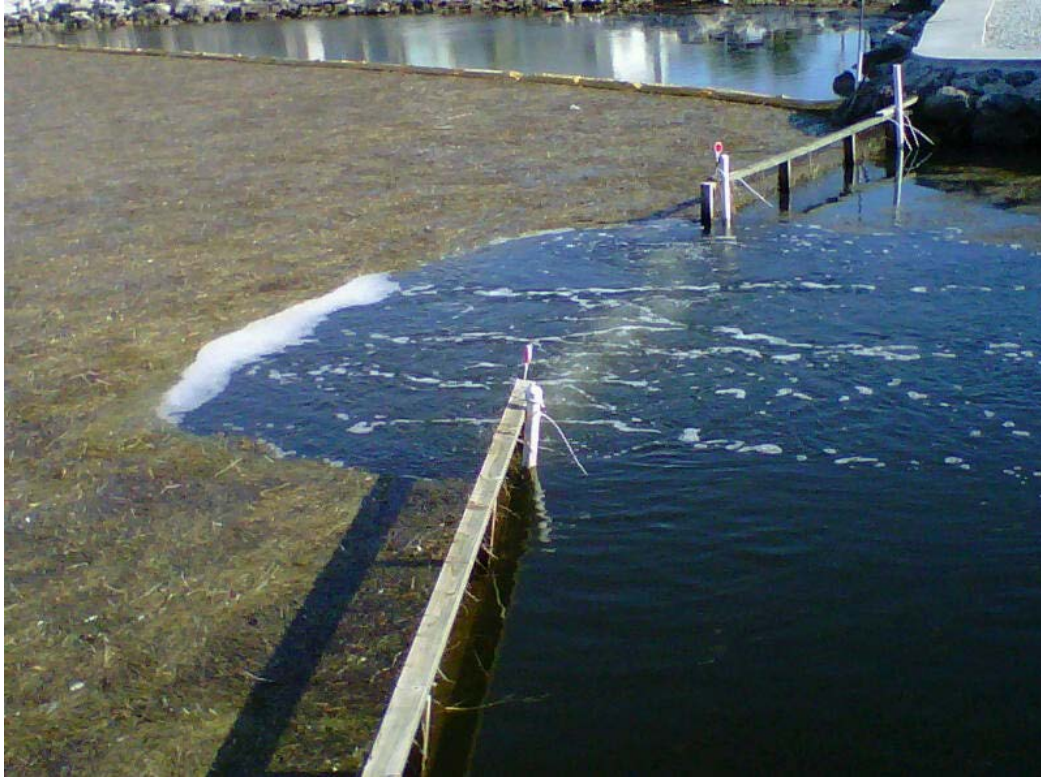
An existing weedgate/air bubble curtain, located on Avenue J Canal in Big Pine, Florida Keys, shows how effective the system is in keeping the seaweed (left side of photo) from entering the canal (right side of photo). This system is operated by the homeowners that live along the canal.

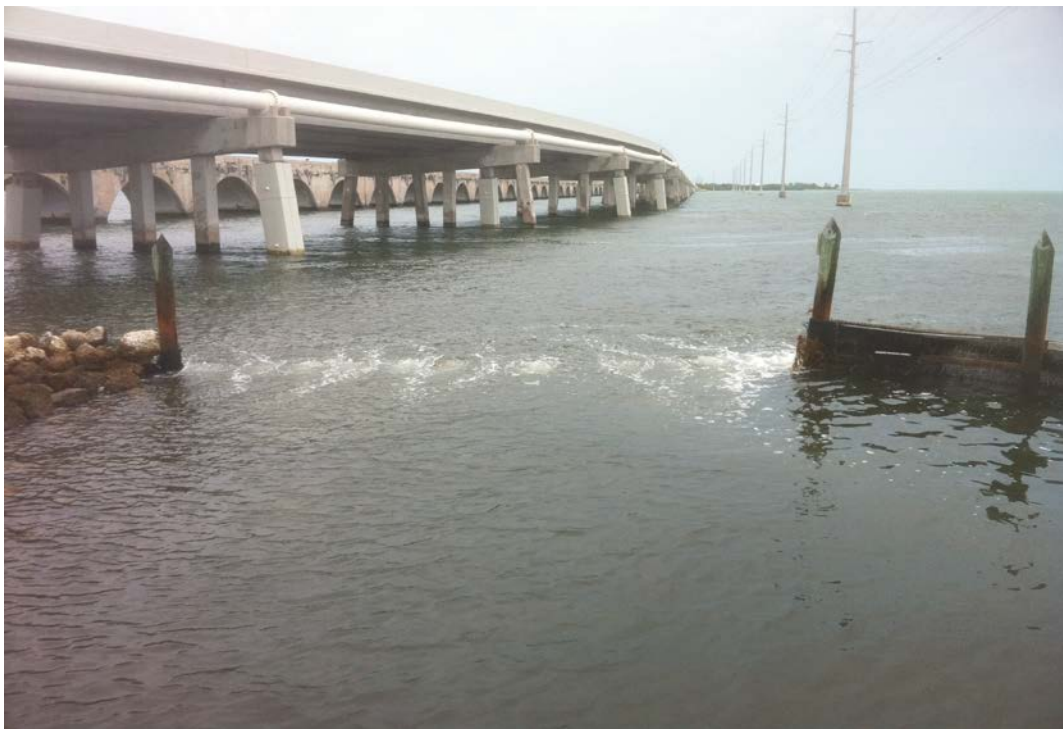
Weedgate/air bubble curtain located at the Big Pine Fish Camp, Big Pine, Florida Keys. View is leaving the canal to open water.

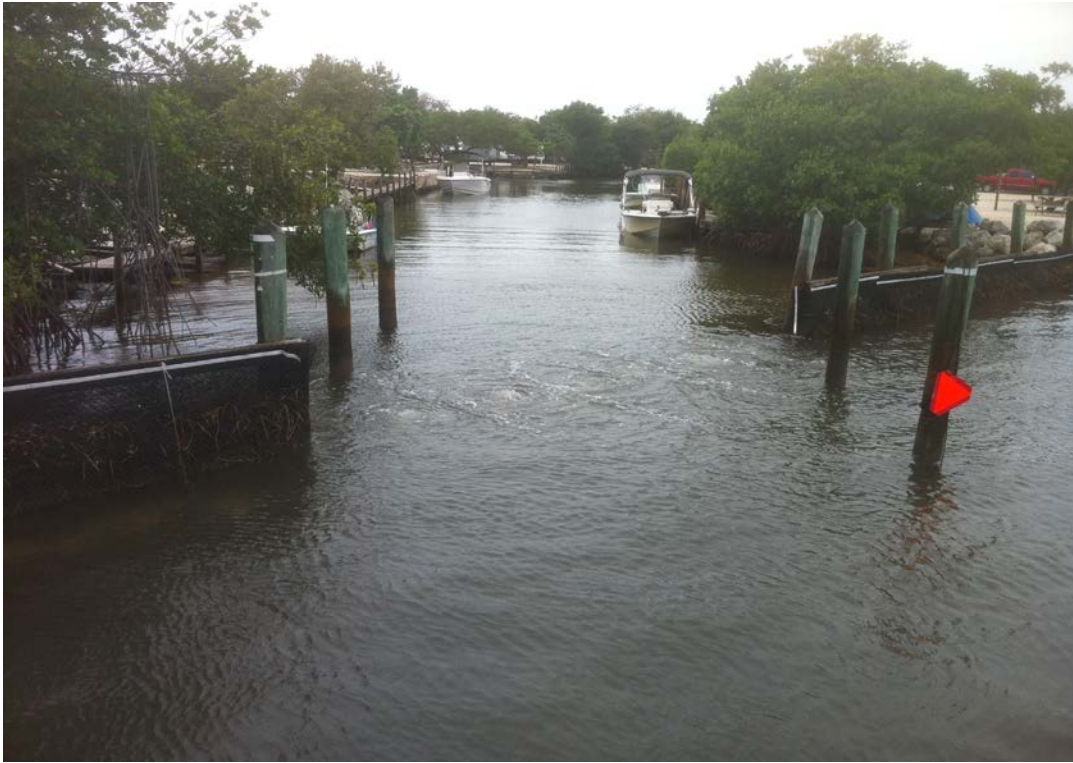
Weedgate/air bubble curtain located at the Big Pine Fish Camp, Big Pine, Florida Keys. View is entering the canal.

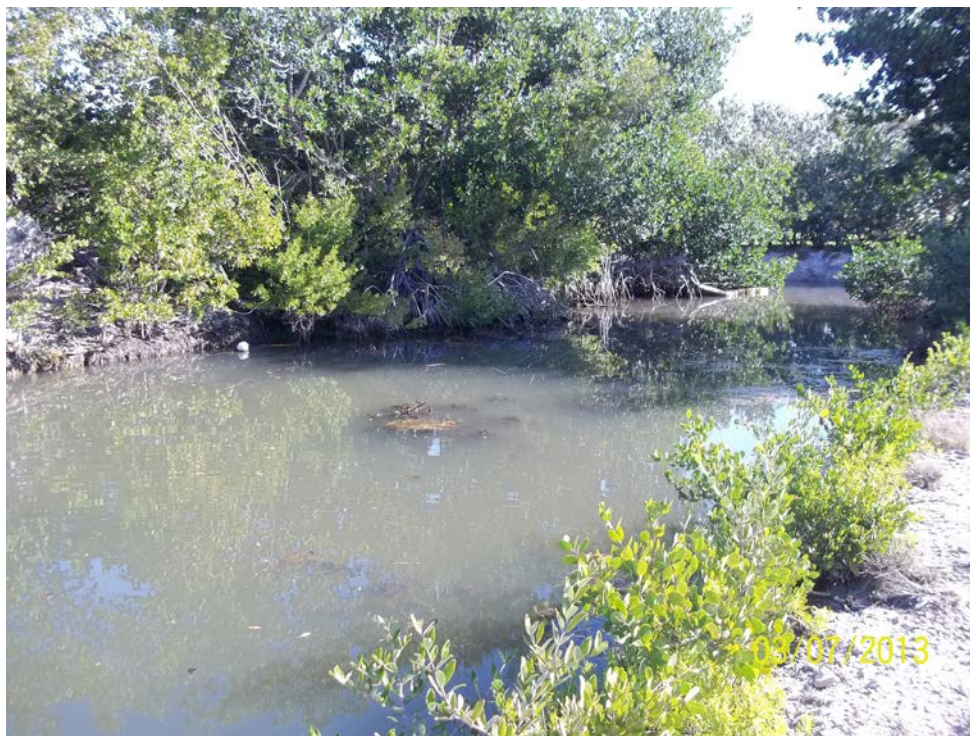
Other canals have poor water quality due to the lack of flushing and will require culvert or pumping systems to enhance the natural tidal exchange in the near shore waters.
