## Monroe County Selection of Demonstration Canals for CULVERT INSTALLATION

### Canal ID: 459 Geiger Key

**Location:** MM 10 Boca Chica Ocean Shores subdivision, Oceanside

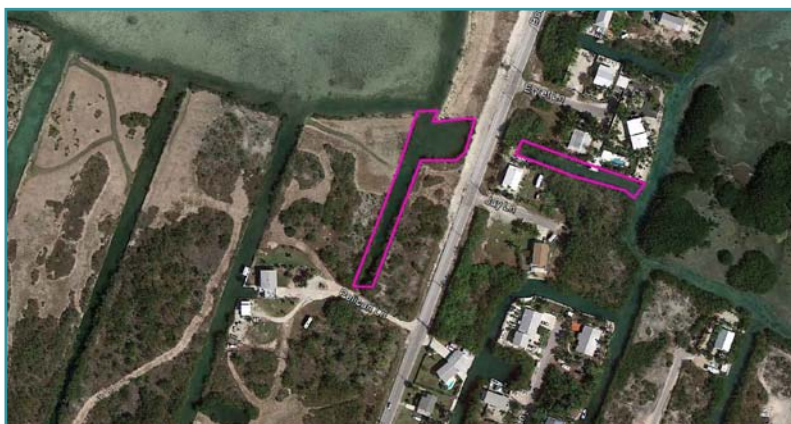
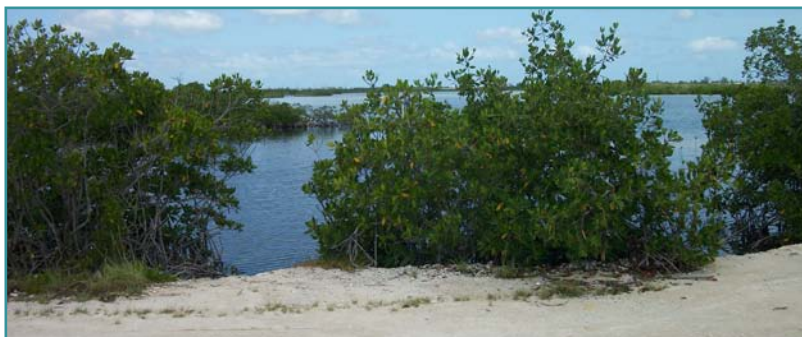
**Restoration Technology:** Culvert installation under Boca Chica Road with connection to Canal 460 Geiger Key to assist with flushing and prevent the entrapment of weed wrack at the end of the canal.

**Site Conditions:** The canal faces southeast and discharges into Similar Sound. The plat book indicates the property is owned by the federal government. The County indicated they cannot pre-empt federal use of the property and additional research is being conducted to determine the nature of the federal interest in the property.
