## Monroe County Selection of Demonstration Canals for ORGANIC REMOVAL

### Canal ID: 290 Big Pine Key

**Location:** MM 31 Not located within a subdivision, Bayside

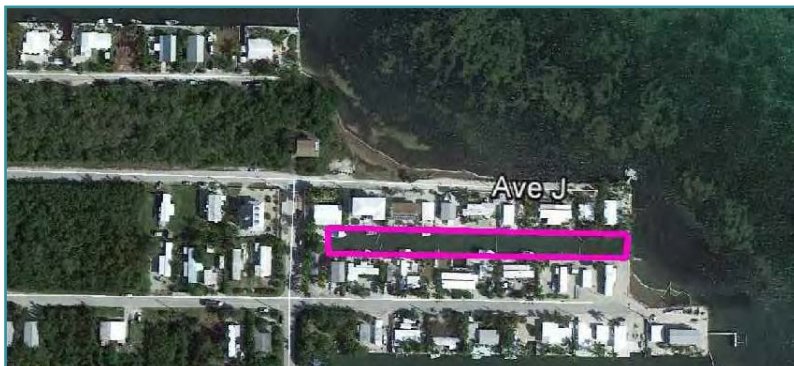
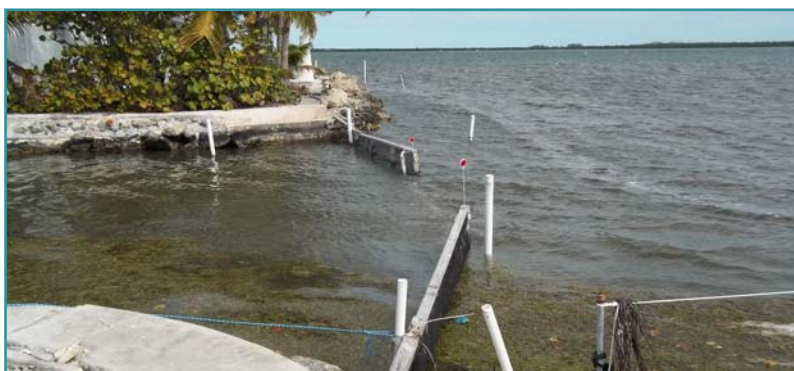
**Site Conditions:** The canal faces due east and discharges into Bogie Channel. The plat book reflects private ownership of lands below the high-water mark is asserted over 0.06 acres of submerged land in the adjacent canal.
