# Restoring Resilient Oyster Reefs in Florida's Big Bend

Final Report to  
The Nature Conservancy  
And the  
National Oceanic and Atmospheric Administration  
August 31, 2015

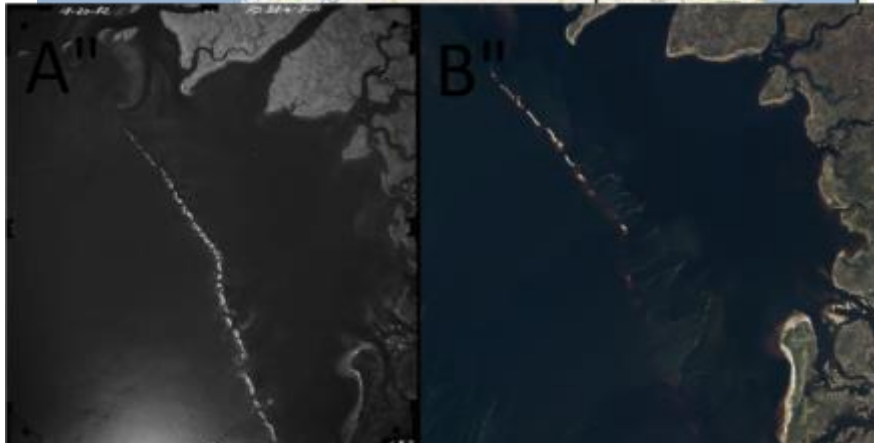
Figure 2. Aerial photographs of the Lone Cabbage chain of oyster reefs at low tide in 1982 (left) and 2010 (right). Note loss of entire reefs, loss of total reef area, and widening of gaps between reefs. East pass of the Suwannee River is shown at the top of both photos.

Some features of the recent history of the reef have been documented by aerial photographs (Seavey et al. 2011, see Figure 2). As recently as the early 1990s, the chain extended from East Pass south to Buck Island (6.2 km) with as many as 38 individual bars. By comparison, by 2010 the reef extended only 3.3 miles, with only 13 islands. Further, the size and depth of the inlets had changed markedly, with expansion in width from 27 to 984 meters on average. The elevation of bars prior to 2010 is unknown, but post-2010 trends in elevation (-7.2 cm/yr), elevations of oysters on less degraded inshore bars, and local oral histories suggest that the Lone Cabbage reef elevation may have been reduced by up to a meter in some places since the early 1980s. While the reef chain has been closed to harvest since the late 1970s, local fishermen indicate that harvest may have been exceptionally heavy in some years when closures in the much larger Apalachicola fishery forced large numbers of oystermen onto these beds. In addition, there may have been some illegal fishing pressure since the closure which has varied with oyster dock prices and local availability. Thus while harvest pressure has probably not been an important forcing function for oyster populations on this reef in the past two decades, it is possible that episodic harvest events in the past may have been important to the trajectory of oyster populations on this reef.

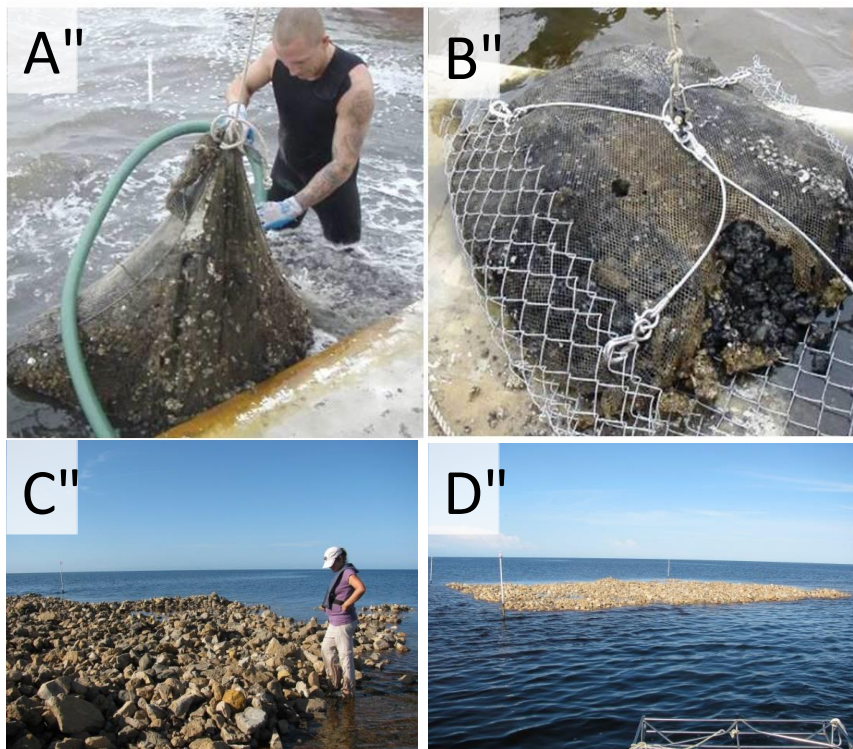
Figure 3. Aquaculture clam bags (A,B) and limestone boulder (C) materials used to construct durable oyster reefs (D) in the Lone Cabbage oyster reef chain.

cultch, living oysters, and other encrusting organisms (Figure 3). The mesh bags were used to grow cultured hard clams (*Mercenaria mercenaria*) on lands leased from the State of Florida by commercial clam farmers that are adjacent (cf 11 km) to the Lone Cabbage Reef complex. During storm or extreme weather events, many of the clams die and their shell becomes colonized by oysters and other species – an average of 8,000 living oysters per bag has been recorded. These bags are often then abandoned on the lease by the clam industry because it is cheaper and easier to use new bags than to reclaim these older, encrusted clam bags for re-use in clam farming. We estimate over 20,000 encrusted bags are currently available to be relocated for oyster bar restoration. These bags and their living contents (cf 35 – 135 kg) are durable, heavy, and represent ready-made oyster reef building blocks that are resistant to wave action and strong currents. We employed local watermen to remove and transport the bags for use in oyster restoration. Thus, the removal and relocation of the clam bags can benefit the clam industry and employ fishermen, while the reuse of this material can form a cheap, locally sourced, and effective construction product for oyster restoration.

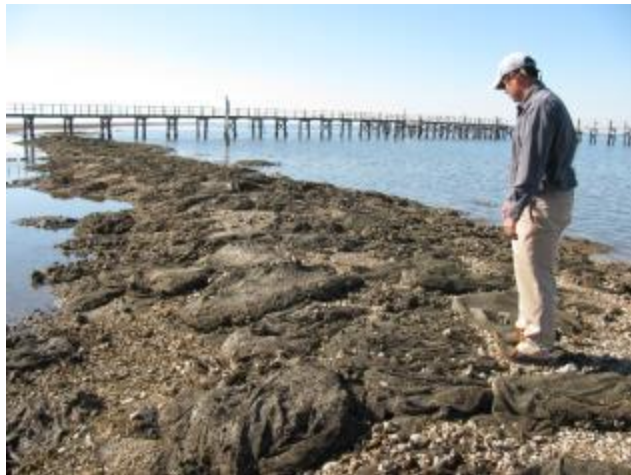
Figure 4. Constructed oyster reef composed entirely of repurposed clam bags on Atsena Otie Key near the town of Cedar Key, FL.

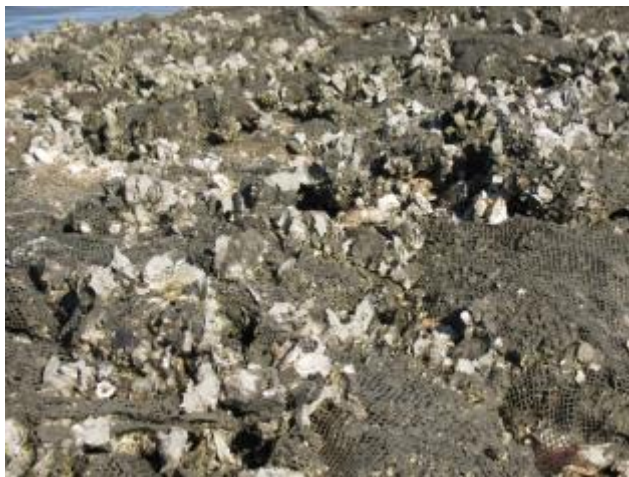
Figure 5. Oysters growing through mesh clam bags on Atsena Otie reef.

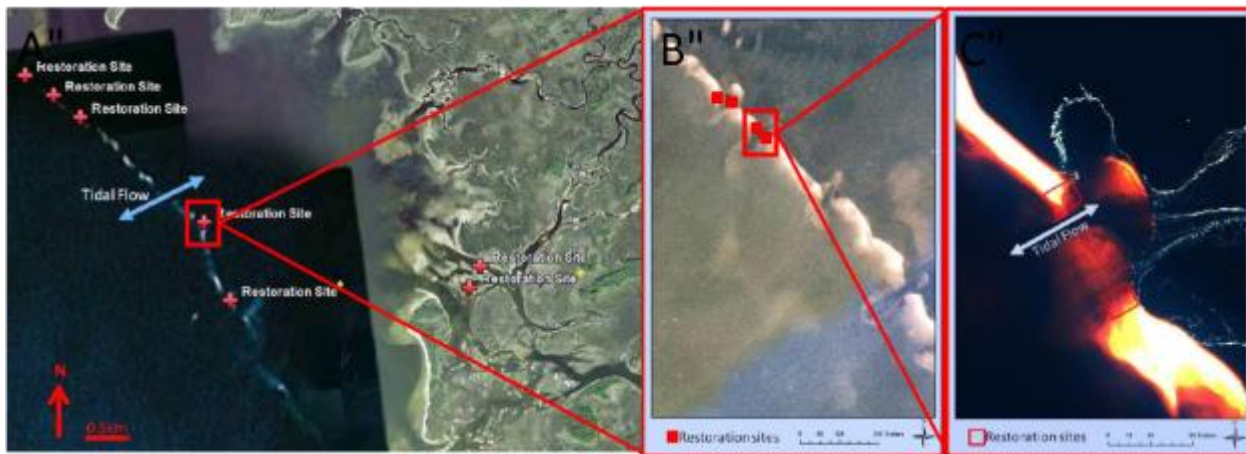
Figure 6. Maps showing approximate location of construction sites within the Lone Cabbage chain of bars in the Suwannee Sound (A), and the arrangement of restored reefs at inlets at the landscape (B) and local (C) spatial scales.

We initially recognized that the inlet/bar arrangement of the Lone Cabbage chain resulted in important flow characteristics that could have feedbacks to oysters and other reef faunal dynamics. Generally the reefs force flow into the intervening inlets at some point as water recedes below the level of the bars, and flow rates of up to 2.5 m/sec have been witnessed on strong outgoing tides. Because of this relationship, we considered one inlet formed by the ends of two bars should be the experimental unit, rather than individual bars. We randomly designated the first major inlet at the north end of the chain as a restoration site, and then alternated restoration with control sites moving south. Edges of reefs adjoining these inlets were then numbered so that the northernmost pair (restoration) was 1 & 2, the next pair (control) was 3&4, and so on. We created four total inlet treatments, with sites 1&2 and 5&6 being restoration sites, and 3&4 and 7&8 being the intervening control sites (Figure 6).

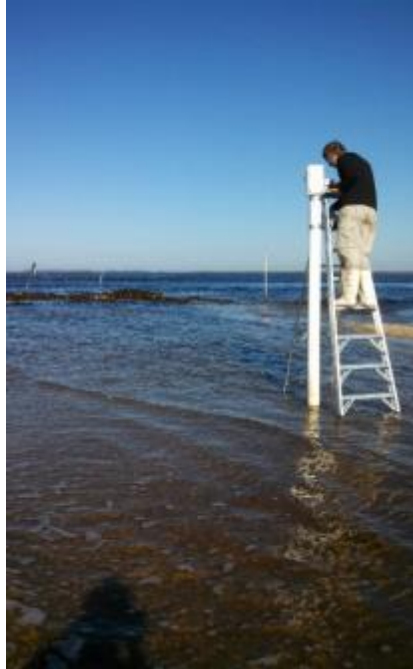
Figure 7. Trail camera mounted on PVC pole aimed at restoration site 2 on Lone Cabbage Reef, December 2013.

We used trail cameras in time-lapse mode to estimate usage of each of the sites by aquatic birds. Cameras were placed 2.5 m above the substrate within a weatherproof housing mounted on 15.2 cm diameter PVC poles driven into the substrate (Figure 7). Cameras were deployed in fall/winter 2013/4 following placement of the rock, between 22 October and 17 December. This period coincides with the maximum period of both fall migration and of winter residence for most of the aquatic birds in Gulf coastal Florida.

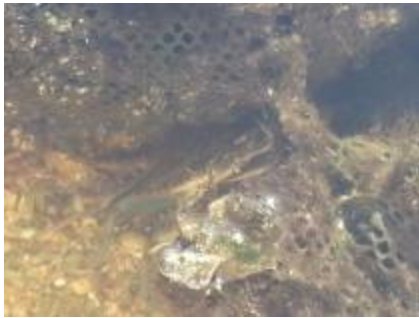
Figure 8. Blue crab (*Callinectes sapidus*) in refuge between two clam bags.

The study site is generally estuarine in character and provides good habitat conditions for blue crabs (*Callinectes sapidus*, Figure 8). We often saw blue crabs on the oyster restoration sites and noted that the embayment landward of Lone Cabbage reef has a high density of blue crab traps. Since blue crabs are a typical predator on oyster reefs, we measured crab density on restored and control sites.

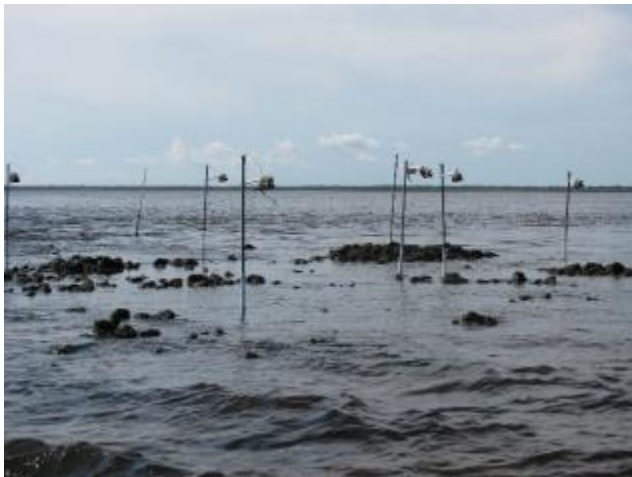
Figure 9. Cameras mounted on PVC poles approximately 1 meter above the reef for estimating crab densities.

2.3 meters above the substrate on 5.4 cm diameter aluminum poles set into 10.1 cm diameter pvc pipe driven into the substrate (Figure 9). Cameras were placed on falling tides as the water

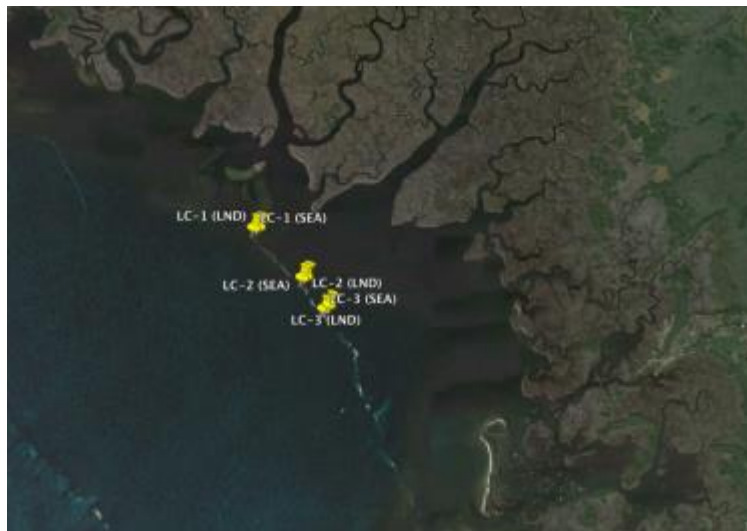
Figure 10. Locations of salinity recording instruments seaward and landward sides of Lone Cabbage reef.

Because we were interested in the potential effect of the reef on salinities we deployed six sensors in landward and seaward pairs (Figure 10).

Each station consisted of a conductivity-temperature-depth (CTD) sensor (CTD-Diver, Schlumberger Water Services, Tucson, AZ) logging at 15-minute intervals. Sensors were inserted into a slotted PVC housing mounted via rebar to a cement block and placed directly on the benthic surface. Stations were placed to keep sensors submerged at low tide (30–45 cm above the benthic surface) and were located between 5 and 30 m from the reef edge; the seaward reef slope is shallower than the landward side, requiring station placement at a greater distance. Data were collected from November 2013 through June 2015; sensors were downloaded and housings cleaned every 2–4 months. Daily, tide-filtered discharge data were downloaded from the USGS Gopher River station on the Suwannee River (station ID: 02323592).

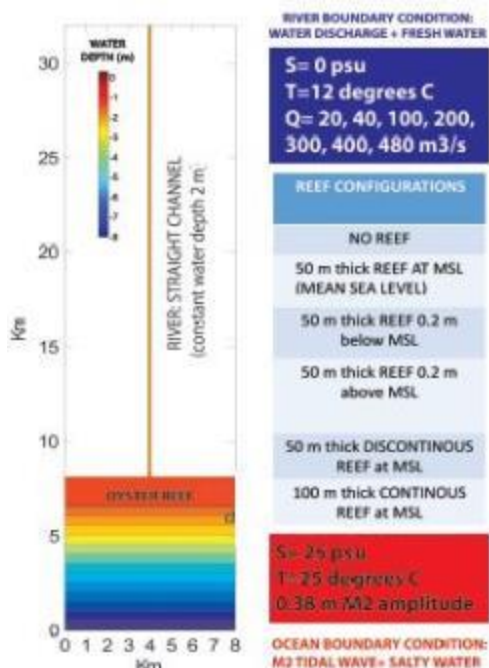
Figure 11. Schematics of domain configurations (left) and topographical/hydrographical conditions modeled to understand the effect of reef chains on detention of freshwater in Suwannee Sound.

We also modeled the potential effect of the Lone Cabbage chain of reefs on freshwater detention within Suwannee Sound by modeling salinities. We used the 3-D Regional Ocean Modeling System (ROMS) which is a numerical, hydro-dynamic model that solves finite-difference approximations of the Reynolds-Averaged Navier-Stokes (RANS) equations using the hydrostatic and Boussinesq assumptions (Chassignet et al., 2000; Haidvogel et al., 2000), with an explicit time stepping algorithm (Shchepetkin and McWilliams, 2005; Haidvogel et al., 2008). Domain configurations (Figure 11, left) represented an idealized morphology based on Suwannee Sound. We compared hydrodynamics resulting from the interaction of different water discharges (Q) and oyster reef configurations (Figure 11 right). The basic idea behind this relatively crude modeling effort was to see if there was any support for the hypothesis that restored elevations would lead to greater detention of fresh water.

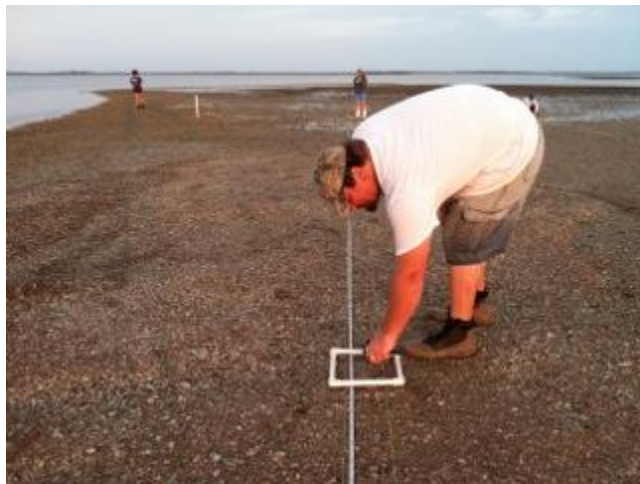
Figure 12. Restoration site 5 looking south, April 2013 prior to restoration activities. Note the complete absence of typical oyster reef structure, and very low density of oysters.

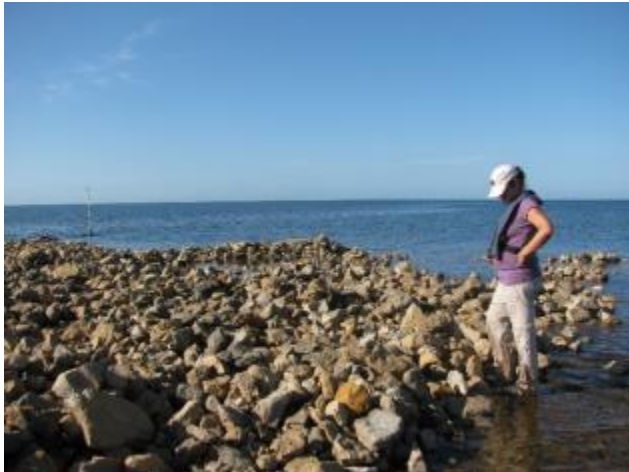
Figure 13. Limerock boulders at low tide on restoration site 1 in the Lone Cabbage reef, approximately 1 week after placement.

diameter (Figures 13 – 15), with no fine material. Because we had some short term funding external to this project to devote to this, we purchased the rock and paid for trucking to, and storage at the town of Suwannee in December 2012. Since this was well prior to obtaining construction permits, the material was stored in Suwannee from December 2012 through September 2013. The rock was then moved by barge to the construction site in late September 2013 after obtaining all construction permits. The barge was moved into place at high tide, and stabilized in place using hydraulic spuds that

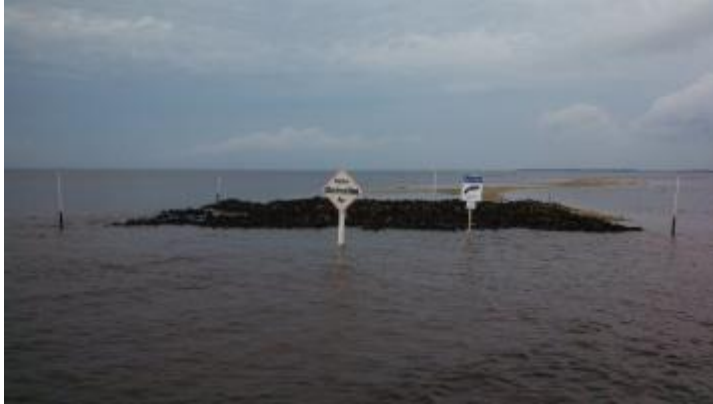
Figure 14. View of restoration site #1 from south looking north, 3 months following rock placement.

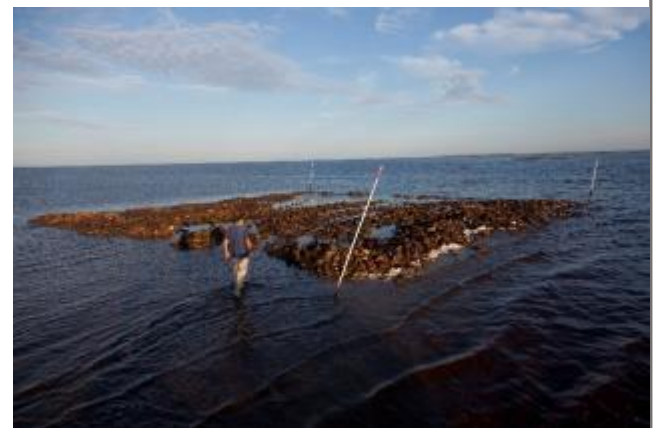
Figure 15. Rock on Lone Cabbage reef restoration site 1 approximately 1 month following deposition.

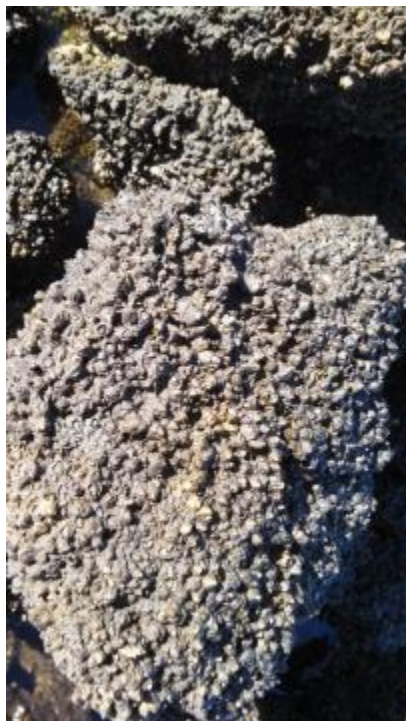
Figure 16. Limestone boulder covered with barnacles, fall 2013 on the Lone Cabbage reef.

*Reef colonization and pattern of oyster growth:* The rock portion of the reef was installed in late September 2013, and was rapidly colonized by a near-monoculture of barnacles (Figure 16).

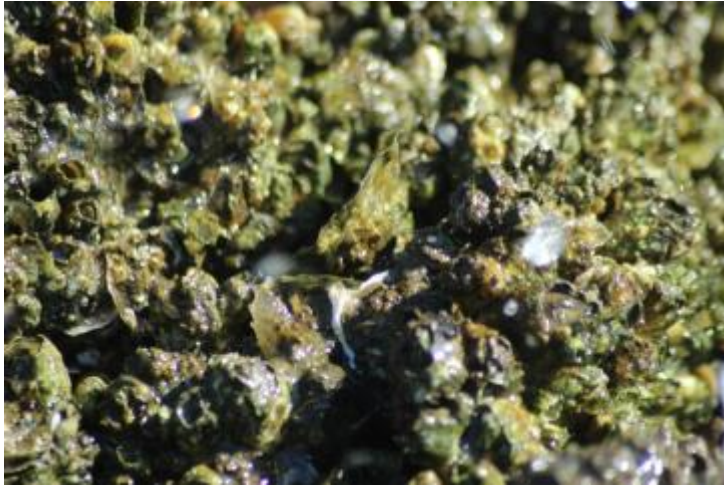
Figure 17. Small oysters growing together over a gap between rocks. Note that the seam between rocks has become invisible.

Performance of the rock substrate was generally good, with an increase in oyster density over nearby control sites of 2.65X, suggesting more rapid recruitment and survival under generally favorable salinity regimes seen during the period of study. There was also apparently good resistance to movement, and to sinking into the substrate. For this site, the size of rock (10 – 20 cm diameter) seemed appropriate and smaller sizes would probably have performed less well because of wave action and strong currents. Oysters also cemented themselves across the cracks between some rocks or to one another across those gaps, further stabilizing the rocks and creating a cohesive mass.

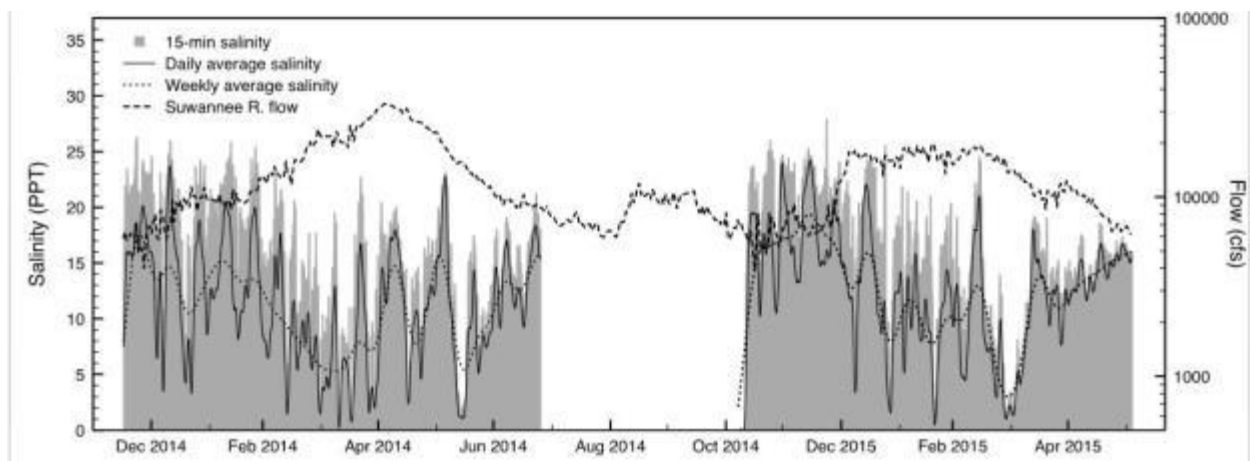
Figure 18. Graph of Suwannee River Discharge (dashed line, Gopher River USGS station ID: 02323592) and average weekly and daily salinities at a station on the seaward side of restoration site 2 on Lone Cabbage reef. The salinity sensor was not in the water during July – October 2014.

The winter of 2014/15 was normal to wet with persistent rainfall and discharge keeping the reef under fresh to estuarine conditions for nearly the entire time, and periods of weeks when the average PSU was 5 or less (Figure 19).

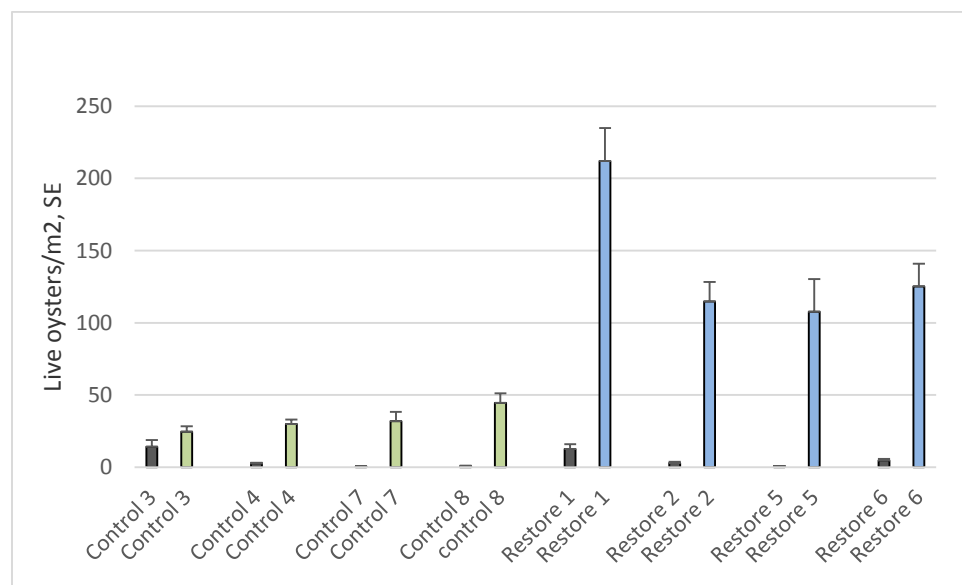
Figure 19. Densities of live oysters + SE counted in transects preconstruction (black, mostly not visible) and postconstruction on eight restored (blue) or control (green) oyster reefs.

Figure 19 and Table 1 show total densities of oysters counted on rock on belt transects across the eight sites preconstruction (April 2013) and post-construction (May/June 2015). In general, there was an increase in oyster density on the control oyster reefs (increase of 10 – 43 oysters/m<sup>2</sup> or 0 – 64X increase) between these dates, probably because the salinity conditions had improved compared with relatively saline conditions in 2011 – 2013. However, oyster densities on rock on restoration sites increased much more, with absolute increases of 107 – 199 oysters/m<sup>2</sup> or 15 – 157X.

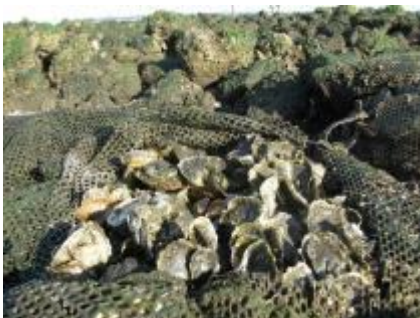
Figure 20. Photo of clam bag cut open to reveal high densities of large oysters. Compare densities with rock immediately behind.

We also measured oyster densities and sizes in a total of 43 clam bags that had been in place for at least 12 months, and found an average of 474 oysters/m<sup>2</sup> (s.d.= 19.8). For sizes of oysters in clam bags see below under *Oyster Size*. Although there were some live oysters in the clam bags when installed, we believe the majority of the oysters were recruited in place – they were surprisingly uniform in size and shape suggesting a cohort effect, and oysters generally had not been evident during installation of the bags (Figures 20,21).

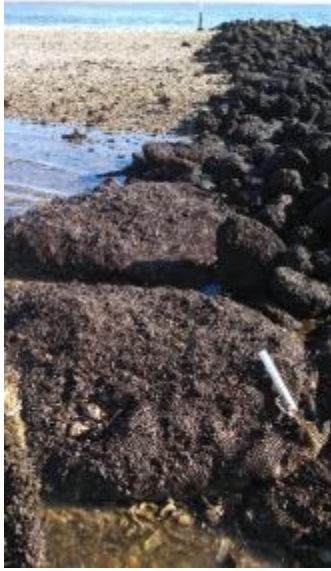
Figure 21. Clam bags as placed on the edge of rock on restoration sites, Lone Cabbage reef.

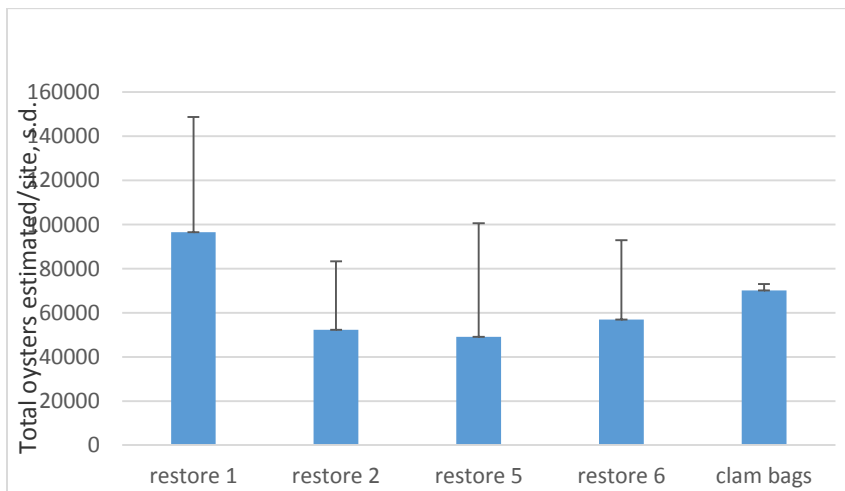
Figure 22. Total oysters estimated on each site for rock (restore 1, 2, 5, 6) and clam bags that had been in place for at least 12 months. Clam bags contributed 52.4% of the oysters on restored sites that had at least 12-month old clam bags on them.

Estimated total densities (rock + bags, calculated from total oyster estimates) averaged 303.5 oysters/m<sup>2</sup>, while oysters on control sites in June 2015 averaged 32.8 oyster/m<sup>2</sup>. Thus oyster densities on restoration sites were 9.26x densities on control sites.

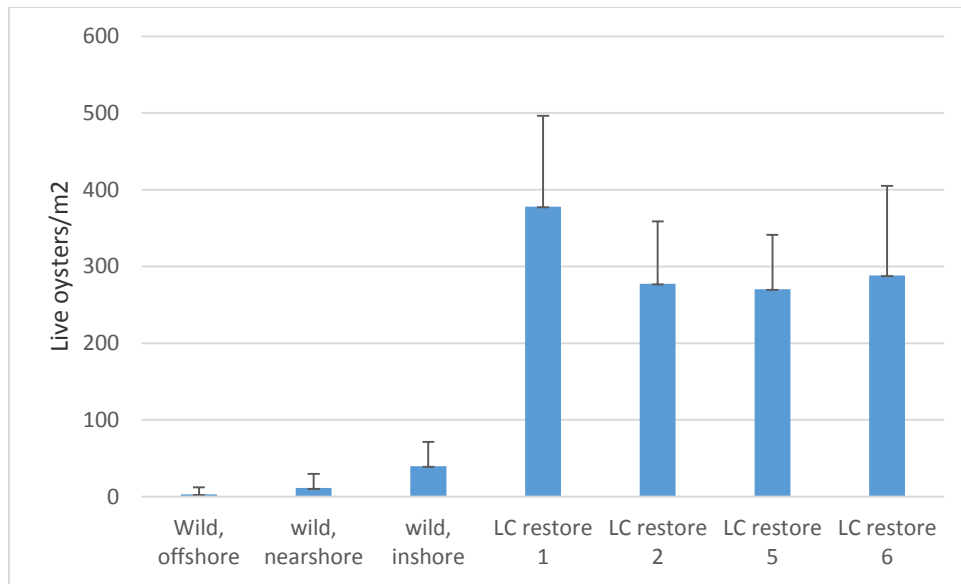
Figure 23. Mean oyster densities on restored sites at the Lone Cabbage reef with densities collected from 38 oyster reefs in the area between Wacassassa Bay and Horseshoe Beach collected in 2010, representing a gradient of conditions from offshore to inshore locations.

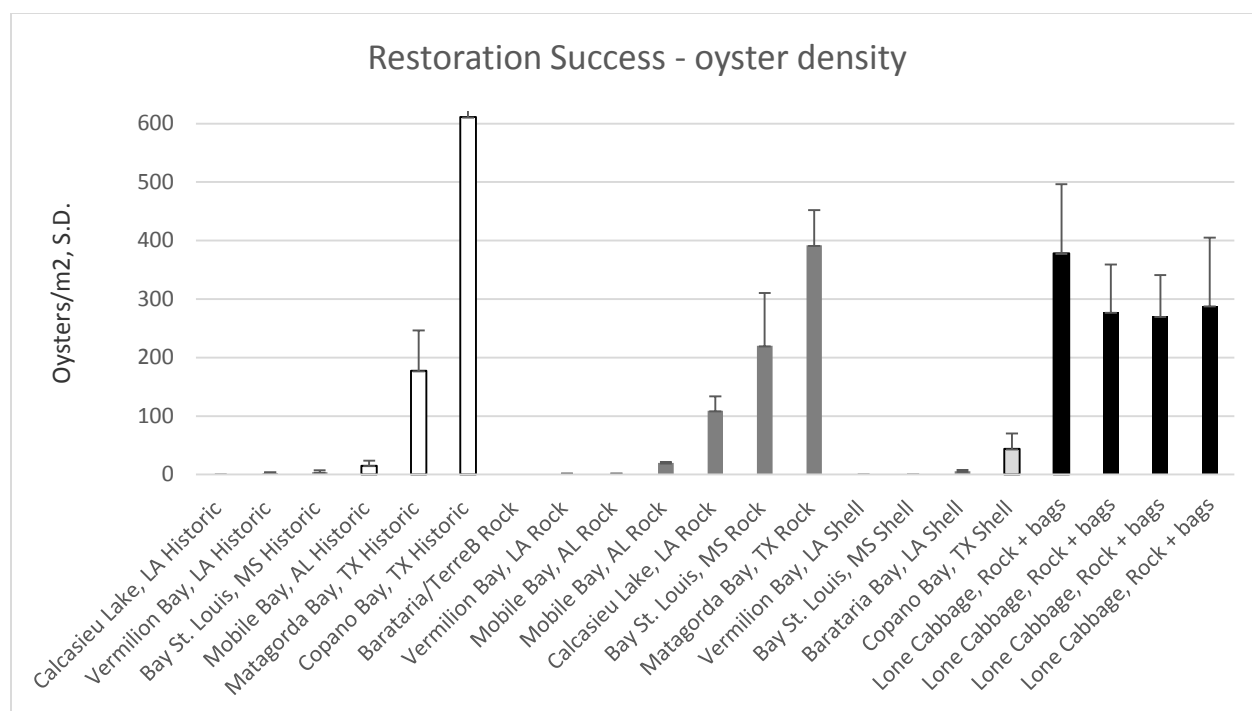
Figure 24. Oyster densities at restored and historic sites in the Gulf of Mexico (from LaPeyre et al. 2014). Historic sites are shown in white bars, sites restored with rock are shown in dark gray, sites restored with shell are shown in light gray, and the four Lone Cabbage restoration reef sites are shown in black.

Figure 24 compares these densities with those at other restored and natural sites around the Gulf of Mexico (LaPeyre et al. 2014). Oyster densities in clam bags on restored sites at Lone Cabbage were higher than all but one of the reported sites (a natural site in Texas). Oyster densities on any of the Lone Cabbage restored sites was higher than 89% of all the sites reported. These densities are not directly comparable since the LaPeyre sites were all subtidal and measured using diver-recovered quadrats counted in the lab, whereas the LC sites were counted in situ without disturbance and we only counted oysters we could see from above. Further, the LaPeyre sites were of various ages post-restoration whereas the LC sites were 19 months post-restoration. Presumably, the LaPeyre counting method is likely to produce an upwards bias in density compared with the method used at Lone Cabbage because more of the oysters are unearthed and counted. It is unclear whether one should expect higher densities at sites with longer postrestoration histories or not, since weather events and harvest could easily depopulate those sites over time. Further, early colonization sites like Lone Cabbage may have generally small, crowded oysters, and competition may result in lower densities as oysters grow. Nonetheless, the densities found at LC appeared to fulfill a designation of high densities of oysters compared with other restoration sites in the Gulf of Mexico, and many natural sites in the Big Bend study area.

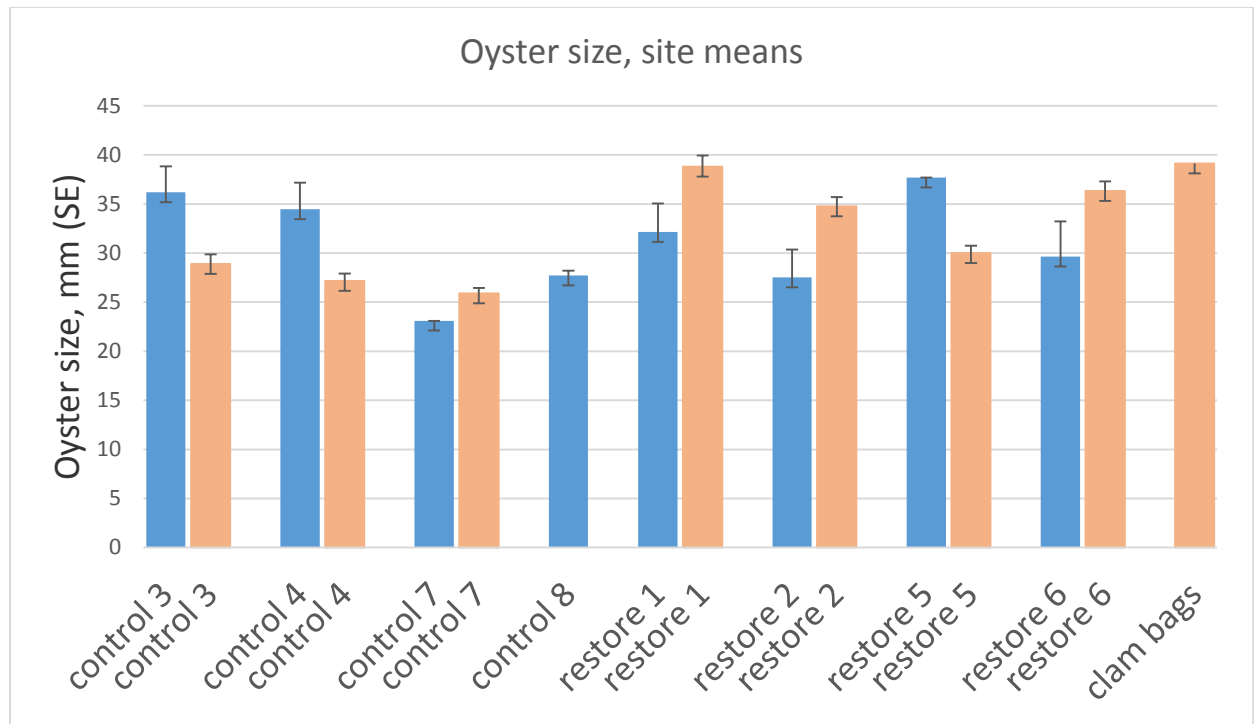
Figure 25. Mean +SE sizes of oysters by site found on control and restoration sites before (blue, April 2014) and after (orange bars, May/June 2015) restoration activities.

**Oyster size:** We found less consistent differences by treatment and time in sizes of oysters measured at the sites at Lone Cabbage. At one of the restoration sites, only a single live oyster fell within our quadrats in the preconstruction and so we were unable to derive an average size. In the three restoration sites at which comparisons could be made pre-and post-construction, all three sites had significantly larger oysters post-restoration. Of the control sites, two were not usable due to small sample size in pre- or post-construction condition. One of the two remaining sites one (control 3) had significantly larger mean oyster size preconstruction, and the other (Control 4) had significantly smaller oysters post-construction (Table 2, Figure 25).

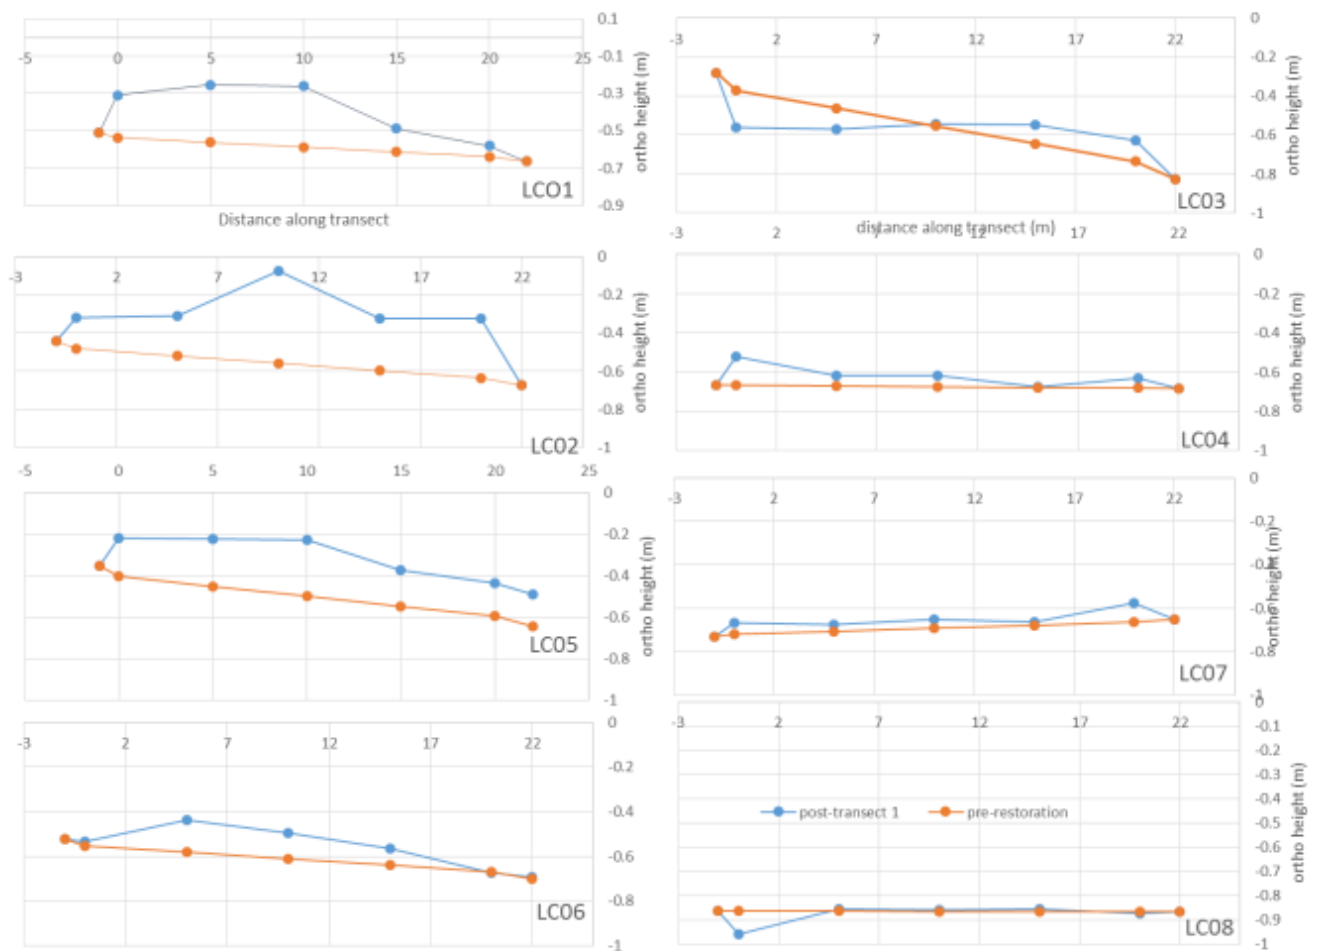
Figure 26. Elevation profiles of restoration (left) and control (right) reefs showing before (red line) and after restoration (blue line). Horizontal axes show decreasing distance away from each inlet at each site.

Placement of rock and bags on the restoration sites by definition increased elevation on those sites initially but it was unclear whether rock and bags would settle into the substrate. Figure 26 shows before and after elevations on the sites that were restored or not. Restoration sites showed average absolute increases in elevation across the reef of 16.05 cm (range -.51 – 32.6 cm) whereas mean elevation change on control sites was 3.1 cm (range -18.7 – 14.8). It is difficult to tell how much of this difference was due to placement of rock (possibly followed by some settling), and how much was accretion of sediment onto the rock. Patterns of sediment accretion were difficult to portray with the relatively coarse grid of measurements we took, but it appeared that sediment either accreted slightly or generally decreased in elevation on control sites, and accreted considerably on the restored sites (see Figure 27). This was confirmed to some extent by our difficulty in finding two of our benchmarks on the restored reefs (buried under 8 – 10 cm sediment), whereas the benchmarks on the control sites were all clearly elevated above the surface of the sediment.

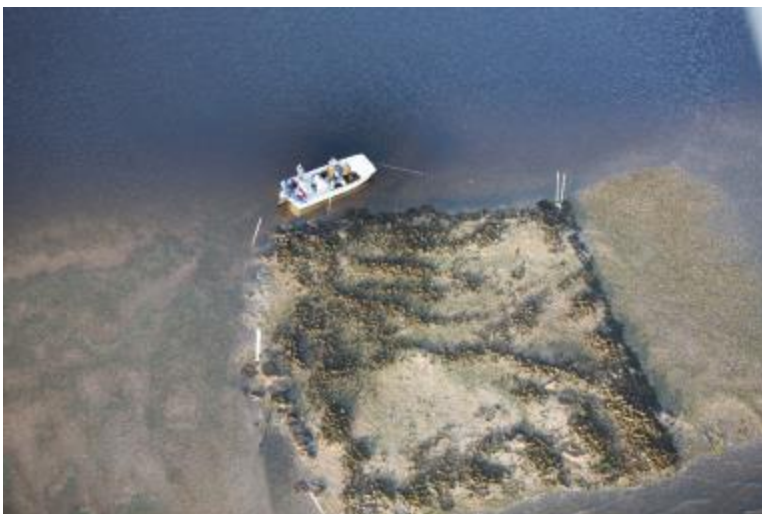
Figure 27. Aerial photo of site 5 on July 1 2015 on the Lone Cabbage reef showing considerable coverage of rock by sediment.

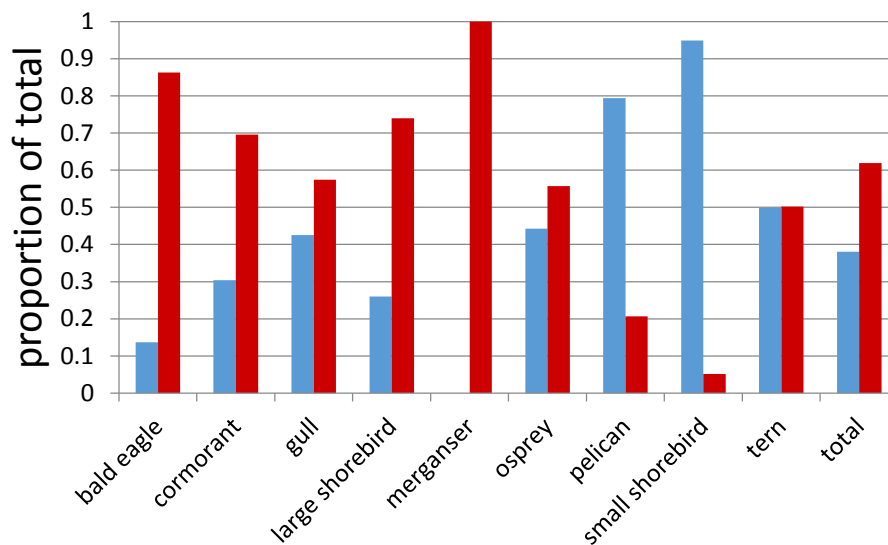
Figure 28. Proportion of all bird-observation frames in which different species groups were observed by treatment (blue = control, red = restoration) at Lone Cabbage Reef.

We found some distinct differences among treatments in usage by species and species-groups (Table 3, Figures 28, 29). For example, the overwhelming majority of small shorebirds (95%) were found in the control sites – this is probably because they generally prefer to forage in flats and sandy/muddy substrates. The larger shorebirds, however, were overwhelmingly found (74%) in the restoration sites – this was probably because their numbers were dominated by Ruddy Turnstones and Willets, which appeared to be attracted to the rocky substrate. The only other group that seemed to prefer the open sandy control sites was pelicans, which typically do not prefer rocky perches. Terns appear to have no real preference between treatments. All other species groups appeared to be strongly attracted to the rocky substrate in the restored sites, with 62% of all birds being seen at the restoration sites.

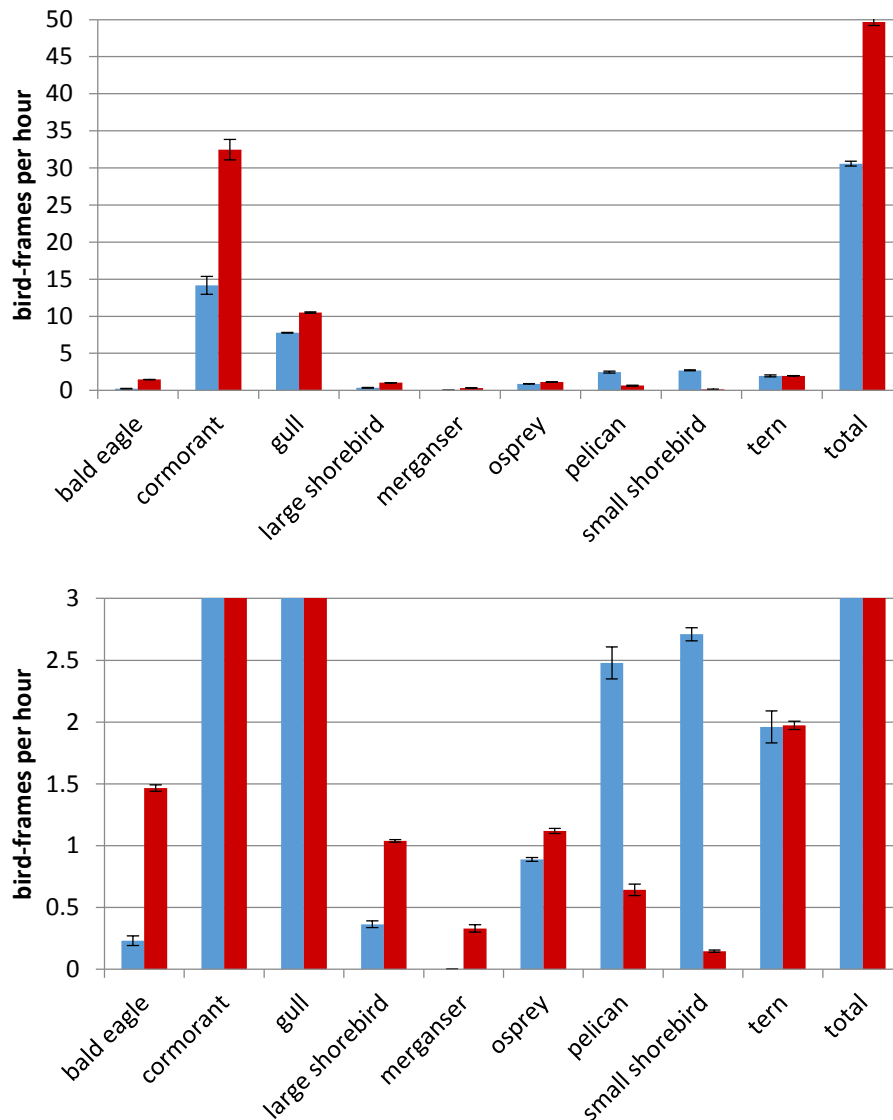
Figure 29. Total number of bird-frames per hour in which different species groups were observed by treatment (blue = control, red = restoration) at Lone Cabbage Reef. Top graph shows entire range, while the bottom graph shows a closer view of less frequently observed species

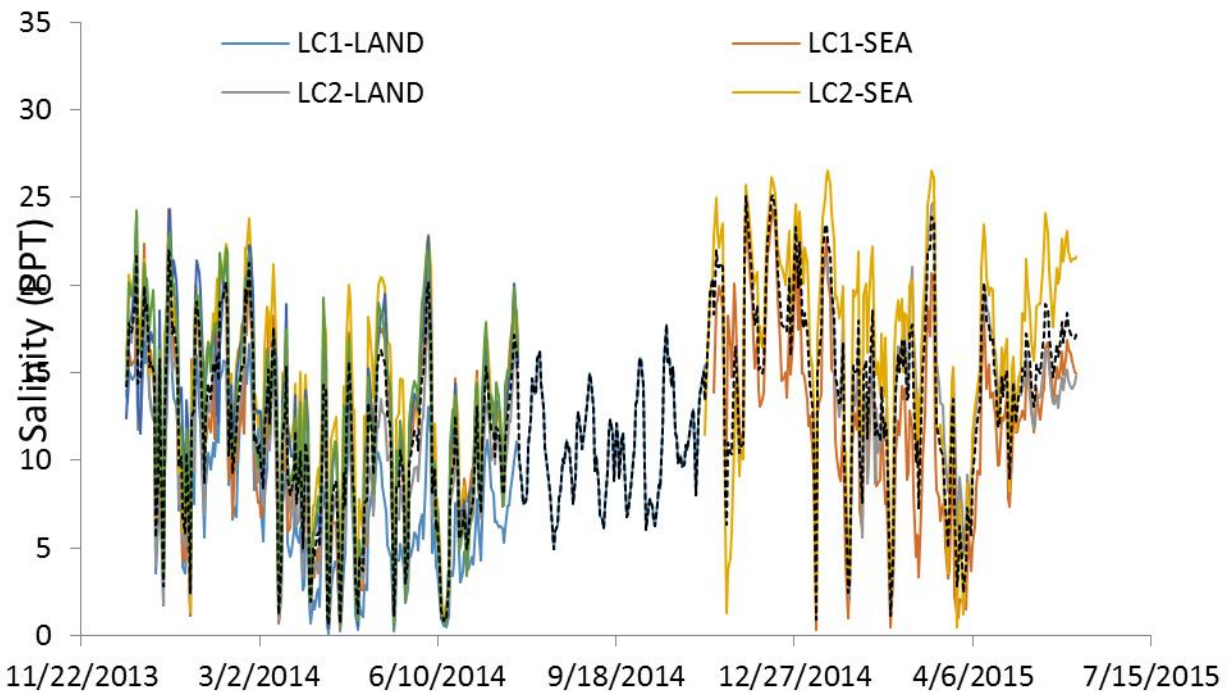
Figure 29. Mean daily salinities on Lone Cabbage reef from sensors on landward and seaward sides of the reef, as averaged November 2013 – June 2015.

Salinity dynamics at Lone Cabbage are a product of 1) tidal flow, 2) river discharge, and 3) the physical structure of the reef. On many days, salinities on both sides of the reef may vary from near-ocean strength to near-zero, presenting a sometimes challenging physiological environment for oysters. During the period post-construction, we found generally estuarine conditions at the reef when averaged over the entire period (Figure 29).

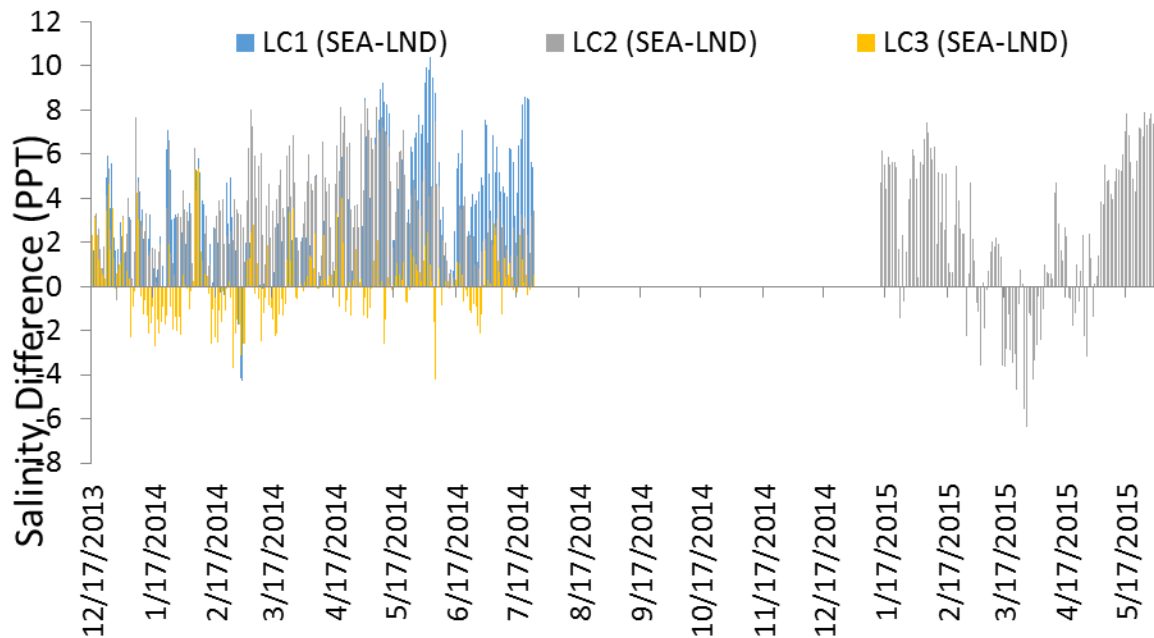
Figure 30. Instantaneous salinity differences between landward and seaward salinity recording stations at Lone Cabbage reef. Positive values indicate higher salinities at the seaward station. All stations with full sea/land pairs were included.

While these averages were important for characterizing the overall conditions for oyster growth, they belie very drastic changes at both daily and weekly scales (Figure 30). For

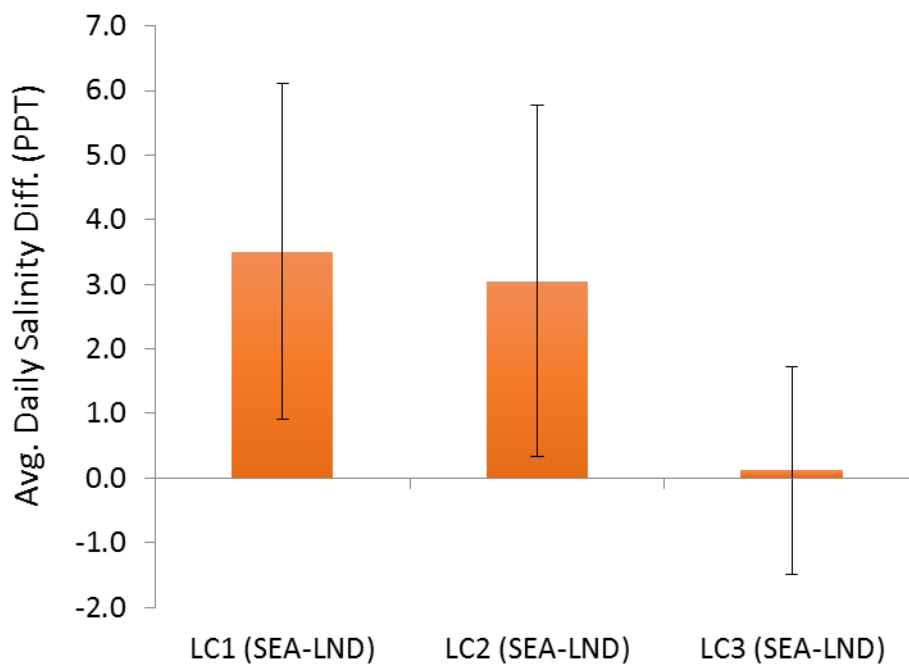
Figure 31. Average salinity differences between seaward and landward pairs of salinity meters along the Lone Cabbage reef, as averaged over 221 – 425 days depending on station pair. Positive values

We also found that there were consistent instantaneous differences between landward and seaward salinities on the reef (Figure 31). Using the three station pairs that had relatively complete data, we found that seaward stations had consistently higher average salinities than landward stations ranging from 0.12 – 3.5 ppt.

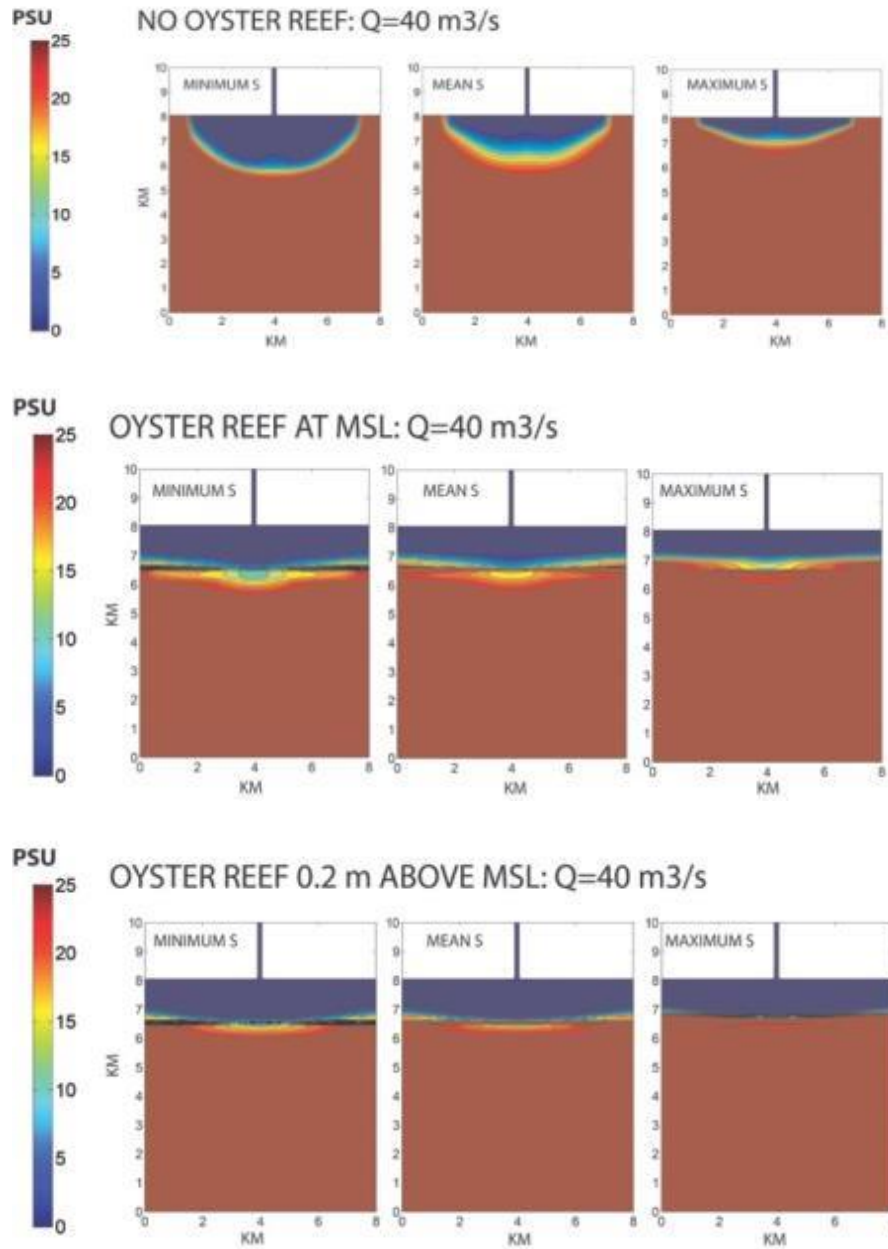
Figure 32. Pictorials of modeled salinities in hypothetical topographies, with no oyster reef, an oyster reef chain with top elevation at mean sea level, and an oyster reef at 20 cm above MSL. Vertical blue line at top of each picture represents the incoming river as seen from above, and the modeled oyster reef is at 6 – 7 km on the vertical axis.

1. Maximum estuarine freshwater extent occurs at low tide, and maximum saline water intrusion occurs at high tide across all simulations.
2. With reef in place, estuarine salinity variability is reduced; freshwater extension towards the sea is also reduced.
3. Instead, the freshwater plume is dispersed laterally within the shallow estuarine zone.
4. This effect is exacerbated with increasing reef height. High reefs lower estuarine salinities on the bay side and reduce overall salinity variability on both the landward and seaward sides of the reef.
