**APPENDIX 10.7.6**  
**LIGHT SOURCE PHOTOS**

### Appendix 10.7.6 Light Source Photos

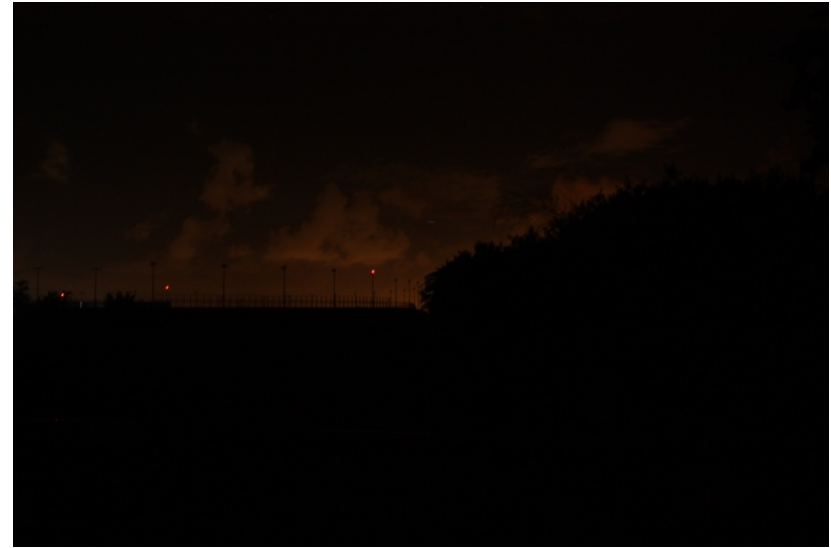
| Station | 1 |

| Location | Southeast corner of the racetrack on SW 344 <sup>th</sup> Street/Palm Drive |
| Direction | North, towards Miami/ North Homestead |
| Sky Quality Meter Readings (Lux) | 0.0019 |

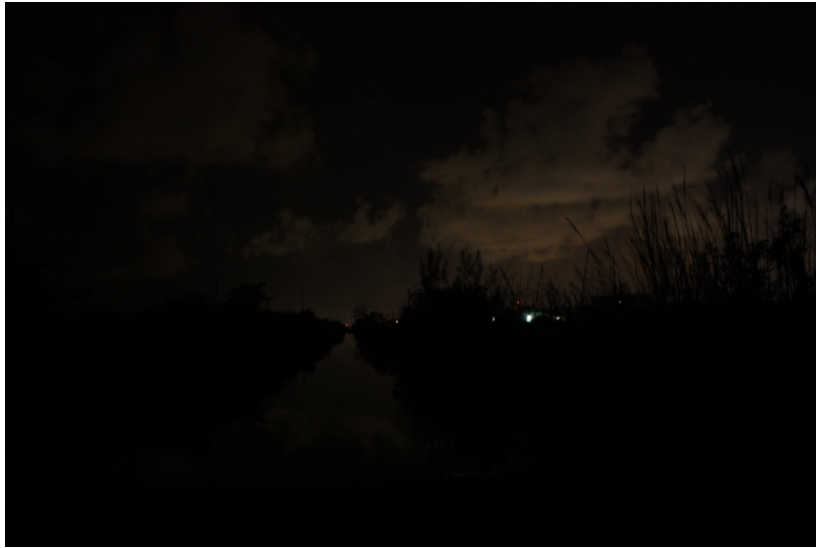
| Station | 1 |

| Location | Southeast corner of the racetrack on SW 344 <sup>th</sup> Street/Palm Drive |
| Direction | West, towards Homestead |
| Sky Quality Meter Readings (Lux) | 0.0019 |

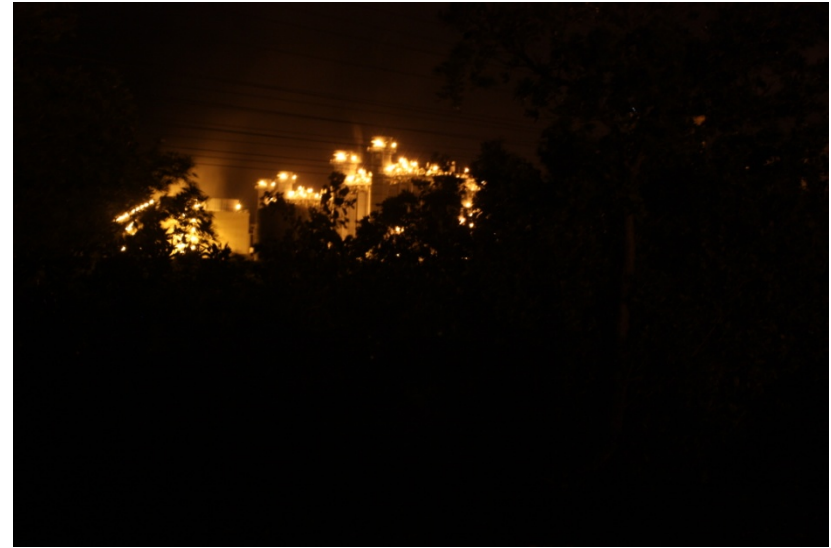
| Station | 2 |

| Location | Gate of the transmission line, northwest of Unit 5 |
| Direction | Southeast, towards Plant |
| Sky Quality Meter Readings (Lux) | 0.0039 |

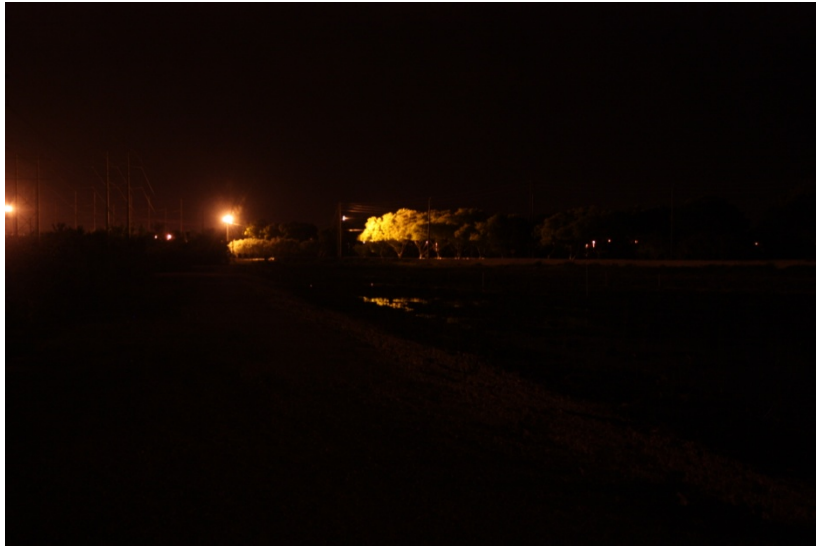
| Station | 2 |

| Location | Gate of the transmission line,<br>northwest of Unit 5 |
| Direction | Southeast, towards southern<br>portion of plant |
| Sky Quality Meter Readings (Lux) | 0.0039 |

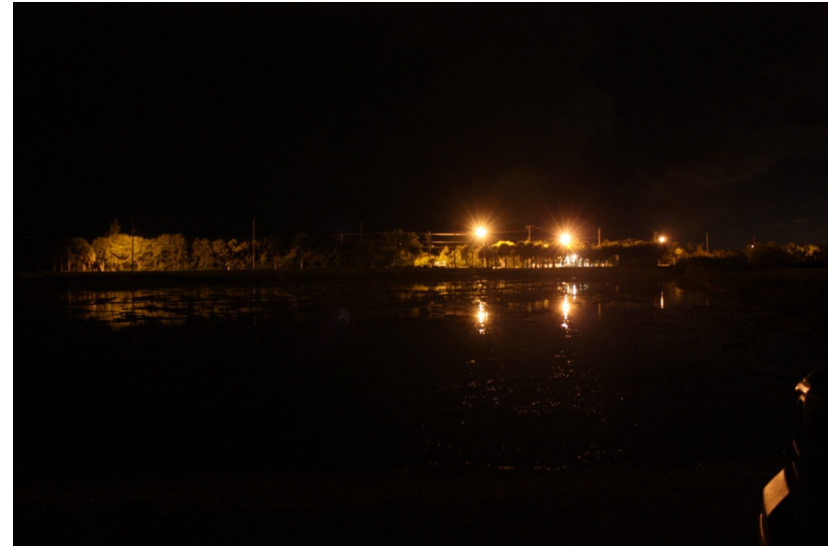
| Station | 2 |

| Location | Gate of the transmission line,<br>northwest of Unit 5 |
| Direction | West, towards plant guardhouse |
| Sky Quality Meter Readings (Lux) | 0.0039 |

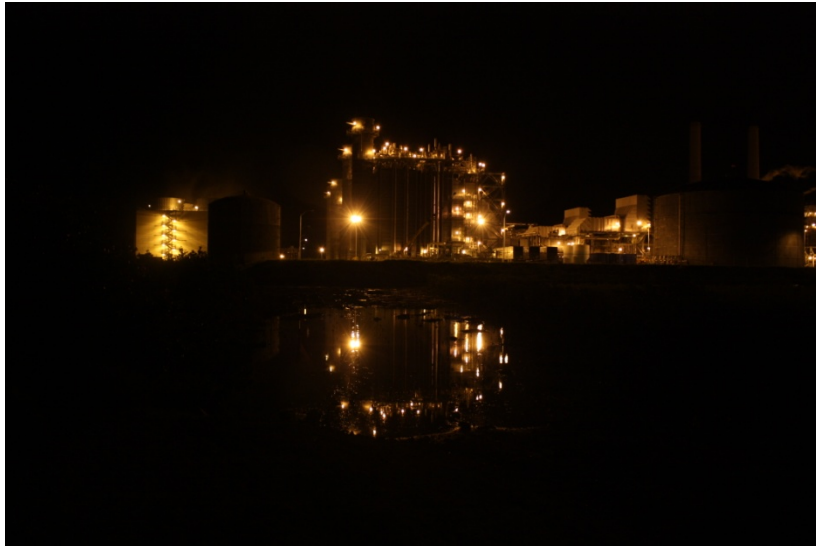
| Station | 3 |

| Location | Second set of transmission towers west of Unit 5 |
| Direction | Southeast, towards plant |
| Sky Quality Meter Readings (Lux) | 0.0036 |

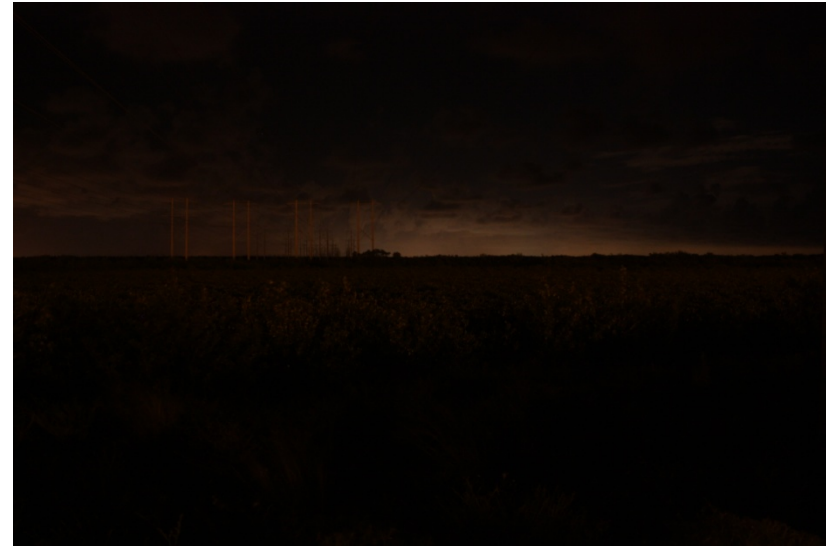
| Station | 3 |

| Location | Second set of transmission towers west of Unit 5 |
| Direction | North, towards Miami |
| Sky Quality Meter Readings (Lux) | 0.0036 |

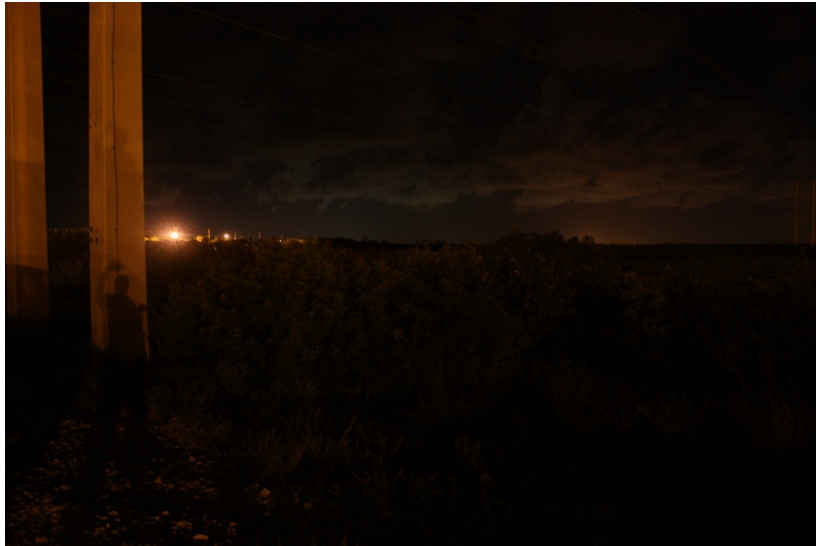
| Station | 3 |

| Location | Second set of transmission towers west of Unit 5 |
| Direction | West, towards Homestead |
| Sky Quality Meter Readings (Lux) | 0.0036 |

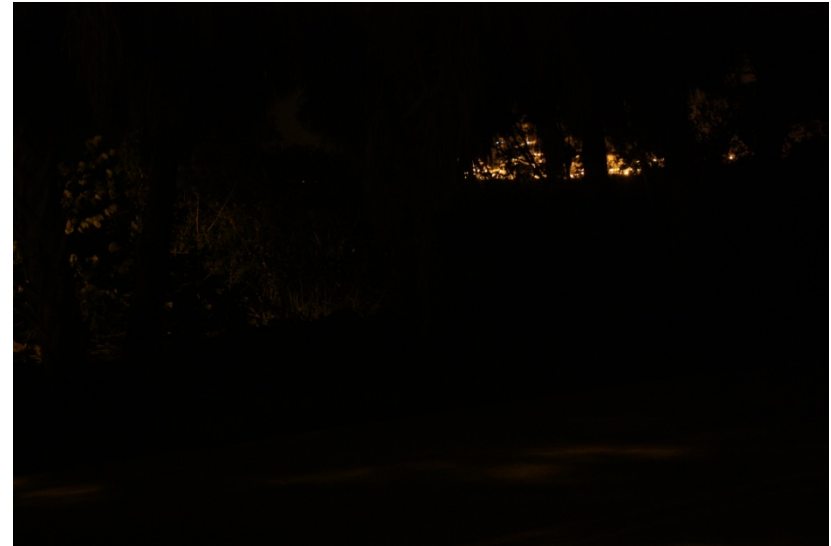
| Station | 4 |

| Location | Boundary A, entrance to existing facility |
| Direction | Southeast, towards plant |
| Sky Quality Meter Readings (Lux) | 0.0098 |

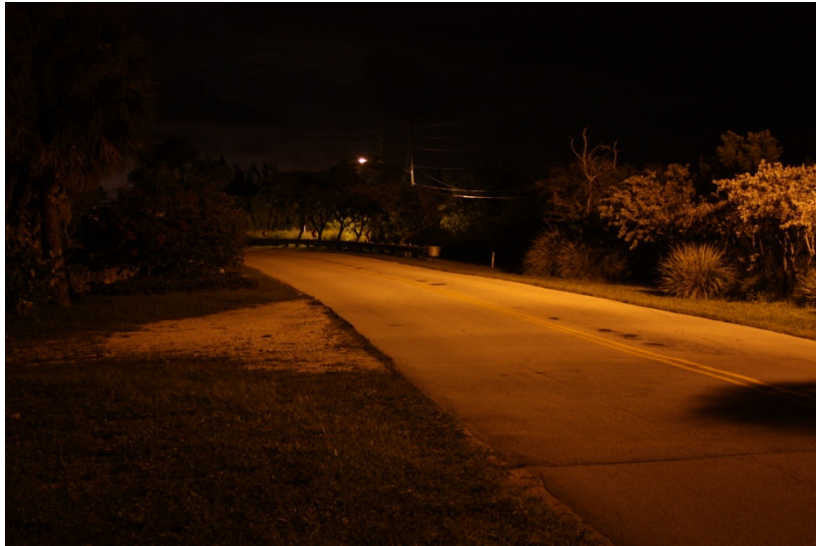
| Station | 4 |

| Location | Boundary A,<br>entrance to facility |
| Direction | North towards road, with Miami<br>in background |
| Sky Quality Meter Readings (Lux) | 0.0098 |

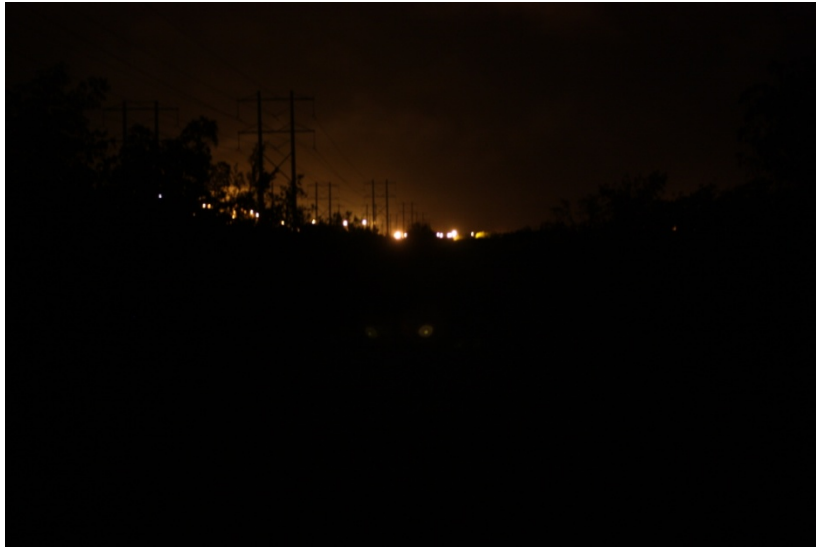
| Station | 5 |

| Location | Boundary B, North boundary of the transmission line |
| Direction | South, towards Plant |
| Sky Quality Meter Readings (Lux) | 0.0017 |

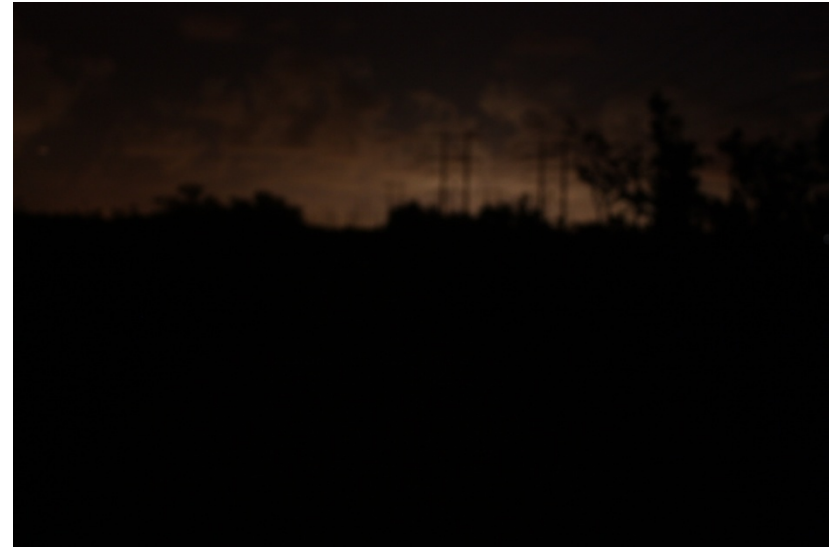
| Station | 5 |

| Location | Boundary B, North boundary of the transmission line |
| Direction | North, towards Miami |
| Sky Quality Meter Readings (Lux) | 0.0017 |

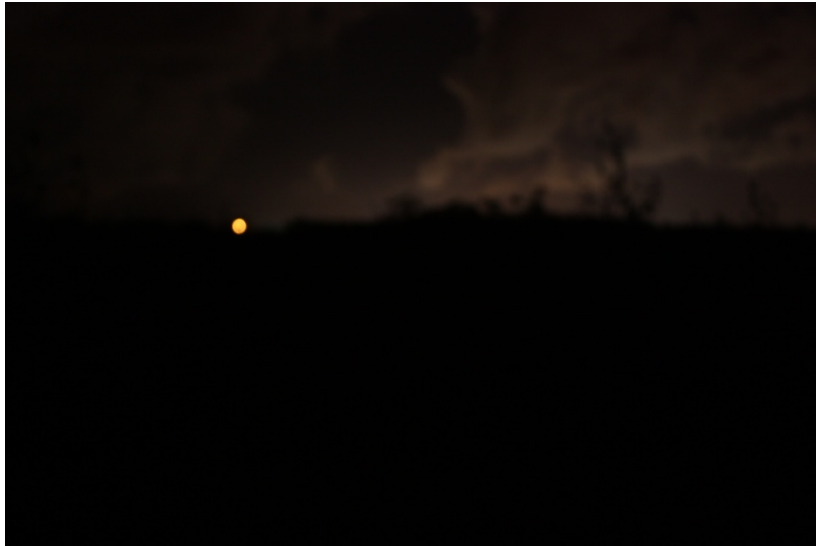
| Station | 5 |

| Location | Boundary B, North boundary of the transmission line |
| Direction | West, towards Homestead |
| Sky Quality Meter Readings (Lux) | 0.0017 |

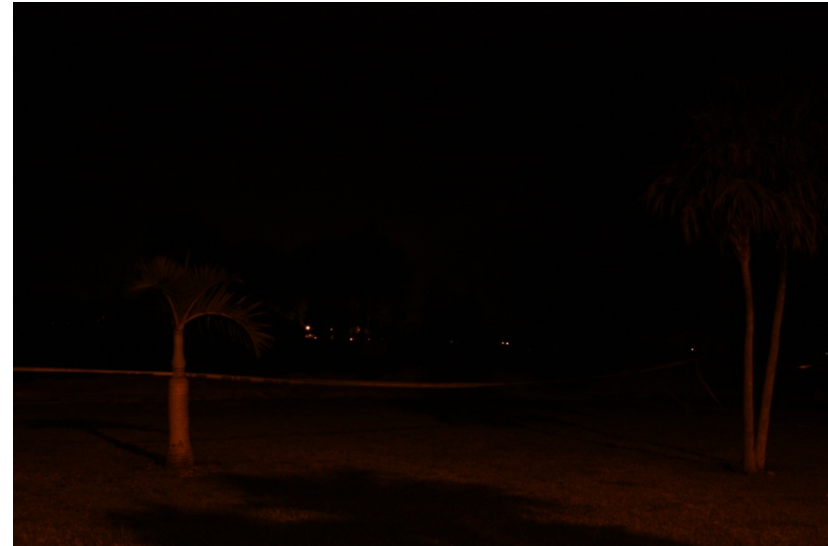
| Station | 6 |

| Location | Southeast corner of the parking lot of the daycare center |
| Direction | Southeast, towards Plant |
| Sky Quality Meter Readings (Lux) | 0.8193 |

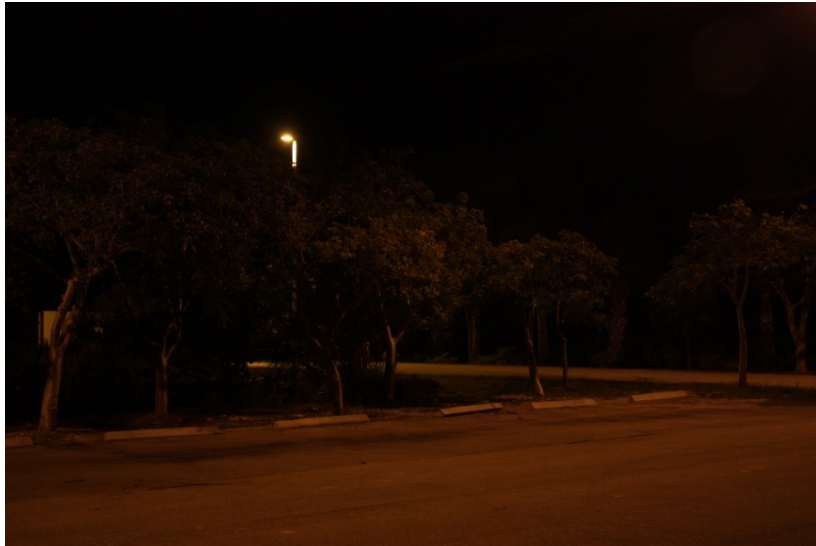
| Station | 6 |

| Location | Southeast corner of the parking lot of the daycare center |
| Direction | West, towards parking lot with Homestead in background |
| Sky Quality Meter Readings (Lux) | 0.8193 |

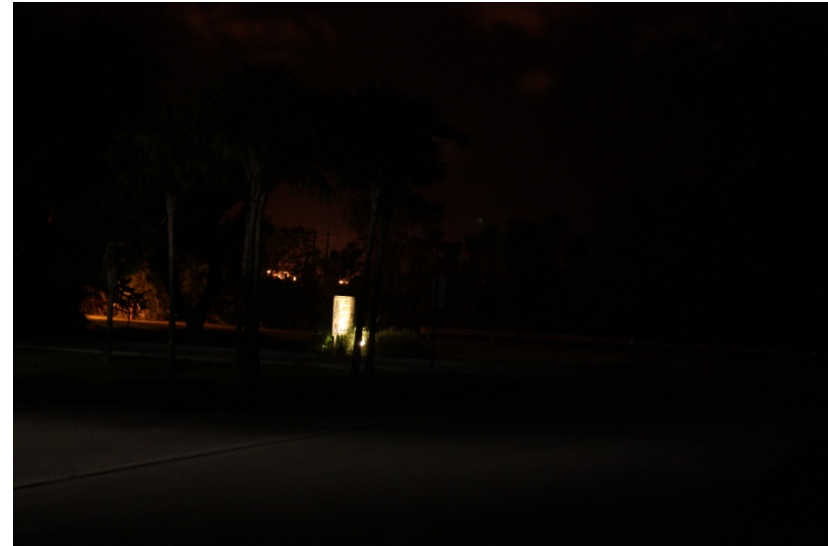
| Station | 7 |

| Location | Parking lot of Biscayne National Park |
| Direction | South towards plant, with parking lot light in foreground |
| Sky Quality Meter Readings (Lux) | 0.0012 |

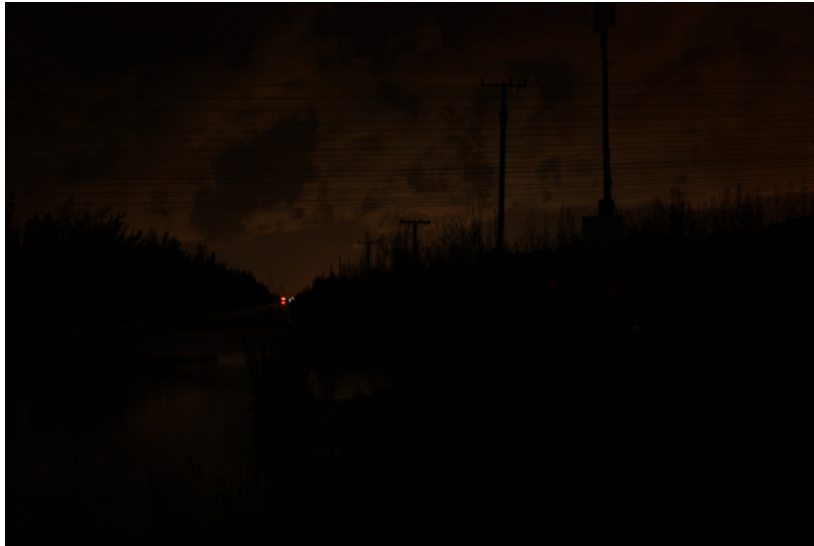
| Station | 7 |

| Location | Parking lot of<br>Biscayne National Park |
| Direction | West, towards Homestead |
| Sky Quality Meter Readings (Lux) | 0.0012 |

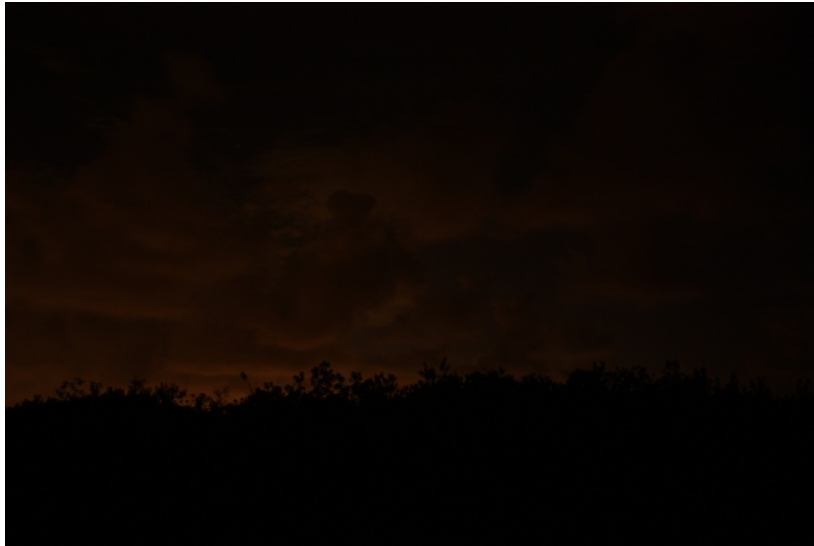
| Station | 8 |

| Location | Near permanent private residence at intersection of SW 117 <sup>th</sup> Avenue and SW 328 <sup>th</sup> Street/North Canal Drive |
| Direction | North, towards Miami |
| Sky Quality Meter Readings (Lux) | 0.0016 |

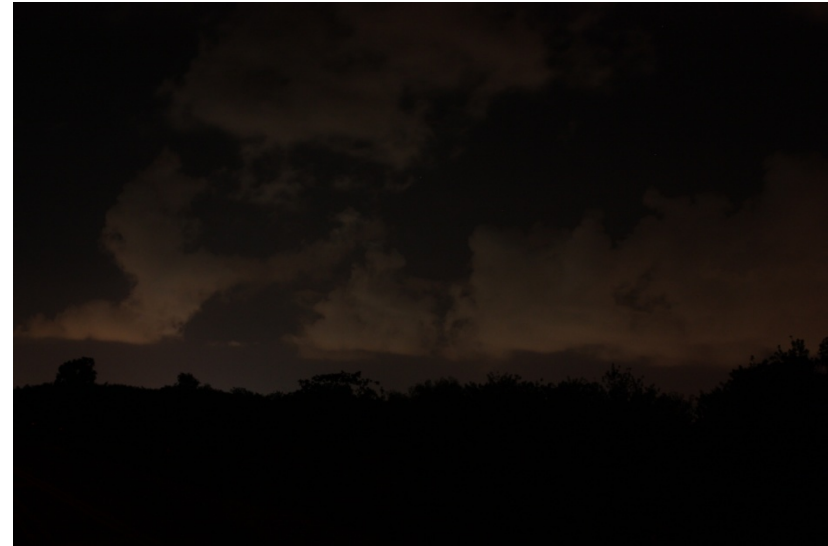
| Station | 8 |

| Location | Near permanent private residence at intersection of SW 117 <sup>th</sup> Avenue and SW 328 <sup>th</sup> Street/North Canal Drive |
| Direction | West, towards Homestead |
| Sky Quality Meter Readings (Lux) | 0.0016 |

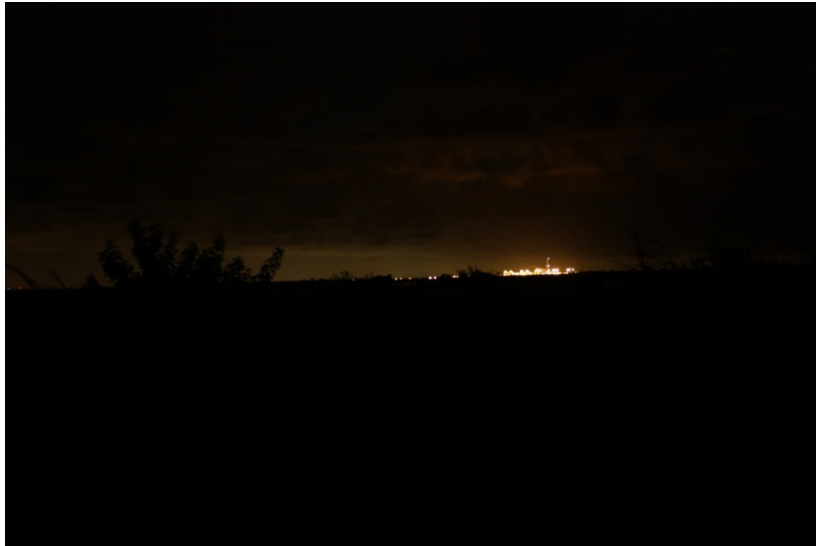
| Station | 9 |

| Location | Southernmost point of the industrial wastewater facility |
| Direction | Northeast towards plant with Miami in background |
| Sky Quality Meter Readings (Lux) | 0.0008 |

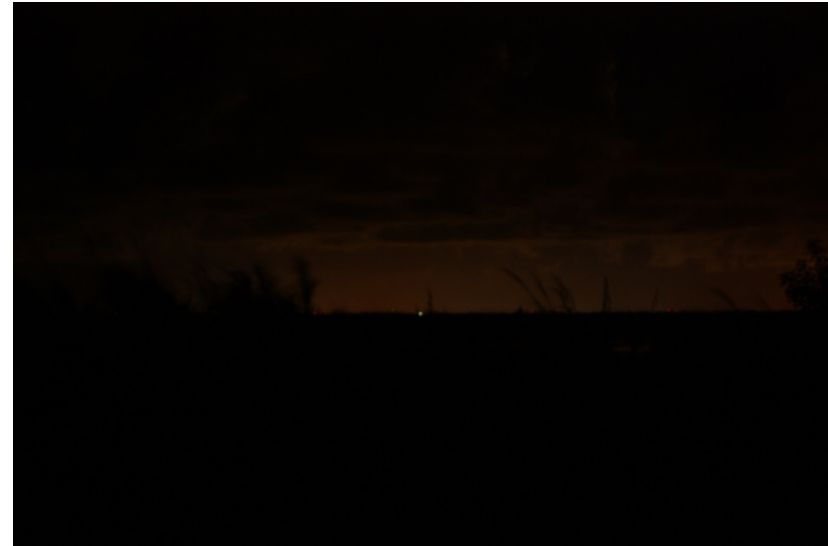
| Station | 9 |

| Location | Southernmost point of the industrial wastewater facility |
| Direction | Northwest towards City of Homestead |
| Sky Quality Meter Readings (Lux) | 0.0008 |

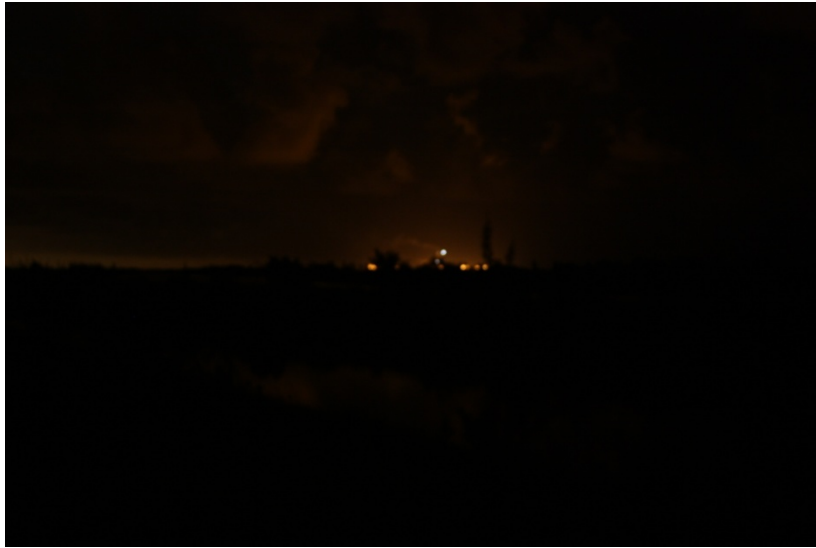
| Station | 10 |

| Location | Westernmost point of the industrial wastewater facility |
| Direction | Northeast, towards plant and Miami |
| Sky Quality Meter Readings (Lux) | 0.0007 |

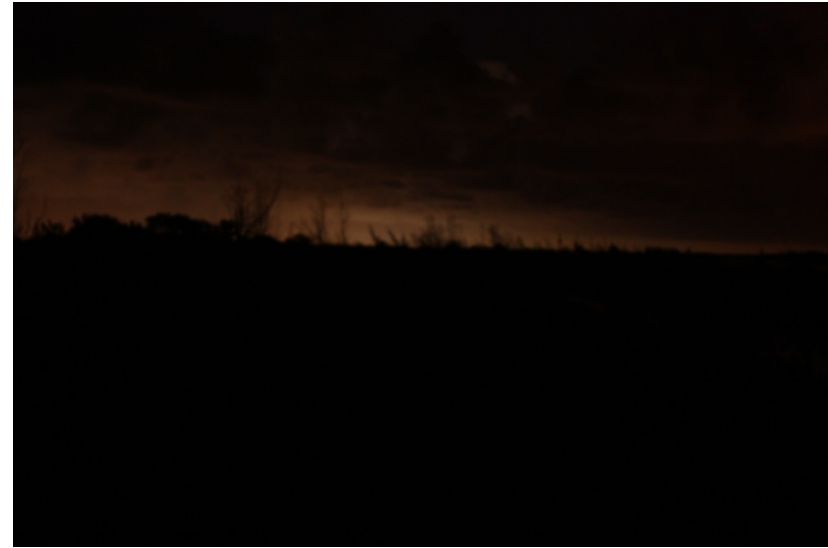
| Station | 10 |

| Location | Westernmost point of the industrial wastewater facility |
| Direction | North, towards Miami |
| Sky Quality Meter Readings (Lux) | 0.0007 |

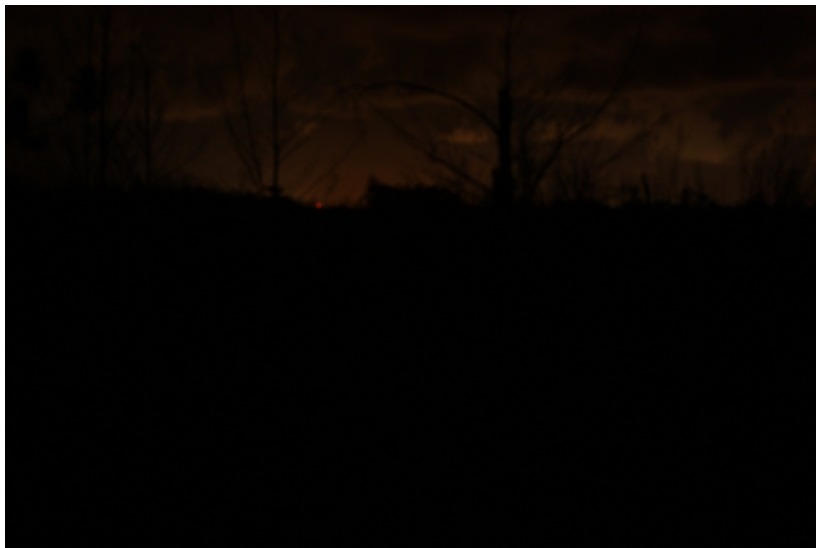
| Station | 10 |

| Location | Westernmost point of the industrial wastewater facility |
| Direction | Northwest, towards Homestead |
| Sky Quality Meter Readings (Lux) | 0.0007 |
