# Summary of Results

## Walk the WBID Exercise for Turkey Creek (WBID 1578B)

*Florida Department of Environmental Protection  
Division of Environmental Assessment and Restoration  
Bureau of Watershed Restoration  
Tallahassee, FL 32399*

August 2012

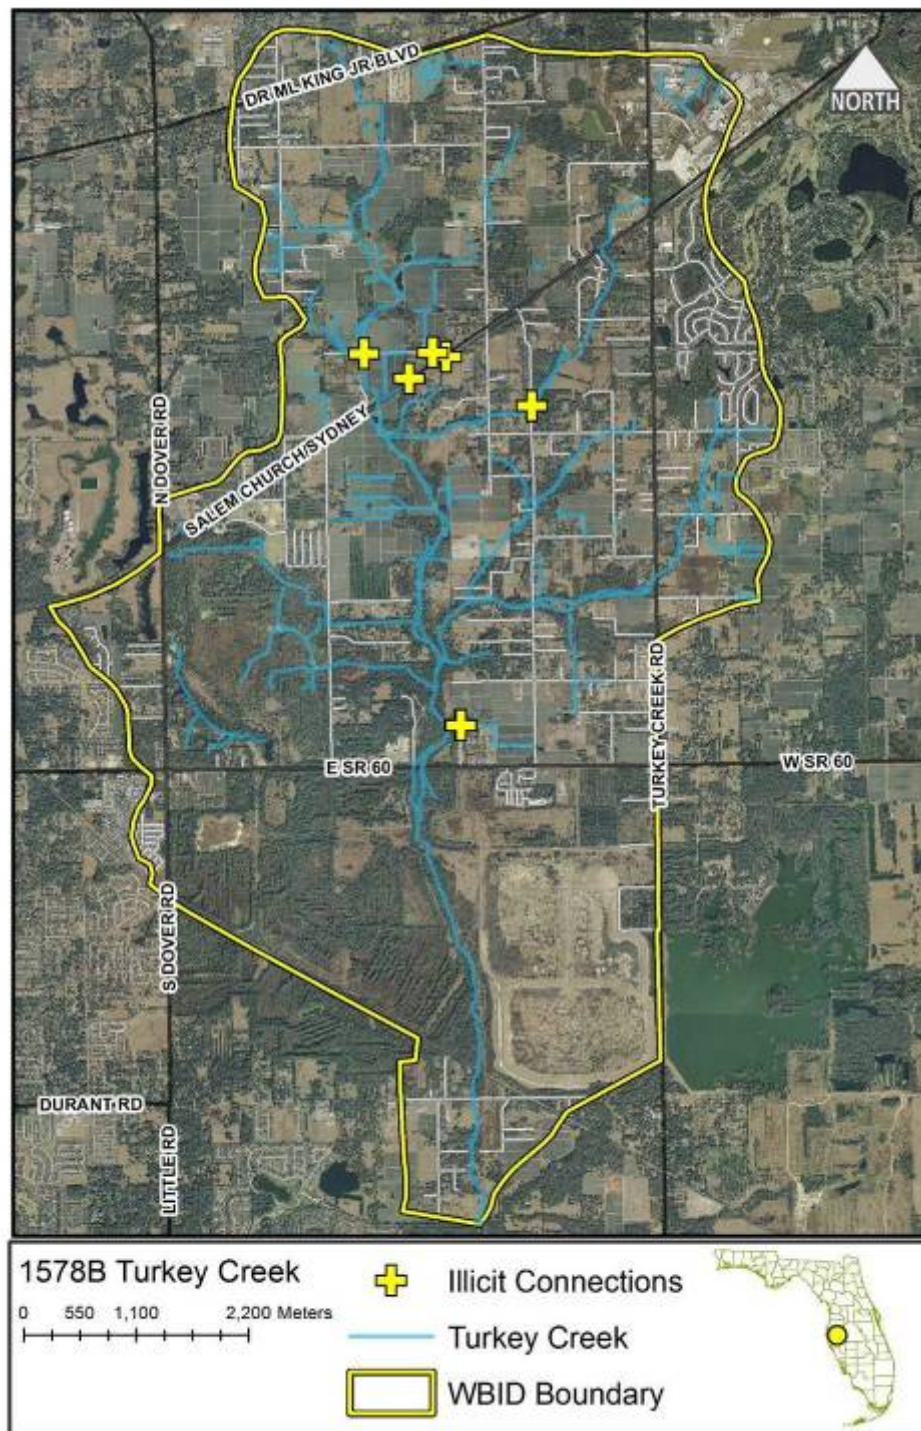
Figure 60. Location of potential illicit connections identified during the Walk.

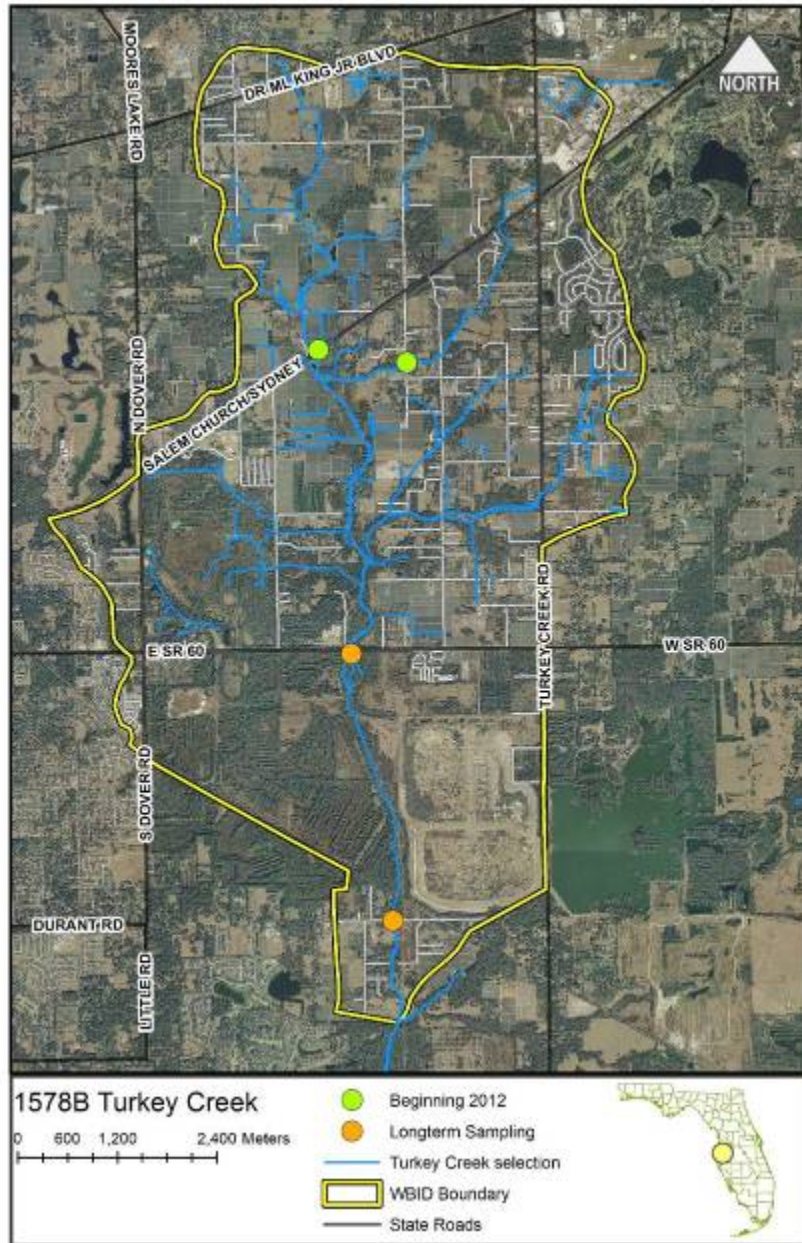
Figure 62. Location of quarterly water quality sampling locations in the Turkey Creek basin. Two additional sampling locations were added north of SR 60 due to the Walk the WBID event.
